## Case study: Teale

Property location: Bellmount Forest, NSW  
 Size: 21 hectares  
 Owners: Jim & Liz Teale  
 Project completion: November 2020

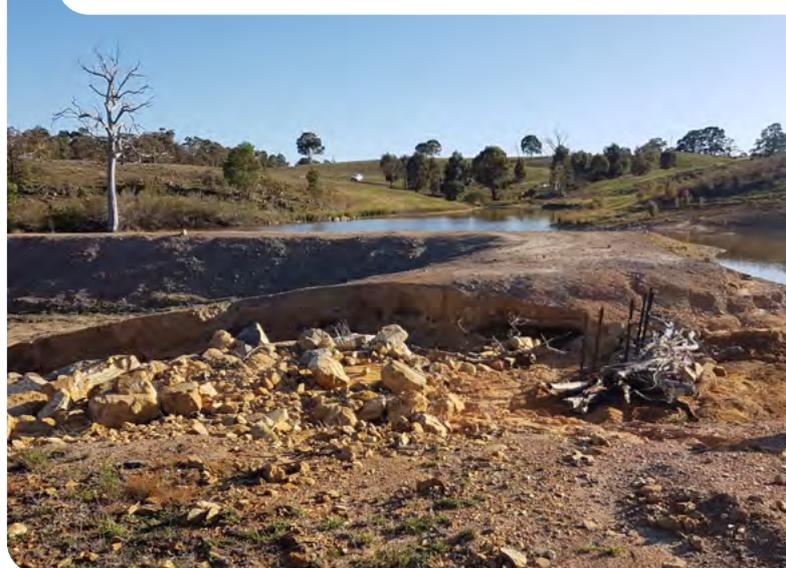
**Top:** After – Lower dam spillway. Completed repair works.  
**Right:** Before – Lower dam spillway. Site prior to on-ground works.

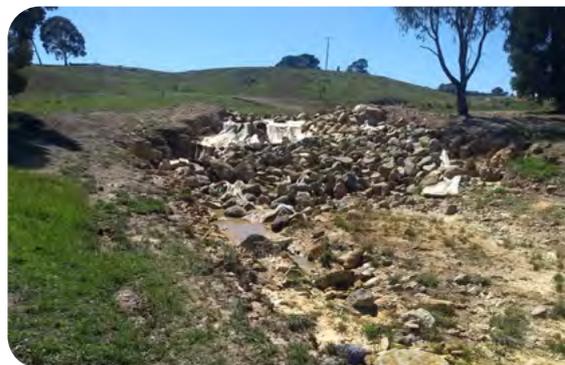
**Main gully, upper section – before**  
Previous erosion repair efforts had caused further, extensive damage.

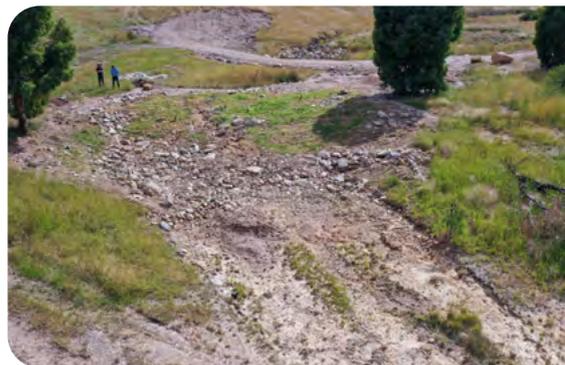
**Main gully, upper section – after**  
Series of rock steps armoured against high-energy water flows, with vegetation planted in between steps to further slow the water flow.

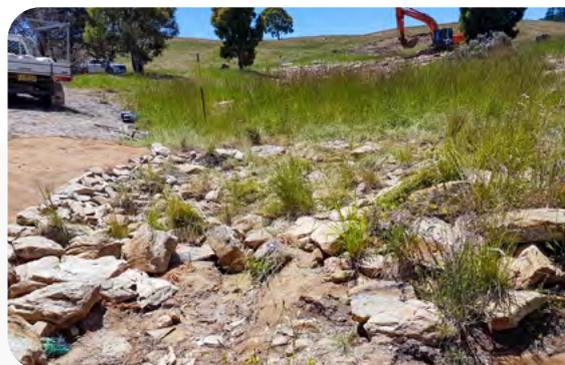
Other minor works included a hand built **rock ramp** to repair an eroded site and the planting of vegetation to slow water flow and capture sediment runoff.
