Case study: David

Property location: Wamboin, NSW
 Size: 16 hectares
 Owners: Fiona David & Jake Blight
 Project completion: November 2020

Initial site assessment

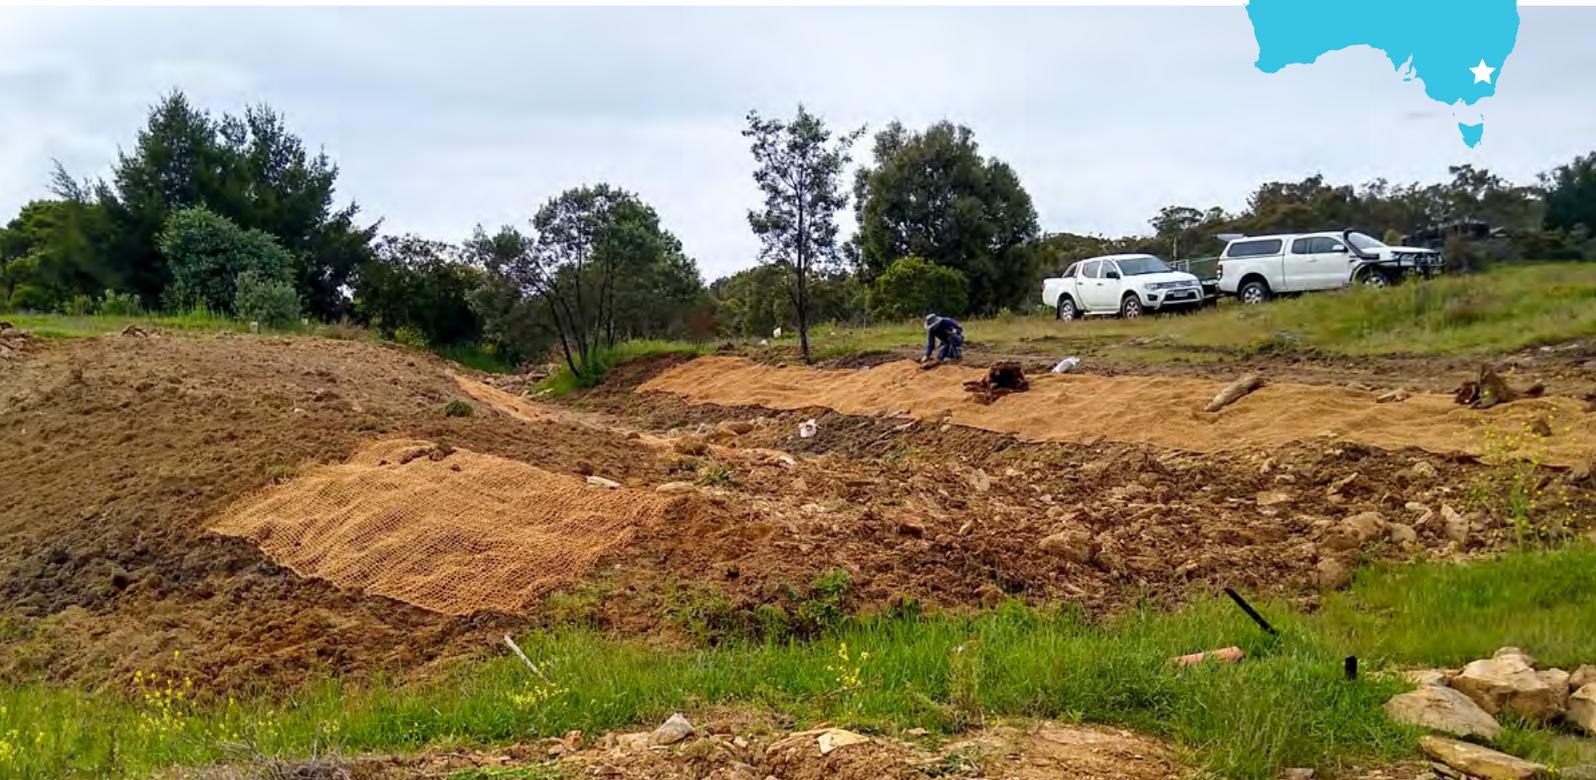
Top: After – Lower half of system following restoration works.
Right: Before – Lower half of system prior to on-ground works.

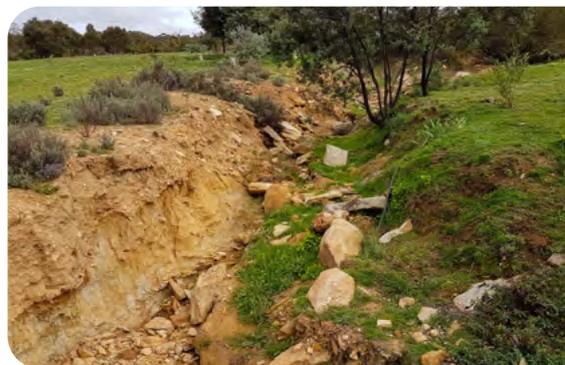
Gullies on the property are severely incised and eroded as a result of the grazing. During peak flow, water concentrates down these gullies causing further erosion and damage to infrastructure.

Before – Highly eroded gully was unable to manage high energy water flows.
