Case study: Centralian Project

Project location: Australian Central Rangelands, NT.
Country: Anmatyerre & Arrernte
Size: Approx. 8,000 hectares across four properties, all within 200kms of Alice Springs.

The intent of this project is to demonstrate drought resilience at scale and assess the environmental and economic outcomes of landscape rehydration in this arid, pastoral landscape. Working landscape rehydration demonstration sites were designed and constructed on creek catchments at the four participating stations.

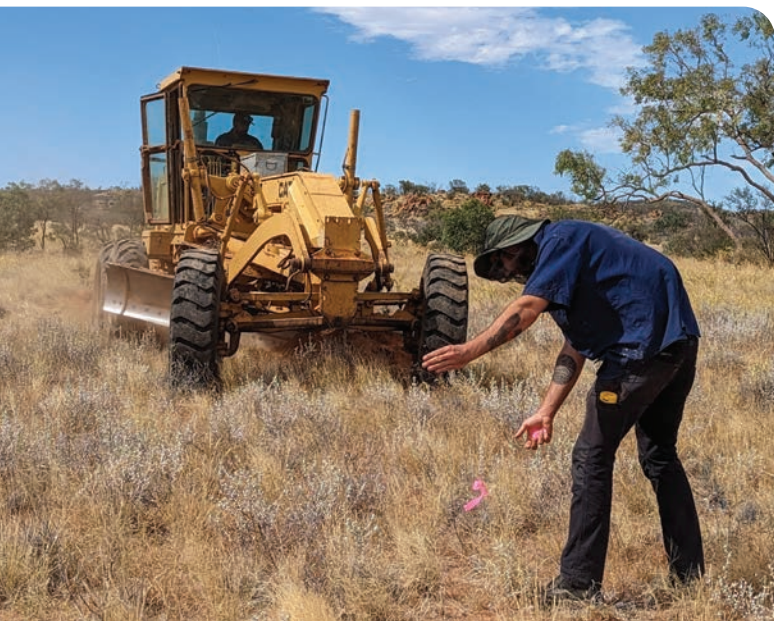
Above – Inspecting a **contour bank** at Narwietooma station.

To complement in-stream structures such as earth banks and further spread water across the landscape, **contour banks** were installed at key locations. These are designed to capture and slow water flow and re-distribute water away from the lower landscape and out onto the scalded floodplains and drier ridges. The contours are designed with emergency overflow sills for extreme flood events, ensuring their longevity and reducing the risk of bank failure.

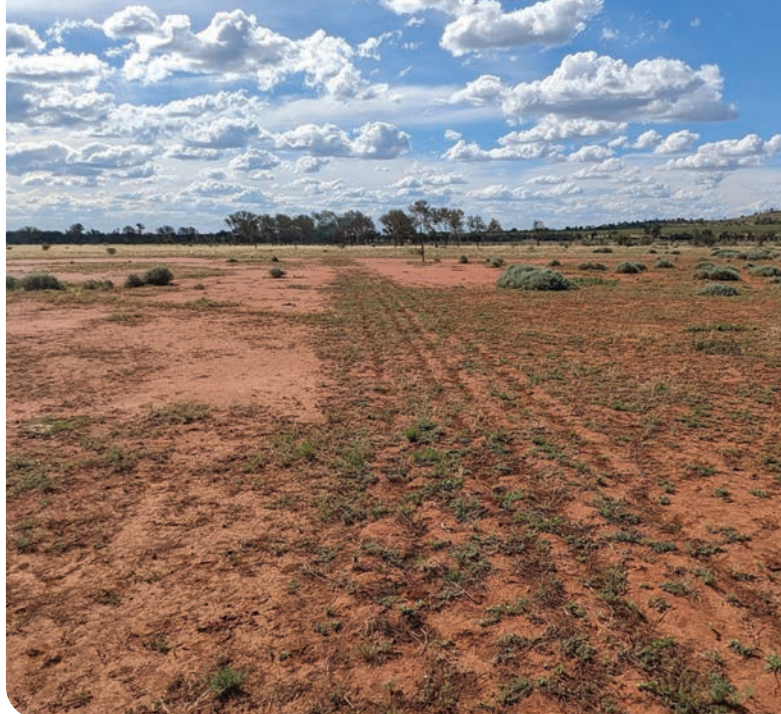
Above – Six months after these **ripples** were made, vegetation has established within the ripped area and upslope where seeds deposited after rain.

Shallow ripples across scalded areas of the floodplain are another simple, low risk, but very effective solution for increasing the surface roughness of the soil. This technique slows the flow of water across formerly compacted and bare soil surfaces, increasing infiltration as well as deposition of seeds and organic material.
