## Case study: Lorrina

**Project location:** Braidwood, NSW  
**Country:** Walbanga  
**Size:** 102 ha  
**Participants:** Andrew Bullock  
& Justine Isemonger  
**Project updated:** May 2023

This project aims to restore Lorrina's natural hydrological processes for improved environmental, aesthetic and production outcomes.

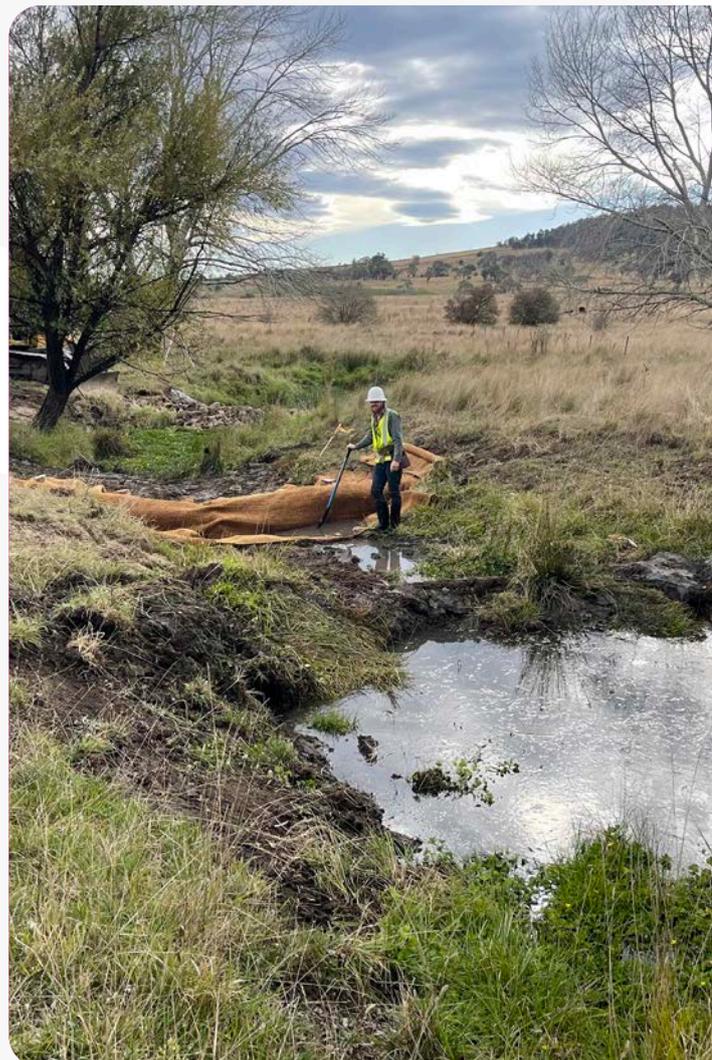
**Above:** Rock weir (foreground) and log-sill weir (background) during the first flow-over event following construction. The rock weir provides backwater to the downstream side of the L4 structure.

**Right:** Construction of the rock weir and log-sill weir.

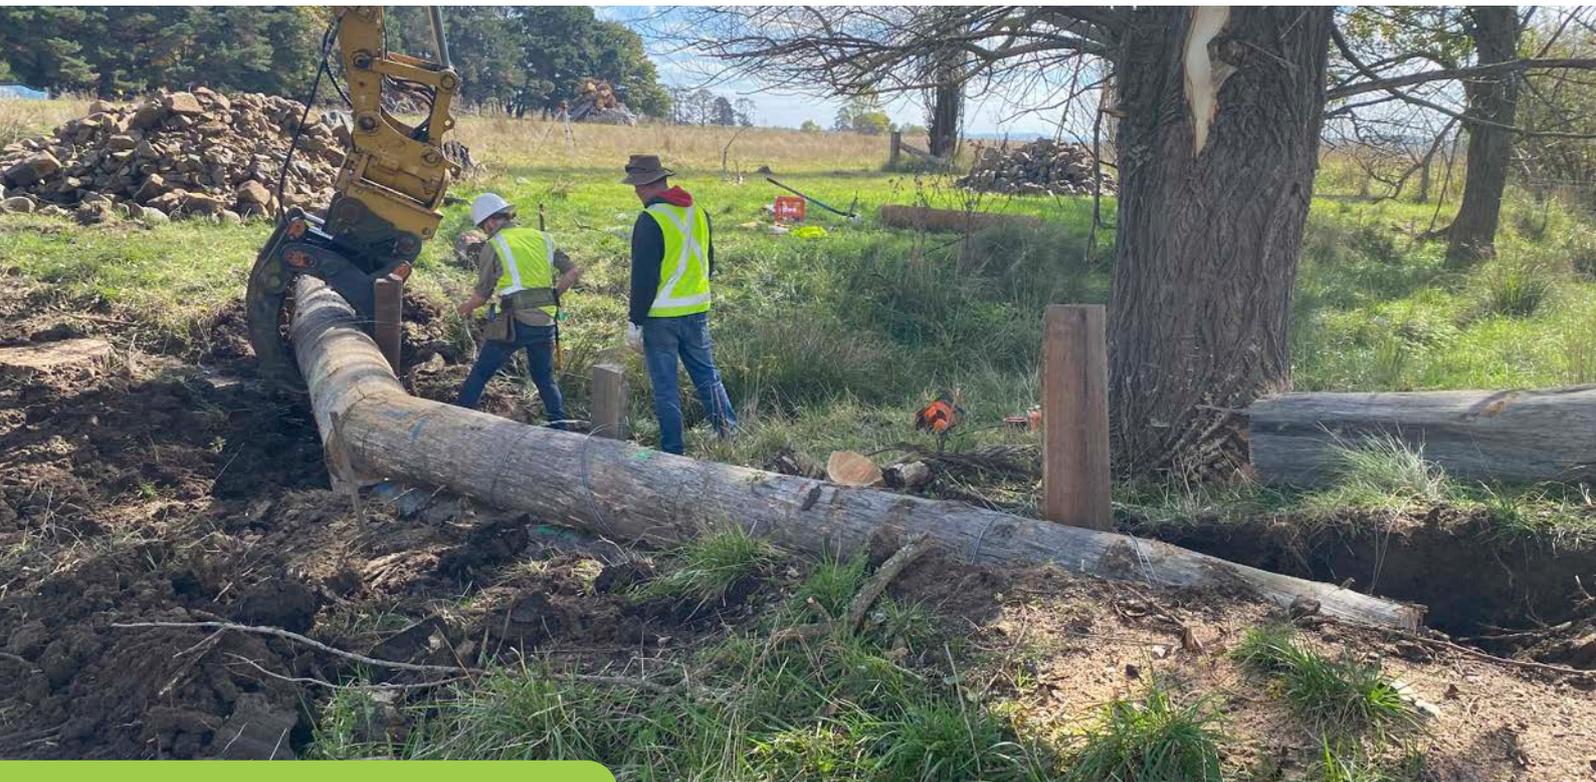
**Above:** Log-and-sill weir construction of top log weir.

**Right:** A series of rock weir structures along Brushy Hill Creek. Soon after completing the work the area received 50 mm of rain over two days. The pools filled up and a gentle flow began through the new rock riffles.

- **Log-&-sill weirs:** to raise stream bed and water level along Brushy Hill Creek and in turn stabilise eroding banks while facilitating water capture into the landscape to extend pasture growth and support riparian vegetation
- **Rock weirs:** of a smaller scale than the log-and-sill weirs to manage the head drop between log-and-sill weir structures. These act as a series of riffles to slow water movement and create pools.
- **Rock groynes:** to diver flows away from an active headcut and back into the meander channel. This will greatly reduce flow velocity and consequently erosion.
- **Rock baffles:** to trap sediment and aid rehydration and restore a recharge zone
- **Access crossings:** two upgrades on existing crossings, two new crossings requiring improvement.

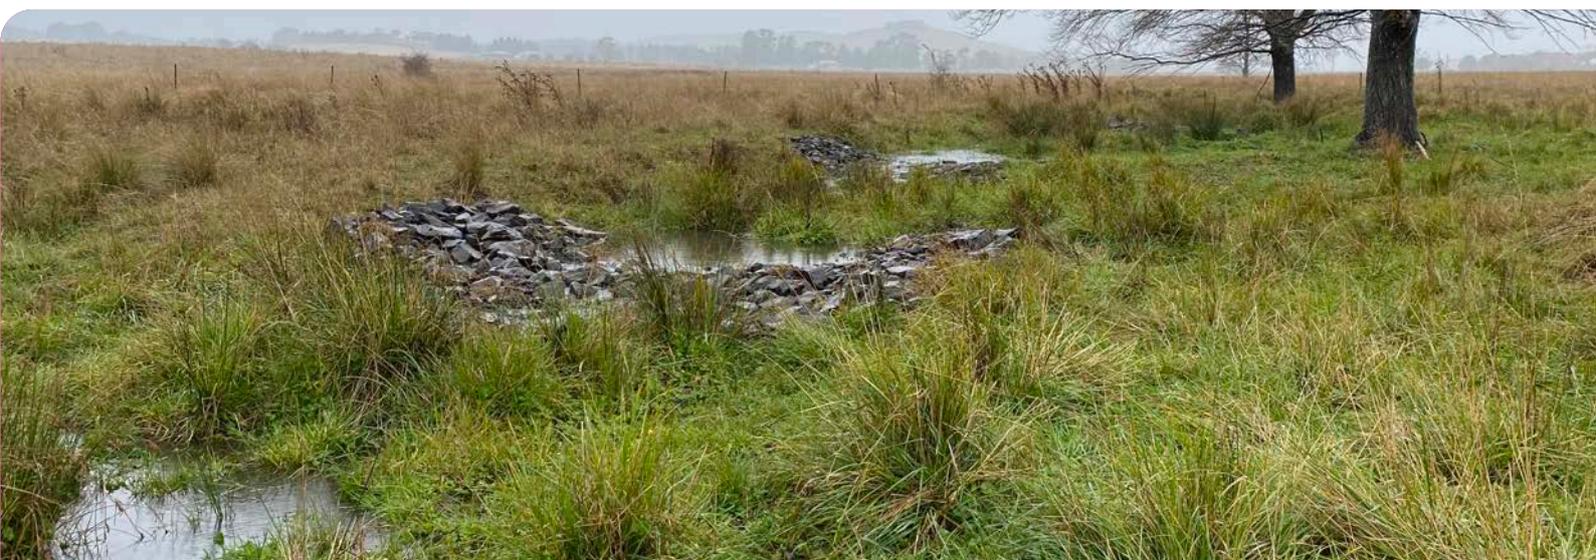
**Top:** Cattle previously had unrestricted access to Brushy Hill Creek which damaged riparian vegetation and contributed to erosion.

The landholder is supplementing the works by fencing riparian areas and revegetating to support the site's long-term restoration.

- **Fencing:** exclude stock from Brushy Hill Creek and tributaries to remediate damage caused by stock accessing creek line and protect newly vegetated area. Fencing redesign to increase the number of paddocks, centralise troughs (minimise piping & pumping costs) and reduce grazing pressure of set stocking
- **Earthbanks & contours:** the purpose of these is to slow water and discharge it out onto paddocks to reinstate overland flow patterns.
- **Water reticulation:** Solar pump to improve efficiency of pumping system from dam to header tank, make water supply for stock more reliable
- **Revegetation:** a mix of native trees, shrubs and grasses planted along riparian areas and paddock bounds to restore small water cycle, increase biodiversity, provide shade and bird habitats, provide wind shelter and improve aesthetic value of property.

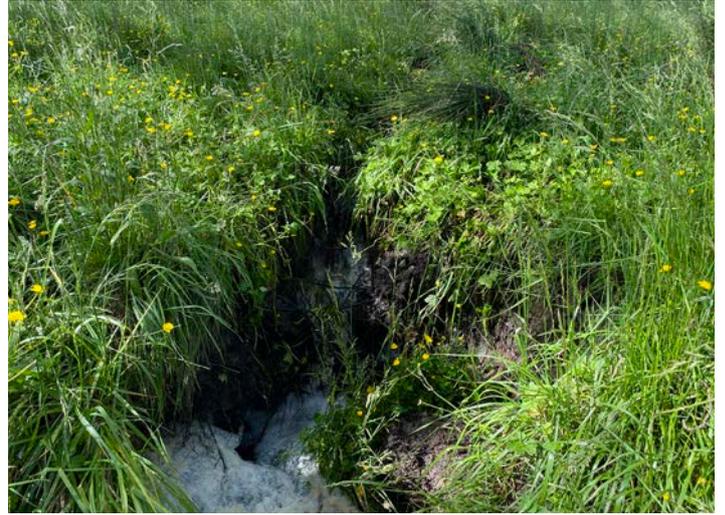
**Top:** An active headcut along a tributary of Brushy Hill Creek as a result of erosion and high velocity flow.

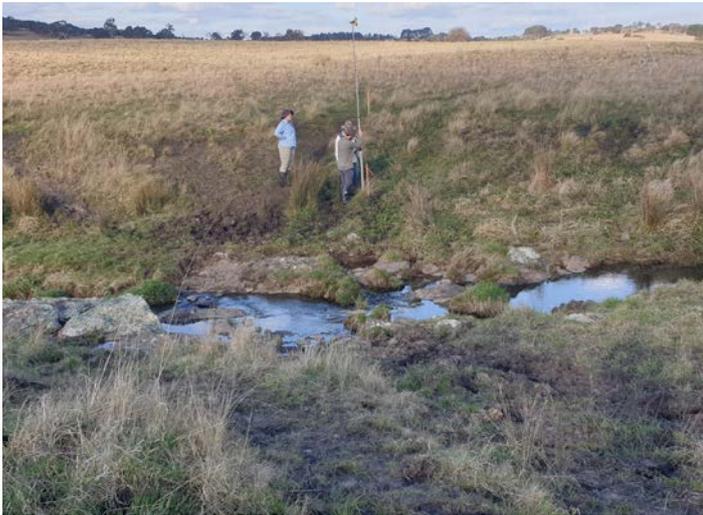
**Above:** Creek crossing before construction works.

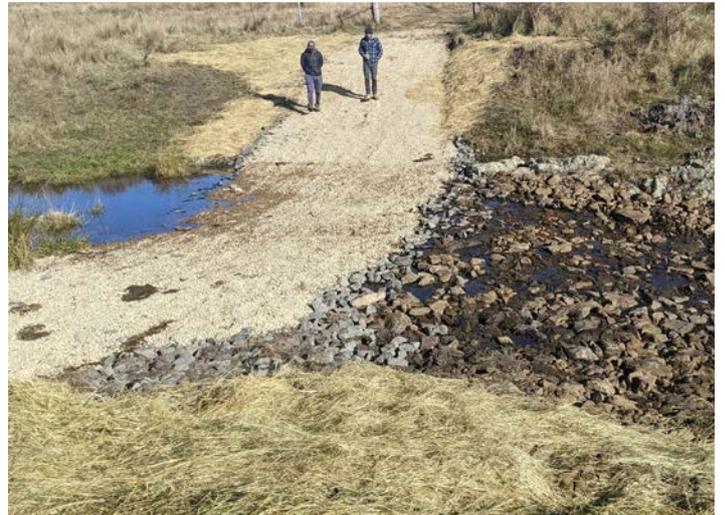
**Above:** Upgraded creek crossing after restoration works.
