Using seasonal rapid stream assessment (RSA) to monitor water quality and stream health parameters at Mulloon Creek, Bungendore NSW

Submitted in partial fulfilment of the requirements for the degree of
Master of Environmental Science (Advanced)
of the Australian National University
March 2024

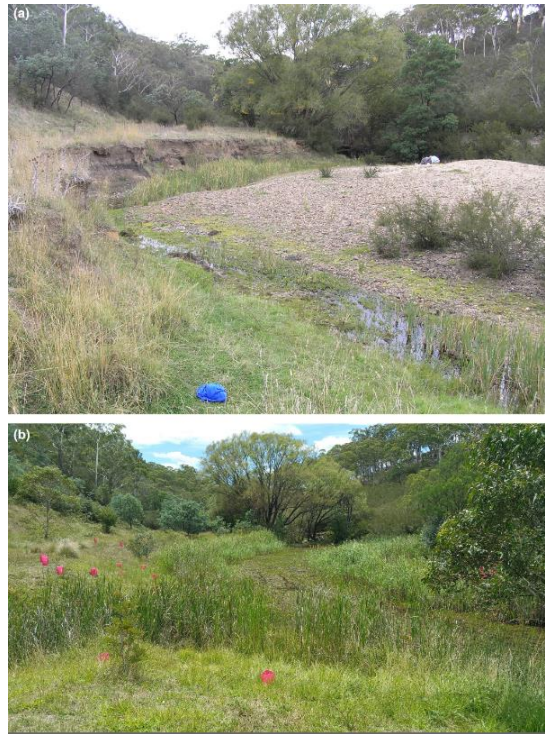
Figure 6. Comparison of pilot projects at Mulloon Creek before and after leaky weir emplacement. In March 2006, a pilot site exhibited signs of degradation, with an eroded stream bank and a noticeable absence of ponding (A). However, by February 2018, significant improvements were evident in the same location (Peter's Pond). Extensive revegetation had taken place along the stream banks, effectively stabilizing them. Additionally, a stone-based 'leaky weir' had been constructed, leading to the formation of large ponds (B) (Peel et al., 2022).

Leaky weirs in the Mulloon Creek area have been instrumental in enhancing river restoration efforts (Figure 6; Peel et al., 2022). By maintaining a consistent flow of water through these structures, the water velocity in the creek decelerates. This slowdown, coupled with elevated water levels, mitigates the erosive impact of swiftly moving water, and it provides a more dependable water source for the local flora and fauna (Dudley and Peel, 2021). Groundwater flows into the creek system, helping maintain water levels and safeguarding vegetation against dehydration. This, in turn, acts as a protective measure for the riverbanks, contributing to a reduction in erosion (Dudley and Peel, 2021). Reinvigoration of streambank revegetation demonstrated the efficacy of the leaky weirs in revitalizing riparian biological processes and reinstating functional linkages between streams and neighboring floodplains.

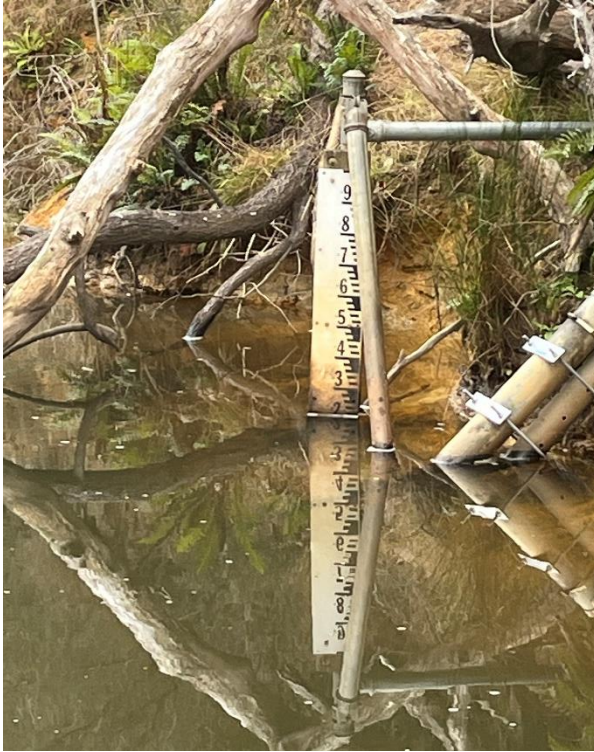
Figure 26. water level gauge in Black Jackie

Stream flow is monitored using devices positioned at Black Jackie and Wombat ponds (Figure 26 and 27). In this fieldwork, stream flow rates below 15mL/day are categorized as low flow, while rates exceeding 15mL/day are considered high flow.

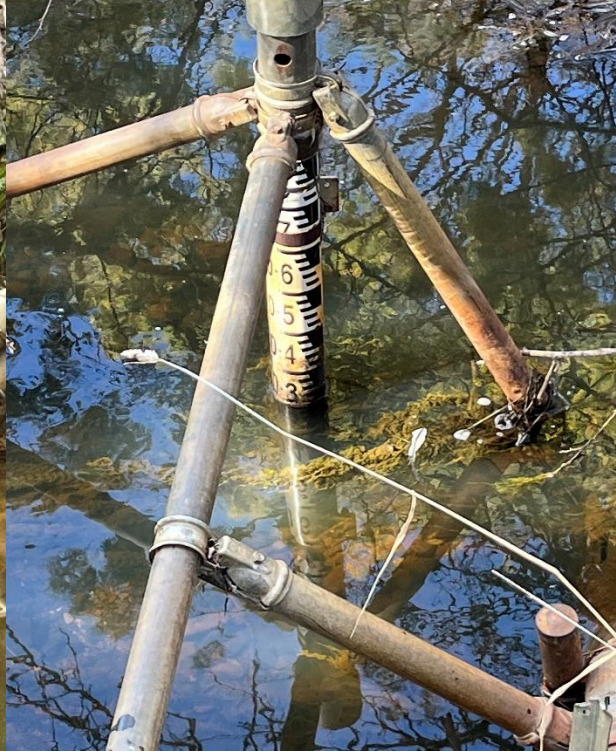
Figure 27. water level gauge in Wombat ponds

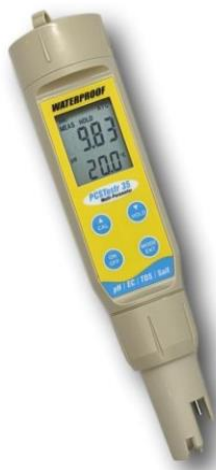
Figure 28. PCS TESTR 35 water quality detector

During the field investigation, two instruments were used to monitor water quality: the PCS TESTR 35 water quality detector (Figure 28) and the Manta water quality sonde (Figure 29). The PCS TESTR 35 water quality detector is capable of measuring five different parameters, namely pH, EC, TDS, Sal, and T. To obtain measurements using this instrument, the surveyor inserts the detector's head into the stream or river being measured and records the data.

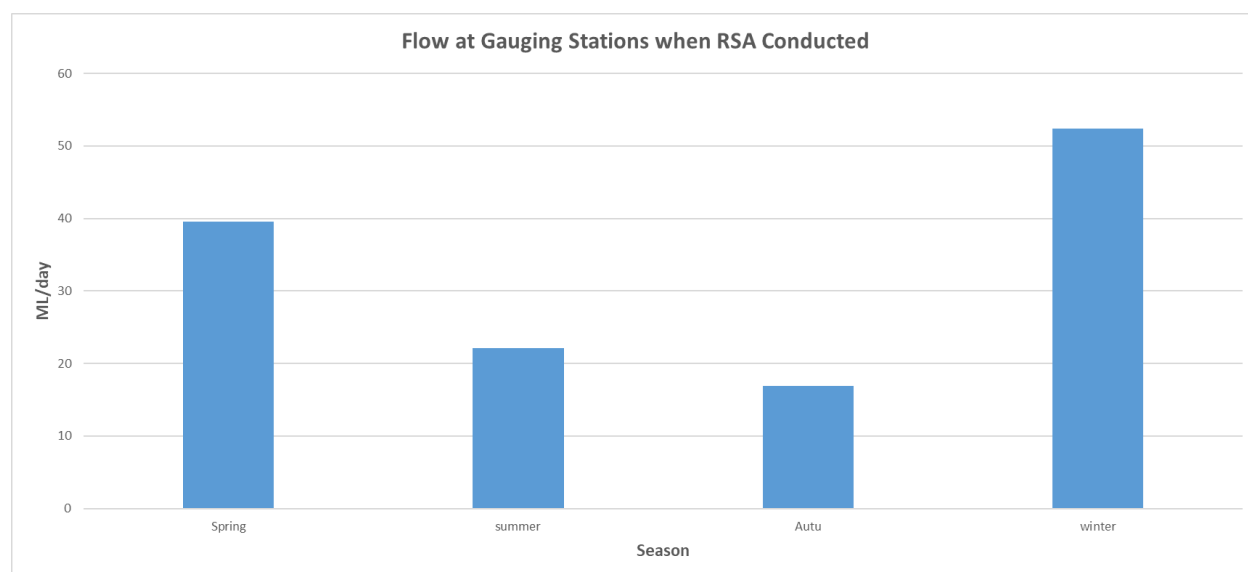
Figure 31. Flow at Gauging Stations when RSA Conducted with season

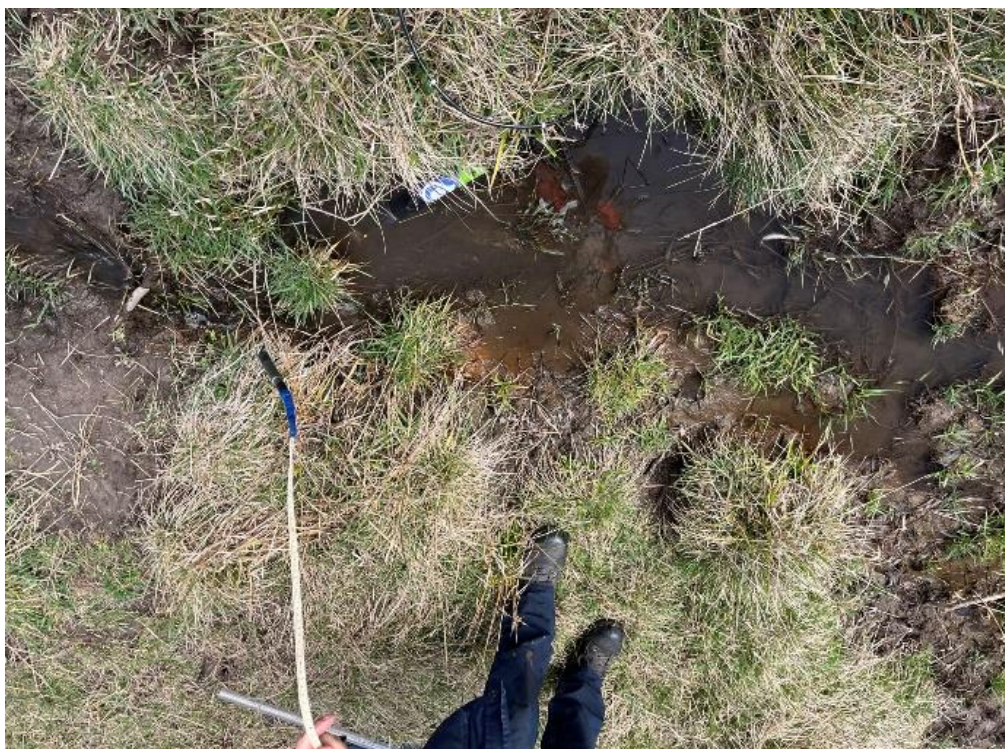
Figure 94. Water in the channel from David's Swamp (Site 14) is typically warmer and more saline than water in Mid-Mulloon Creek

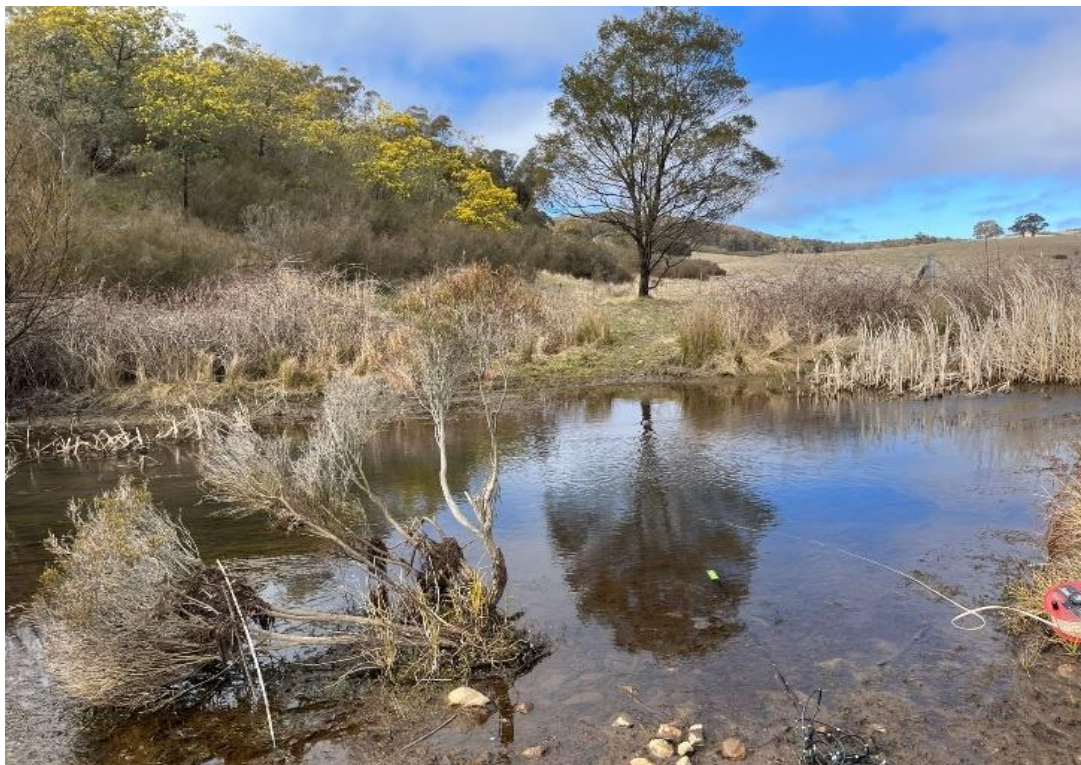
Figure 95. Crossing north of Williams Crossing (Site 12) is episodically disturbed by vehicles crossing, and stock watering

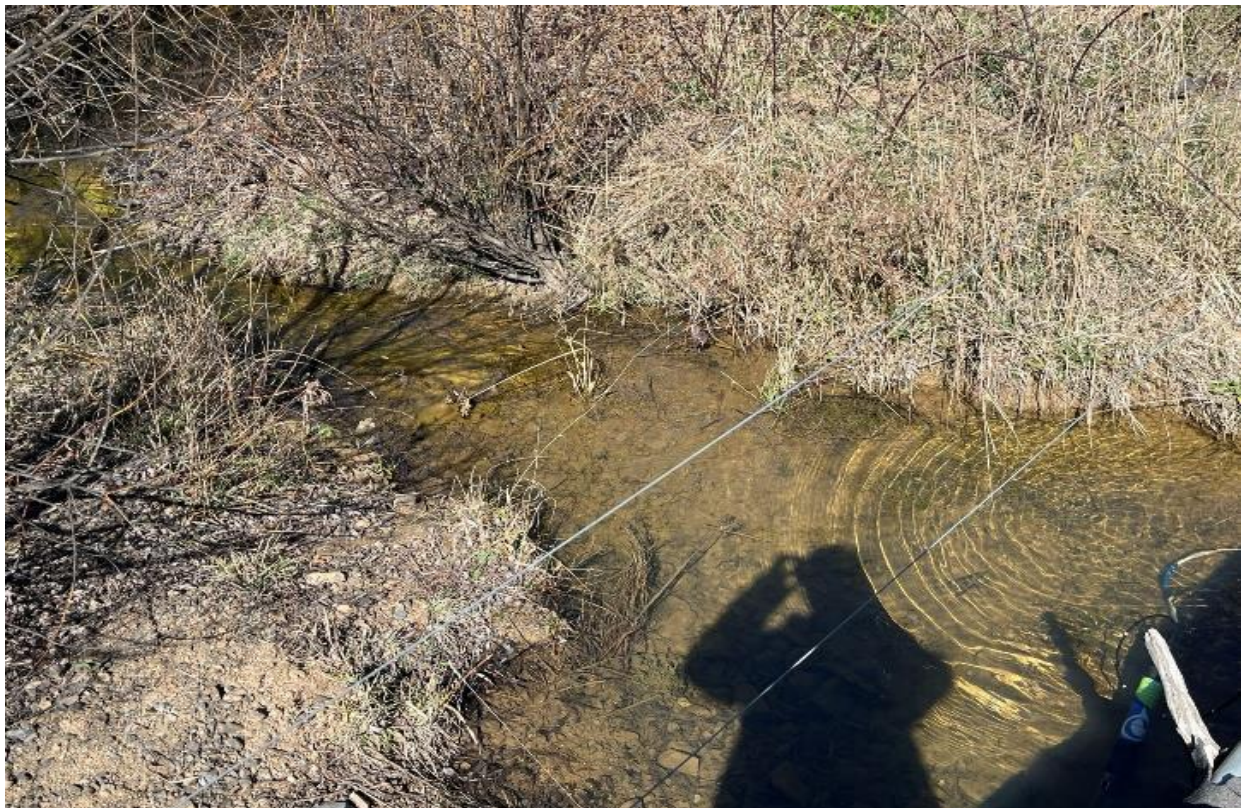
Figure 96. Clear water at Raddle Creek (Site 18) with elevated EC relative to Lower Mulloon Creek

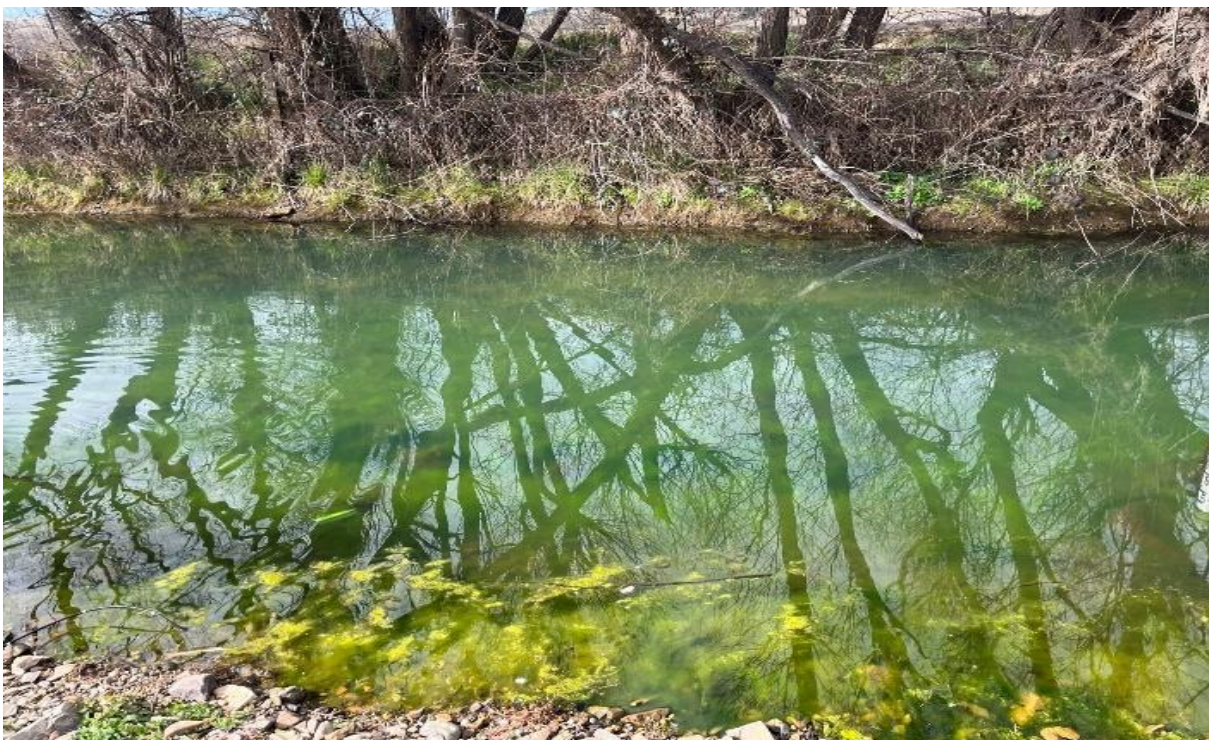
Figure 97. Relatively clear water Sandhills Creek (Site 29) with elevated EC relative to Lower Mulloon Creek

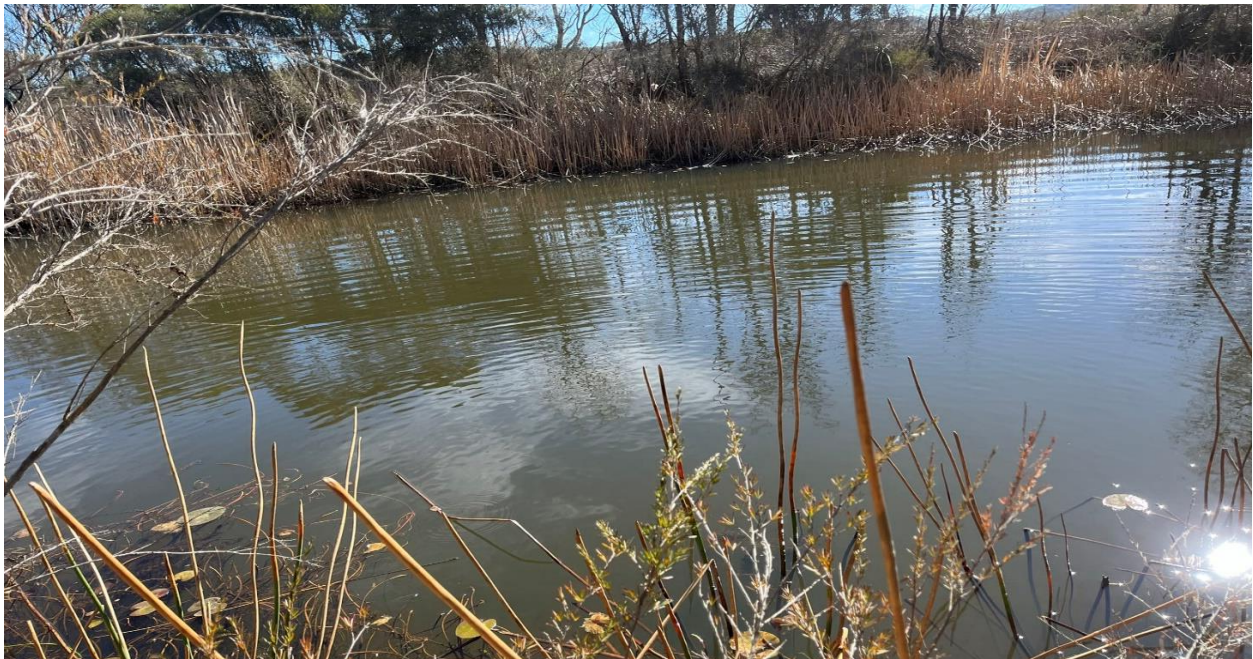
Figure 100. Carrol's 3 (Site 21) experienced elevated turbidity associated with localized waterlogging in 2014 and 2016.

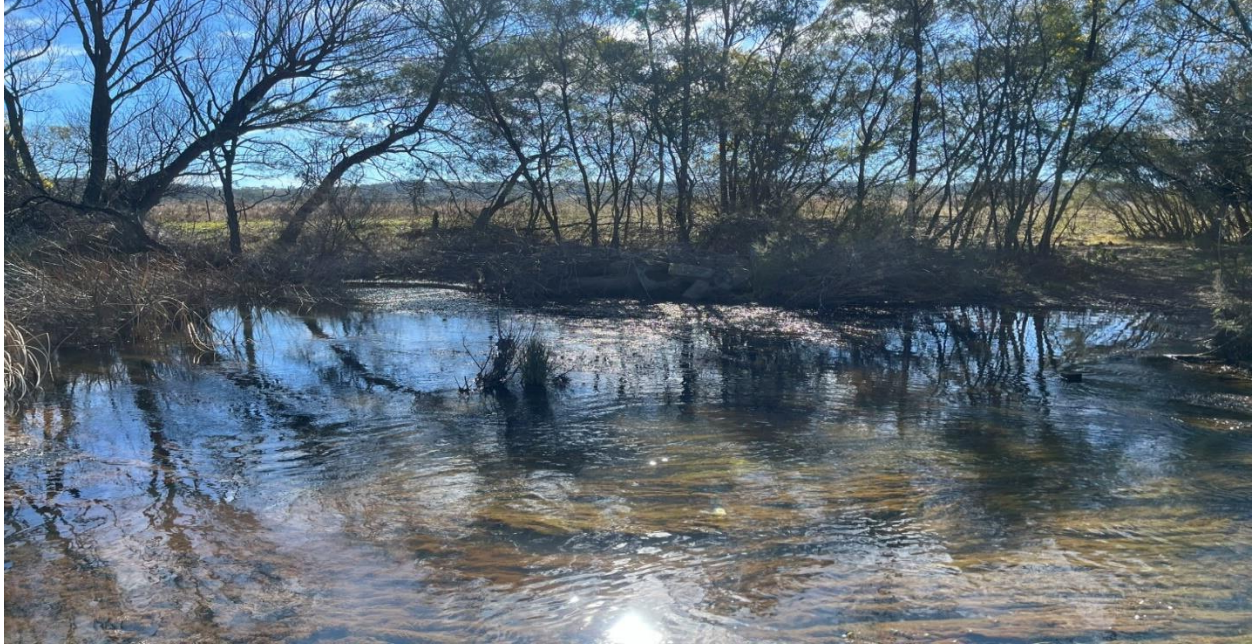
Figure 101. Soil Con weir at Carrol's (Site 22) experienced elevated turbidity associated with localized waterlogging in 2014 and 2016.

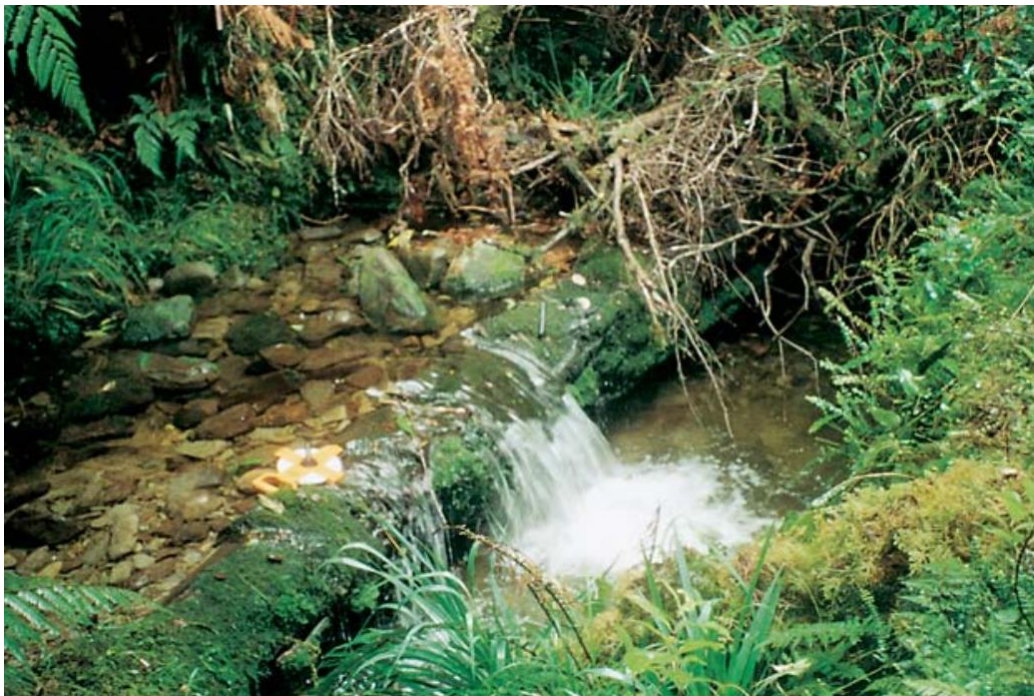
Figure 102. Fallen trees create natural leaky weirs (Meleason et al., 2002)
