Case study: Weetalaba Station

Project location: Glendon Rd, Newlands QLD

The Weetalaba landscape rehydration site is an old alluvial fan which has eroded into a deeply incised gully system, cutting a shortened path down to Rosella Creek, lowering the flowline and eroding into productive agricultural land.

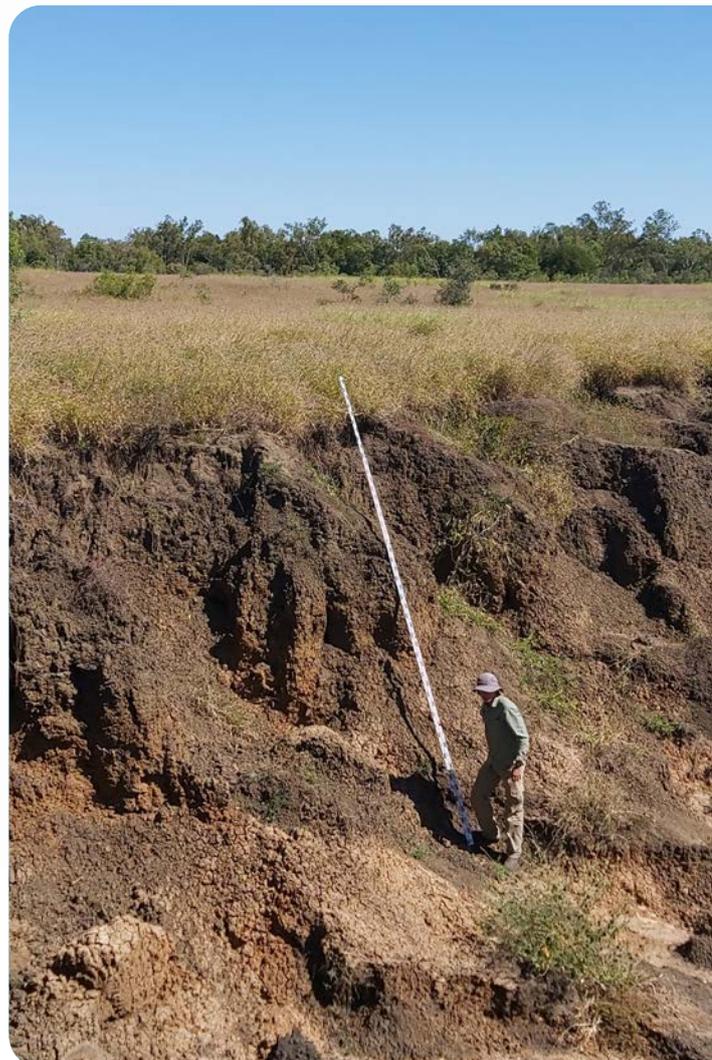
Above – Water formerly flowed through these incised gullies carrying sediments into the Great Barrier Reef lagoon.

Right – Mulloon Consulting team conducting a site assessment of a five-metre deep erosion gully on Weetalaba Station.

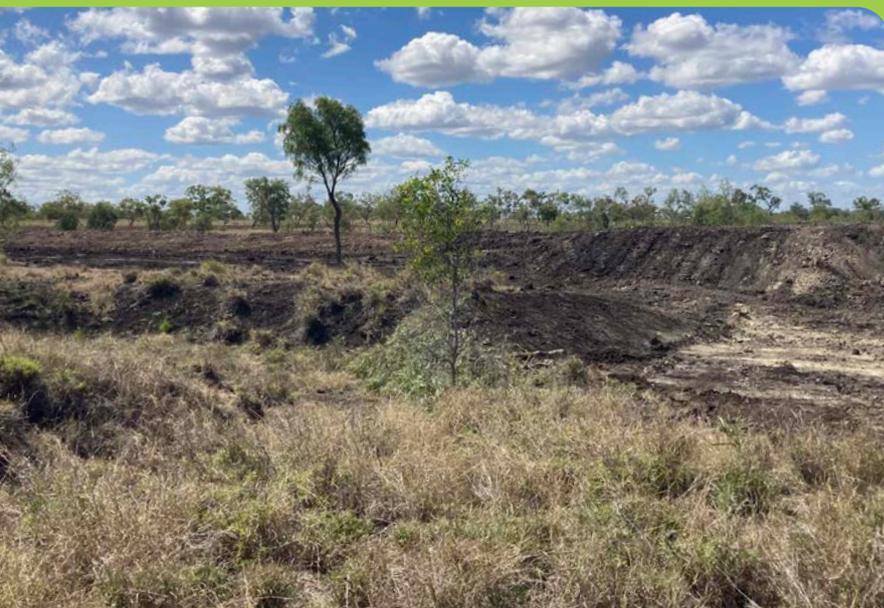
Above – Highly eroded flow line incising into grazing land.

Left – Dam construction to reinstate overland flow patterns.

Earth walls – are reinstating overland flow patterns by discharging water on the alluvial features. This is arresting the progress of advancing headcuts, restarting depositional processes across overland flow pathways and providing water for grazing cattle.

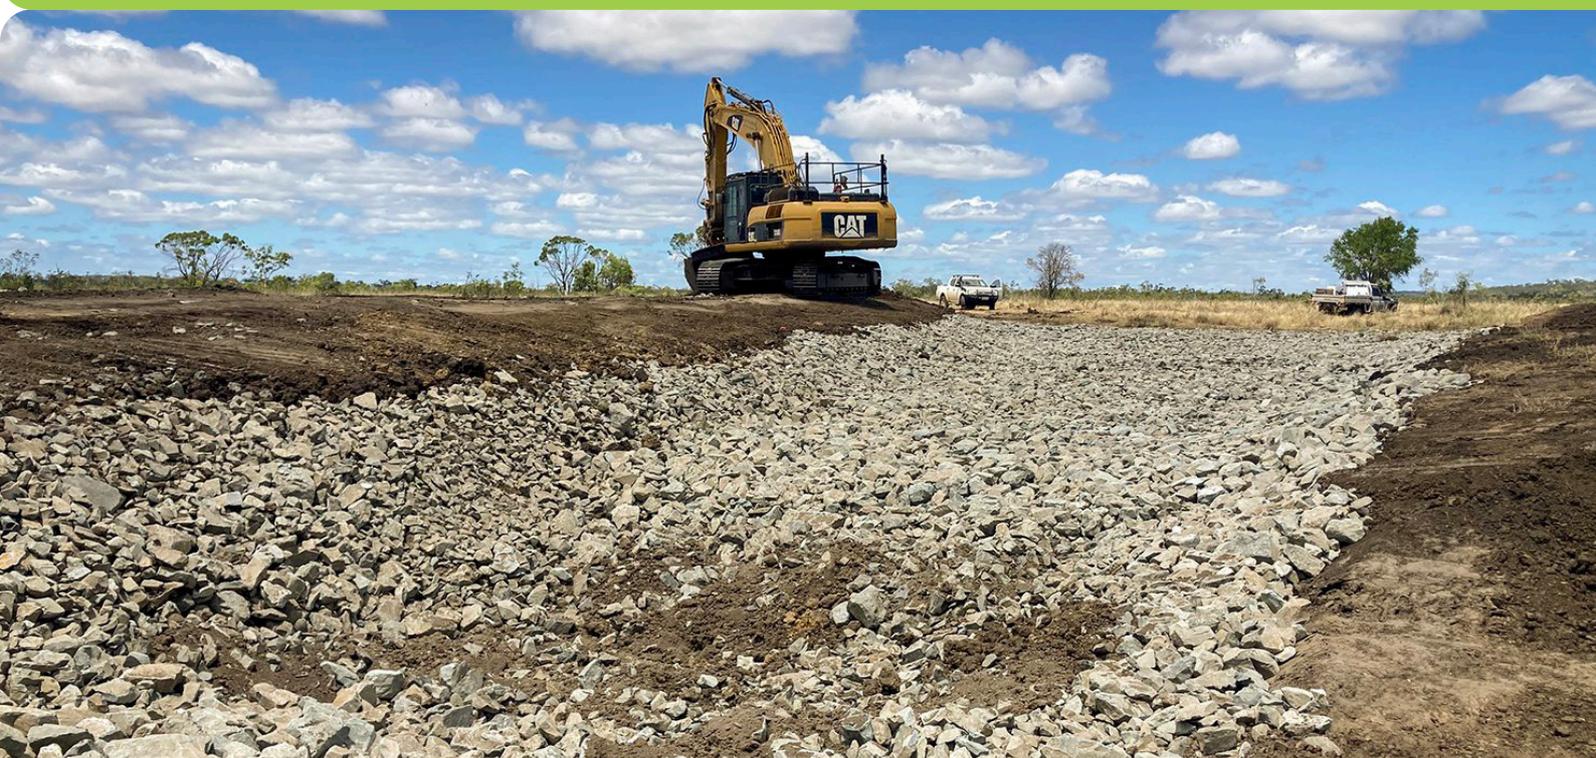
Below – Rock ramp under construction.

Rock ramp (rock chutes) – were built to armour an existing headcut at the bottom of an intact flowline to prevent further incision, and to safely step water down from surface level to bed level.
