# MULLOON REHYDRATION INITIATIVE RAPID APPRAISAL OF RIPARIAN CONDITION

2017-2021 Report

Luke Peel, Susie Miechels, and Peter Hazell

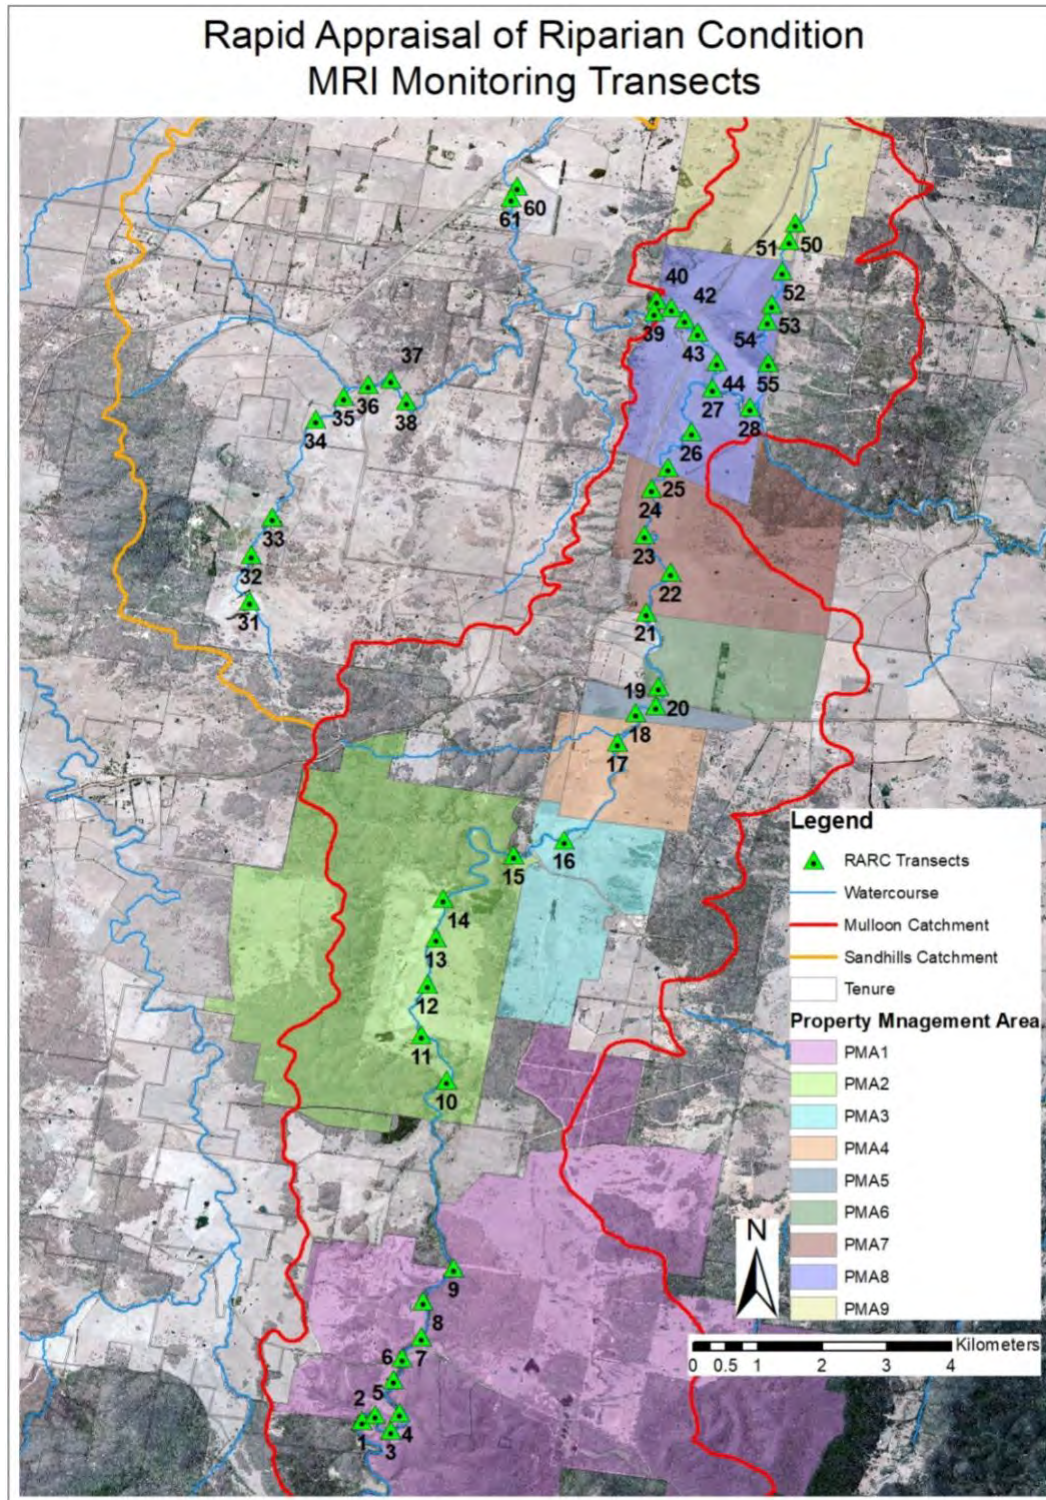
Figure 1: RARC transect locations in the MRI.

Figure 1 presents locations of the RARC transects and respective PMA. PMA2 is the pilot project area where in-stream structures were implemented in 2006-07. Stage 1 of the MRI was implemented at PMA 3, 4 and 5 (2018-19), and Stage 2 of the MRI was implemented at PMA 7 and 8 (2019-current). Planning and design for landscape rehydration works is underway for PMA1 (Stage 3), with implementation expected in 2023. Transect 15 is referred to as the Gorge and located at the boundary of two properties and crown land.

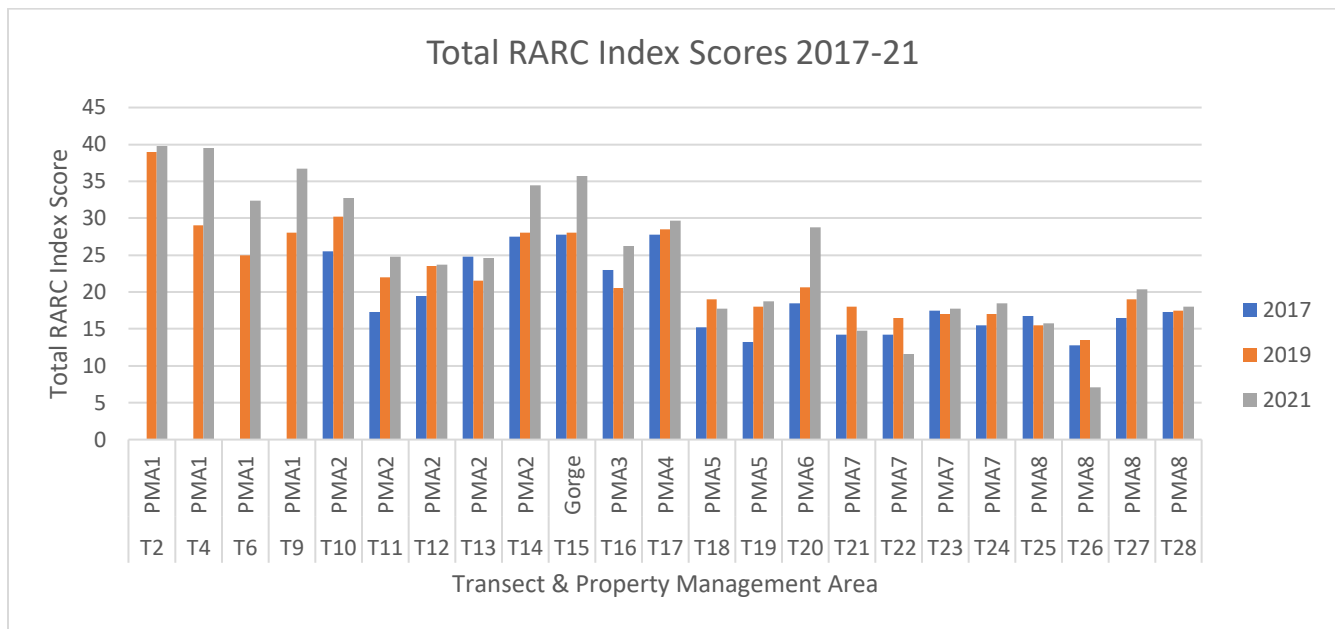
Figure 2: Total RARC Index scores for Mulloon Creek transects 2017, 2019, 2021

Of the nineteen transects monitored along Mulloon Creek since 2017 to 2021, sixteen (84%) transects increased RARC Index scores through the extreme drought and the two major flood events (Figures 2 & 3). Three (16%) transects (22, 25 and 26) experienced a decrease in RARC Index for the same period (Figures 2 & 3).

Transects surveyed during the extreme drought period (2017-2019) indicate 79% (15 of 19) had minor to moderate increases of RARC Index (Figures 2 & 3). Four transects had minor declines during the drought (T13, T16, T23, T25), with all of these transects having minor to moderate recovery post-flood events.

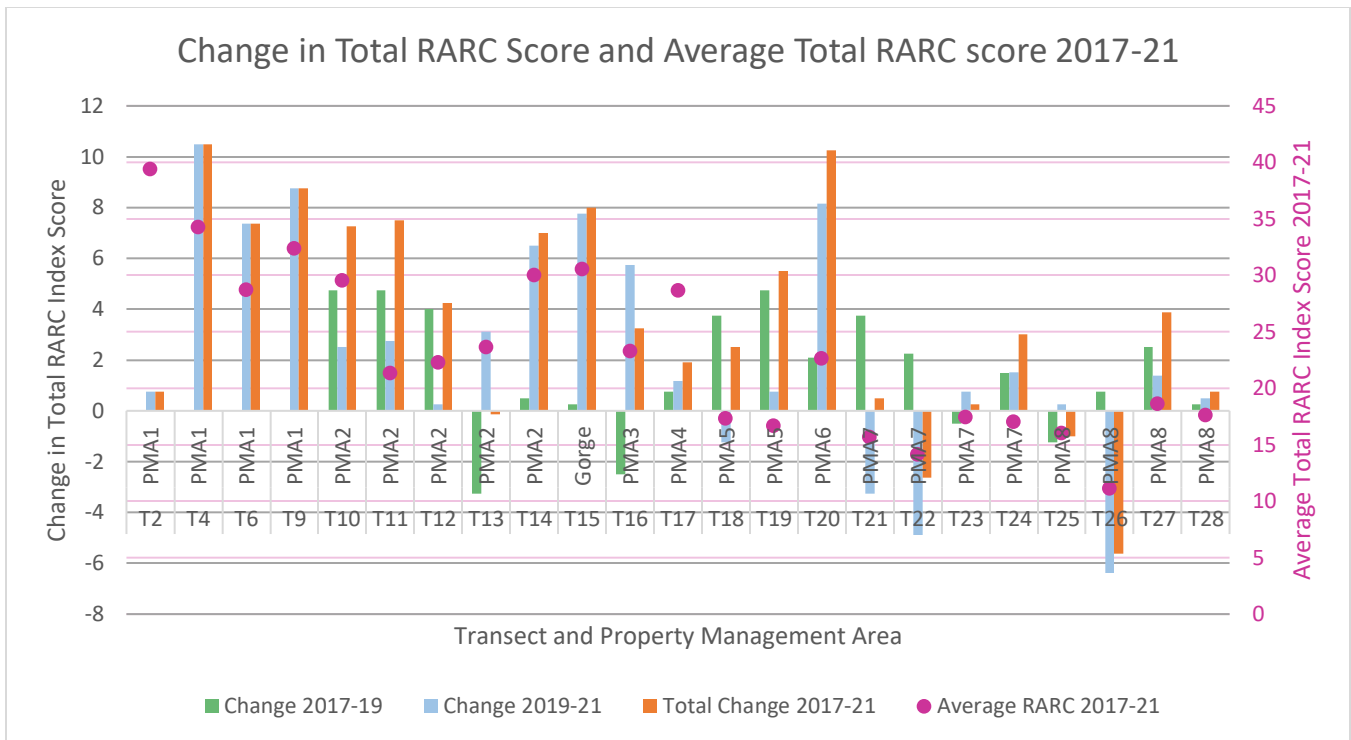
Figure 3: Mulloon Creek transects change in RARC Index score (1<sup>st</sup> Y-axis) and Average RARC Index score 2017-21 (2<sup>nd</sup> Y-axis)

Figure 3 presents the change in RARC Index score for each survey period, plus total change since transect was monitored. A 2<sup>nd</sup> y-axis indicating the average RARC Index score across the three surveys, for context and comparison with other transects.

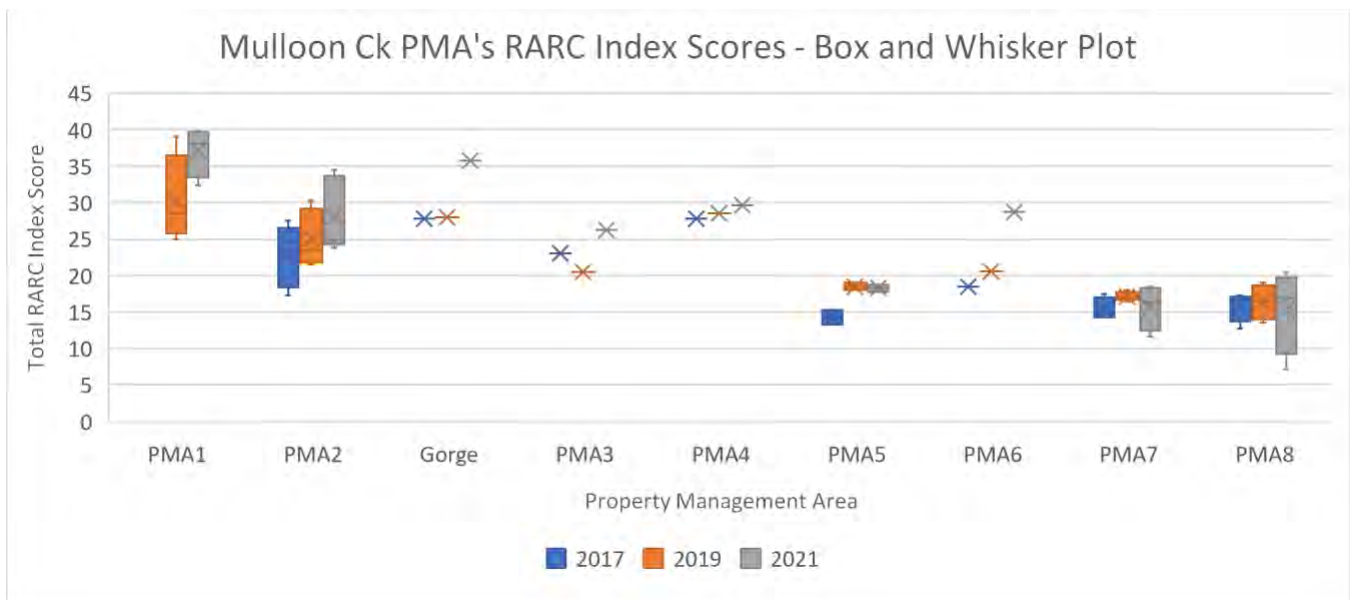
Figure 4: Total RARC Index score for each Property Management Area and survey year

The above results can also be expressed as a box and whisker plot of RARC Index scores for each PMA and survey period (Figure 4). The plots centre, X, represents the median value or 50<sup>th</sup> percentile of the data set and is derived using the lower and upper quartile (25%) values for where there is more than one transects assessed. The maximum and minimum values are displayed with vertical lines ("whiskers") connecting the points to the centre box. The results in Figure 4 provide confirmation that the RARC Index has improved for all PMA's since monitoring commenced, albeit marginally for PMA 7 and 8.

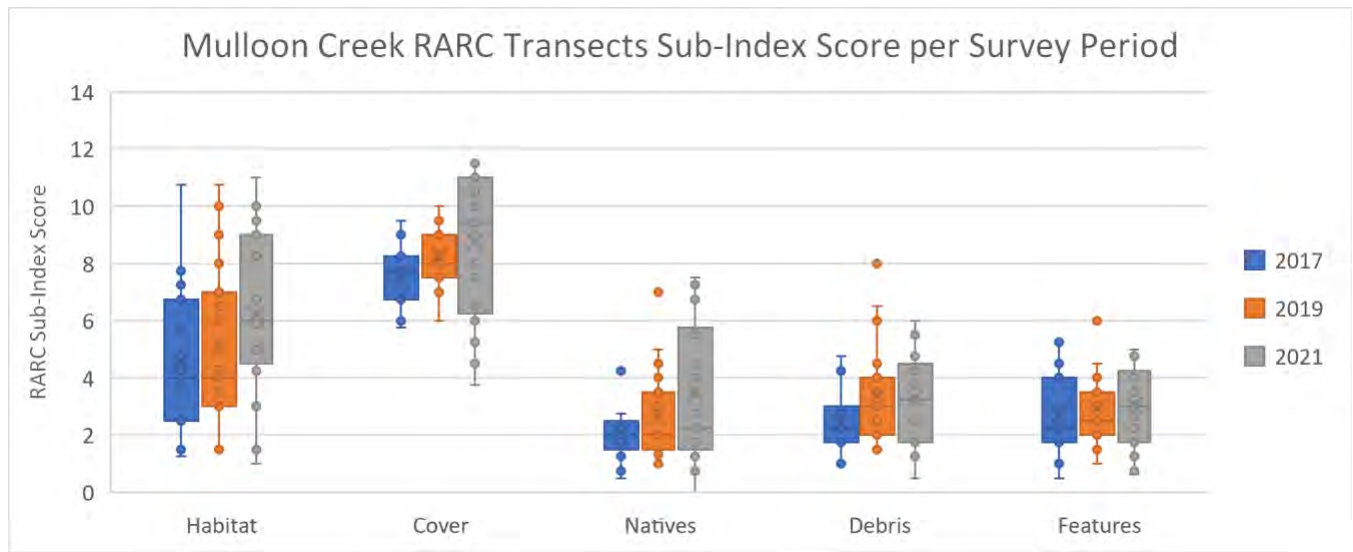
Figure 5: Box and Whisker plots for RARC Sub-Index Scores for all Mulloon Creek transects

The box-and-whisker plots in Figure 5 provide additional insights to the variations in scores, as indicated by the maximum and minimum values (range). For example, the range of scores for the Habitat sub-index has remained relatively stable, suggesting some transects have not improved by much. However, many other transects have improved significantly, which contributes to an increase in the median score. A similar result was indicated for Features, albeit a lower range and median in comparison to Habitat. The maximum values of the Cover, Natives, and Debris sub-indices increased over time, however the minimum values have remained the same or declined. This suggests some transects have remained at the same level or declined slightly, while many other transects have improved as indicated with increased upper limits, corresponding with an overall increase in median scores.

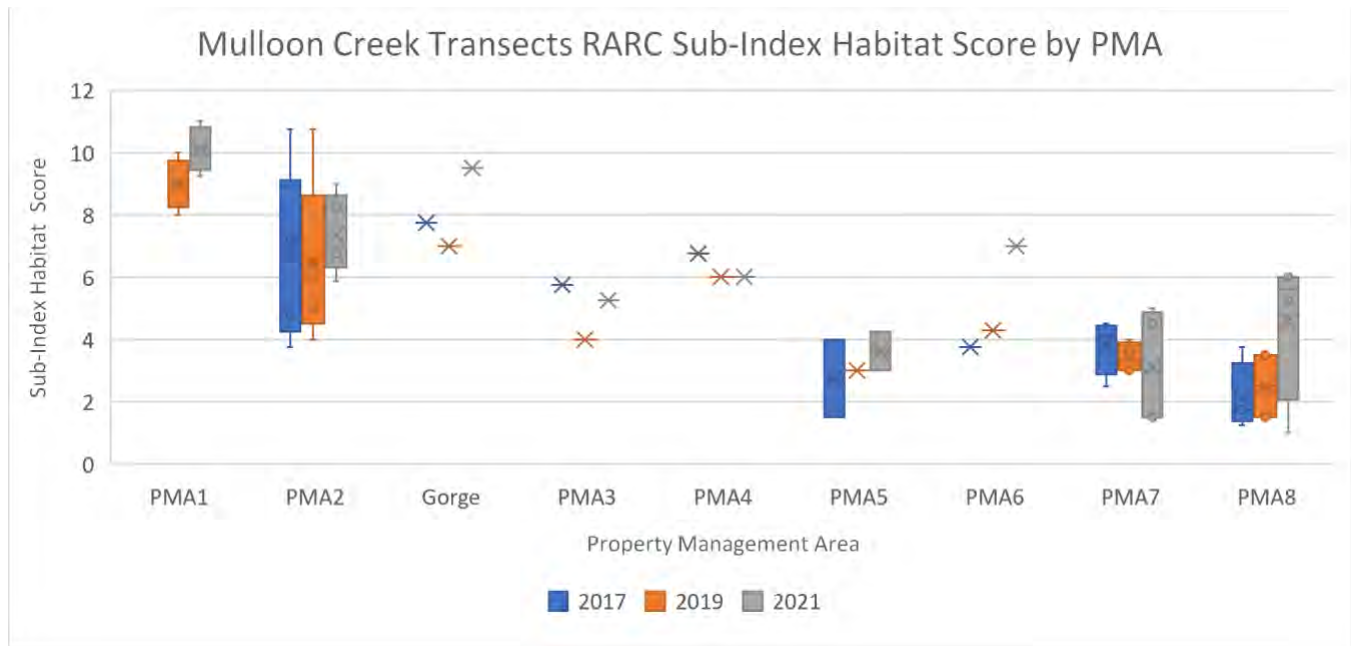
Figure 6: Box and Whisker plot for RARC sub-index Habitat score for each survey period by Property Management Area (PMA)

The Habitat score had variable results for all survey periods, across all PMA's on Mulloon Creek (Figure 6). This reflects the variability of transects, historical land use, and significant climatic events. Transects that had initial high levels of native vegetation and proximity to remnant woodlands or forests had the highest initial scores and increases in median Habitat score. The median Habitat score increased for six of the nine PMA's, these include PMA1, Gorge and PMA6 as the best performing transects. The latter two transects have potentially benefitted from rehydration works immediately upstream, as compared to the response at PMA1 where rehydration works are yet to be implemented, and there are no works upstream. The three other transects that had small to medium increases were PMA2, 5 and 8. PMA3, 4 and 7 experienced a minor decline from 2017 to 2021.

The Gorge transect experienced a small decline in 2019 due to extreme drought, followed by a significant increase in 2021 following the flood events (Figure 6).

PMA7 transects experienced minor declines for the survey periods (Figure 6). The extreme drought caused a minor decline in vegetation extent, and rehydration works completed in late 2019 didn't have enough time to regenerate vegetation prior to floods.

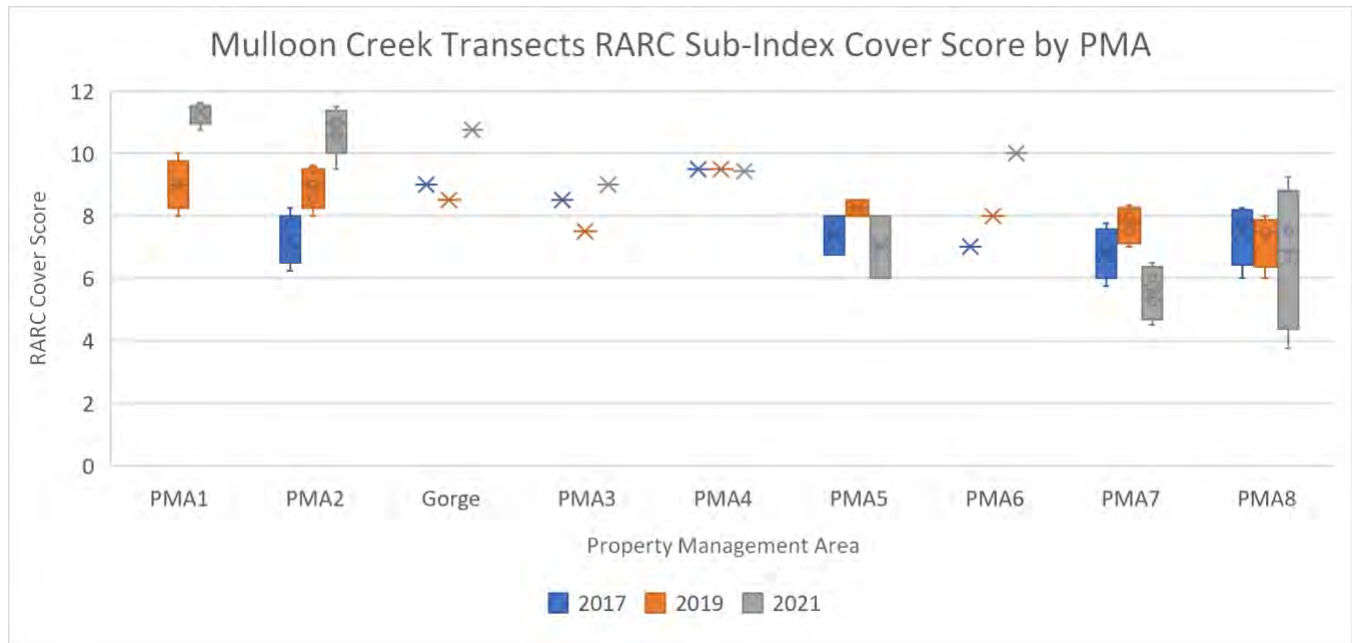
Figure 7: Box and Whisker plot RARC sub-index Cover score for each survey period by Property Management Area (PMA)

The Cover score had variable results for all survey periods across all PMA's on Mulloon Creek (Figure 7) that reflects the variability of a transects historical land use and management, and potentially the effect of rehydration works implemented. Five of the nine PMA's (1, 2, 3, 6 and Gorge) had moderate to significant increases in Cover score from 2017-2021. The remaining four PMA's (4, 5, 7 and 8) had minor to moderate declines in Cover scores. It should also be noted that the floodplain pockets in which the rehydration works have taken place are traditionally grassy environments, with grass, sedge, reed and rush dominated riparian zones. As such, the RARC cover score method may give a false indication of what is or isn't good cover.

PMA4 Cover scores remained relatively stable for all survey periods due to stable and high cover of shrubs (Figure 7). It also had the highest initial Cover score of all PMA's. PMA5 and 7 initially had a small increase in Cover scores during the drought that could be attributed to rehydration works locally and upstream respectively, which encouraged an increase in aquatic vegetation cover. However, the significant flood events had some impact on the aquatic vegetation to cause a small to moderate decline in Cover from 2019-2021. Transects in PMA8 experienced on average a minor decline in Cover scores during the drought (2019) and again following the floods (2021). However, the box and whisker plots indicate some transects increased Cover (higher maximum value), while other transects declined (decreased minimum value). The differences in response for PMA8 transects (Figure 7) could be due to only half the transects having had rehydration works implemented.

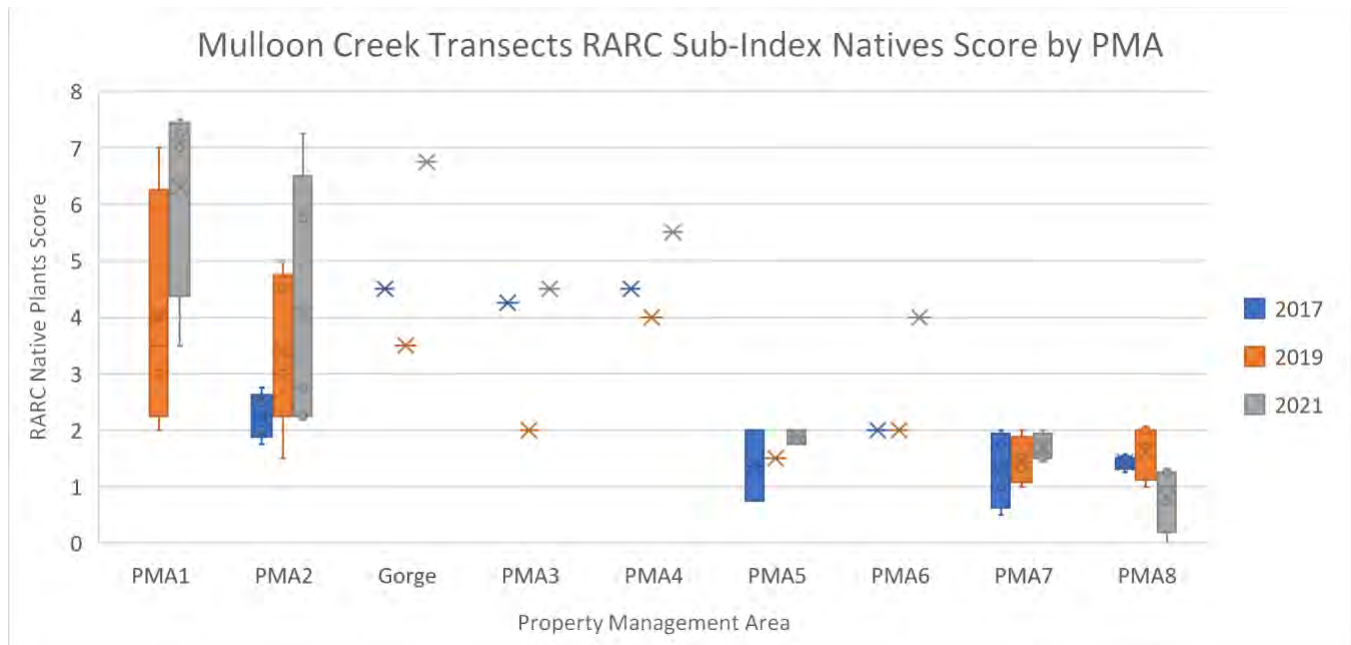
Figure 8: Box and Whisker plot RARC sub-index Natives score for each survey period by Property Management Area (PMA)

Nearly all PMA's (eight out of nine) recorded an increase in Natives score for the survey period of 2017-2021 (Figure 8). The exception, PMA8, experienced an initial minor increase during the drought (2019) followed by a decline in Natives score following flood events (2021). It is important to note that PMA8 is commencing from a low base and only half the transects have had rehydration works implemented days before the flood event of 2020.

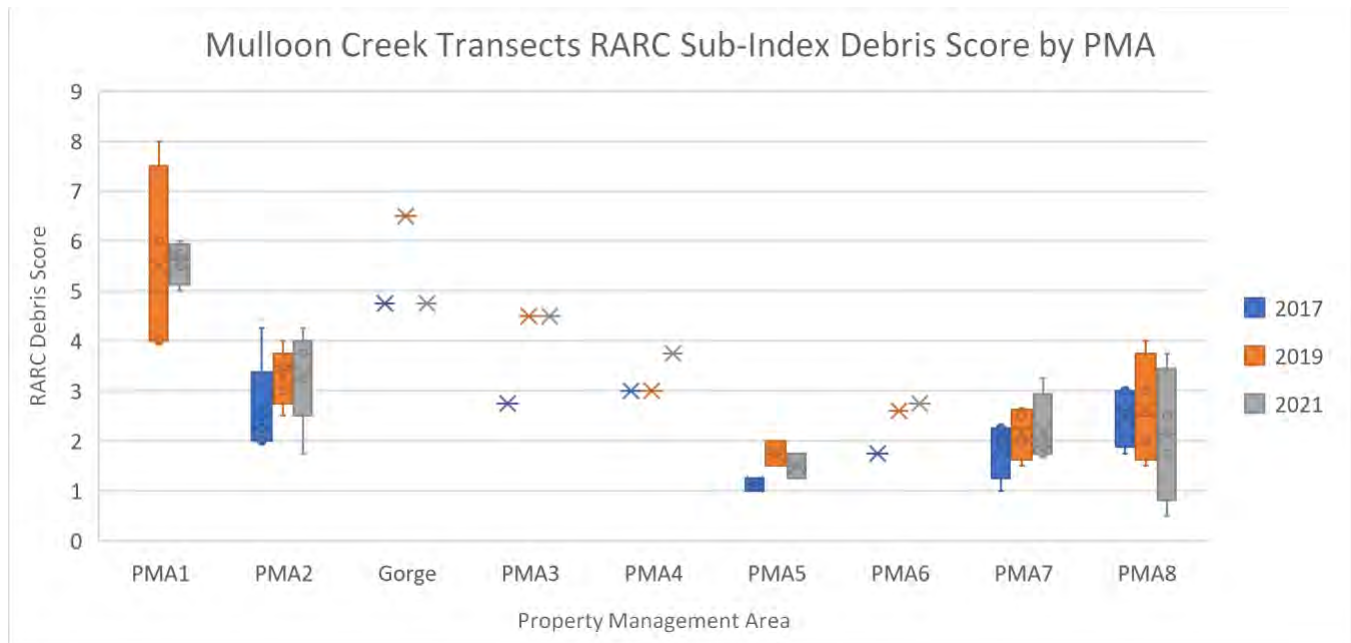
Figure 9: Box whisker plot RARC sub-index Debris score for each survey period by Property Management Area (PMA)

The Debris scores for the PMA's varied across the survey periods due to drought and particularly the flood events that redistributed fallen logs and leaf litter. Other key elements that underpin scoring in the Debris index is the presence of old trees that have hollow-bearing branches and trunks or standing dead trees. Many of the PMA's lack these remnant old trees, hence the scores for PMA's reflected the historical land use, management practices and how many old trees remain.

PMA1 had quite a range of Debris scores in 2019 (maximum and minimum values) with the flood events redistributing material including large amounts that came with the floods from upstream areas badly affected by the 2019-20 fires. This resulted in a reduction in the range of maximum and minimum values, culminating in a small increase in Debris median scores. The Gorge had a significant increase in Debris at the height of the drought (2019), however the force of floods squeezing through the bottom end of the gorge caused the loss of material

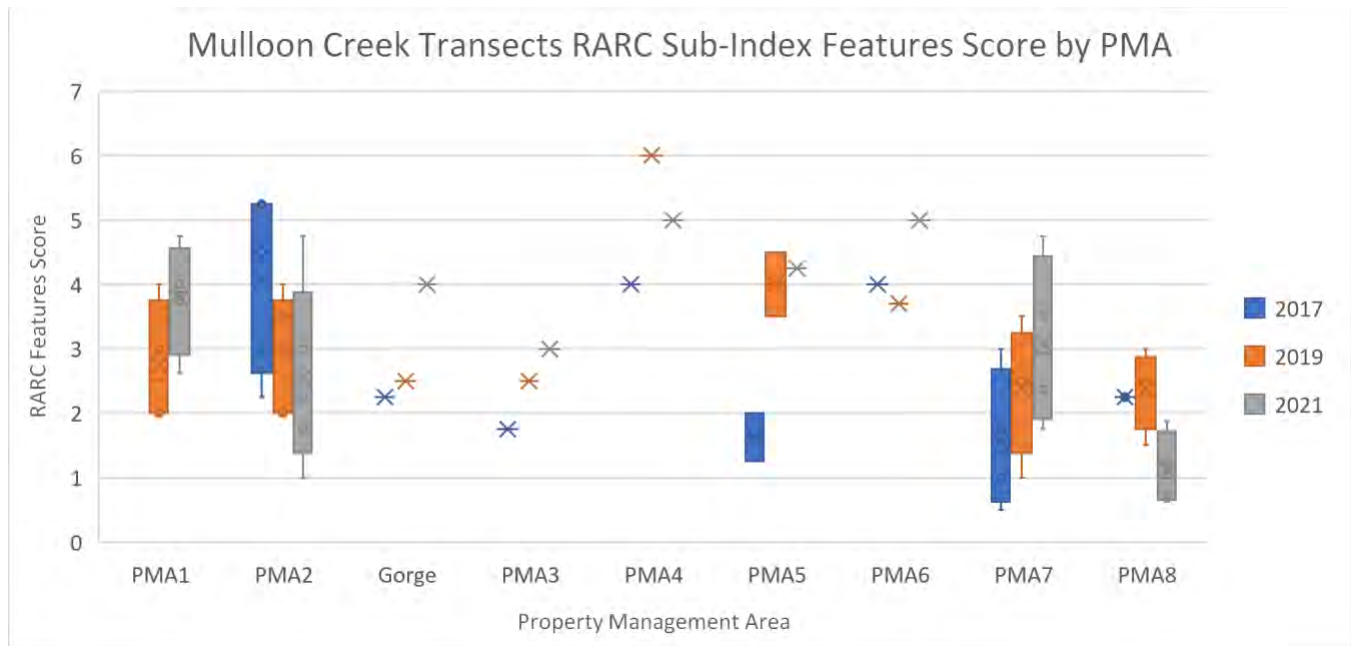
Figure 10: Box and Whisker plot RARC sub-index Features score for each survey period by Property Management Area (PMA)

Figure 10 shows many of the PMA’s (six out of nine) increased Features median scores from 2017 to 2021, except PMA2, 4 and 8, which though improved from 2017-2019, declined from 2019-2021. PMA4 experienced a significant increase during the drought to attain the highest score of all PMA’s due to tree and shrub recruitment. PMA8 experienced a small increase during the drought due to shrub recruitment and reeds.

Pilot project (PMA2) had the highest initial Features score of all PMA’s in 2019 (Figure 10). PMA2 recorded a moderate decline in Features from 2017 to 2019 due mostly to decreased large tussock grasses, potentially due to large native herbivores. During the drought a survey of kangaroos was conducted at PMA2 that found the resident population (2,500) had at least doubled due to lack of fodder in the region and the presence of water in the creek. The decline in Features continued into 2021 due to decreased tussock grasses, and some loss of aquatic vegetation due to flood impact, however this was somewhat offset by good recruitment of trees and shrubs. The

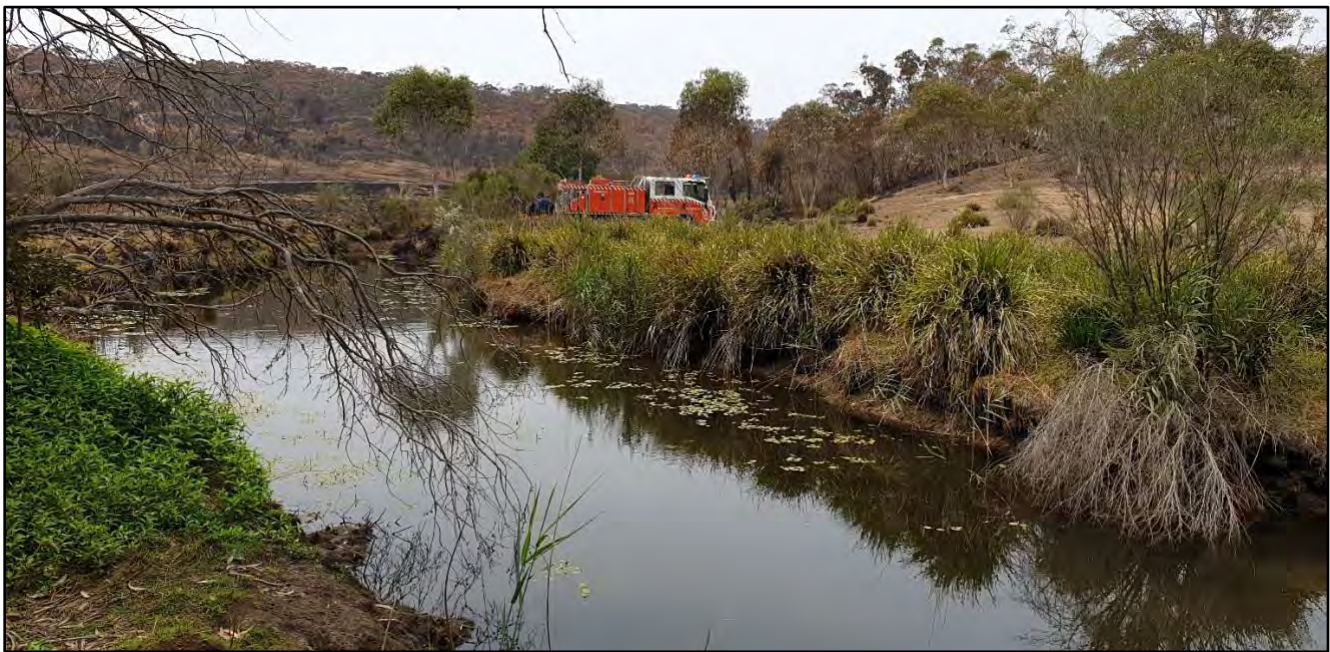
Figure 11: Firetruck rewatering from intact valley system at Baarlijan, fire burnt around area

The use of landscape rehydration techniques as part of a broader wildfire control strategy warrants further investigation. A better understanding of the role of intact valley floors in providing hydrated refugia for flora and fauna during wildfire and in mitigating erosion from intense rainfall post wildfire events would be of value. Consideration of current and historical fire intensity spatial mapping along with the known locations of intact or rehydrated valley floors would contribute to a better understanding of landscape rehydration as a fire mitigation strategy in the Shoalhaven River catchment (Figure 11).

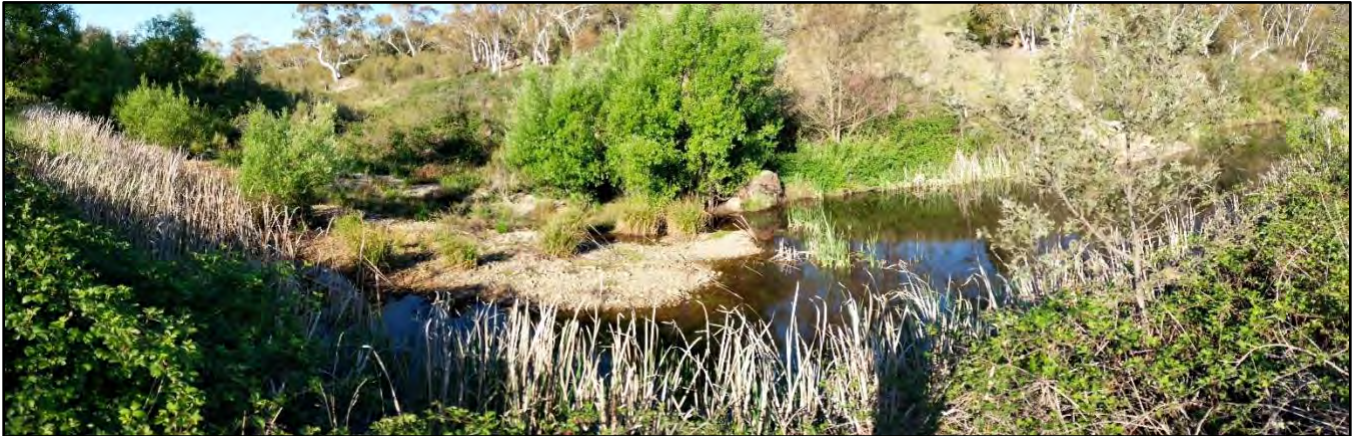
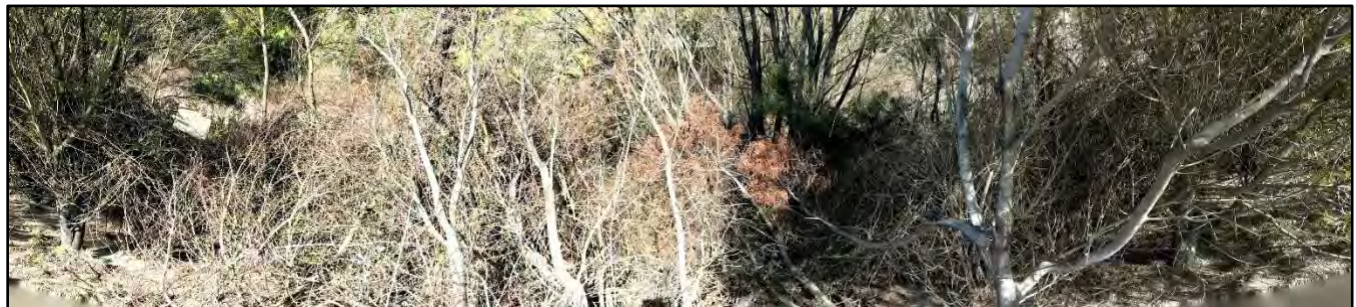
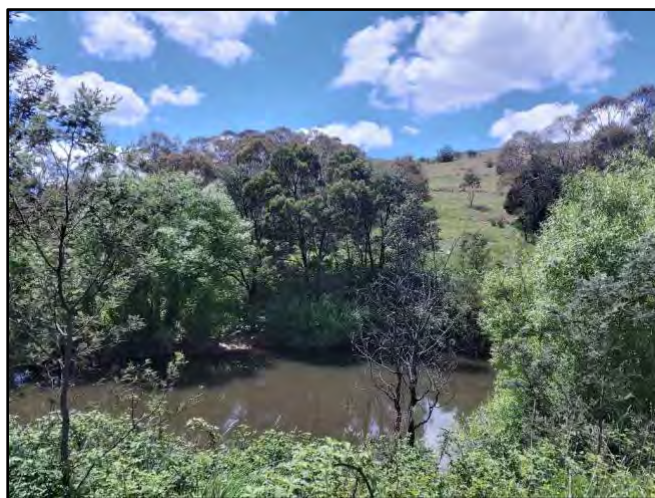
These transects reflect the historical land use and management (clearing, stock access to waterway), with the riparian zone deficient of native vegetation and replaced with willow revetments established in the 1970's and 80's. Native vegetation were present at all sites but were at their highest levels at the gorges that top and tail this pocket floodplain that influence T10 and T14. The remainder of the transects would be comparable to transects further downstream and would potentially have achieved a RARC Index of less than 15 prior to the pilot project rehydration actions in 2006-07. Management decision to implement rehydration actions and restrict stock access to the riparian zone coupled with native plantings have achieved good native vegetation response. Although some

natives have been planted, many more upper, mid and ground-storey native plants have self-propagated including aquatic plants, and all have thrived as can be seen in the results for RARC sub-index Natives score (Figure 8) and the site photos (Figures 15-20).

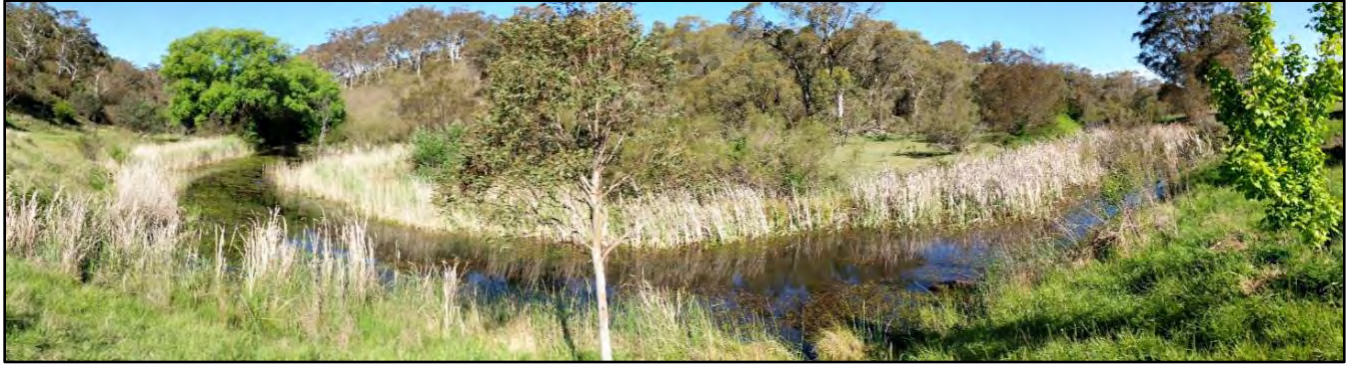
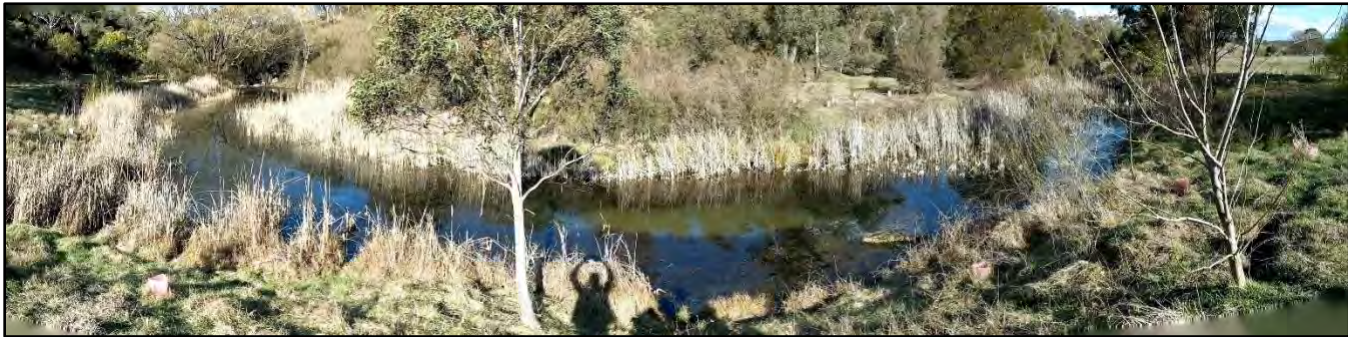
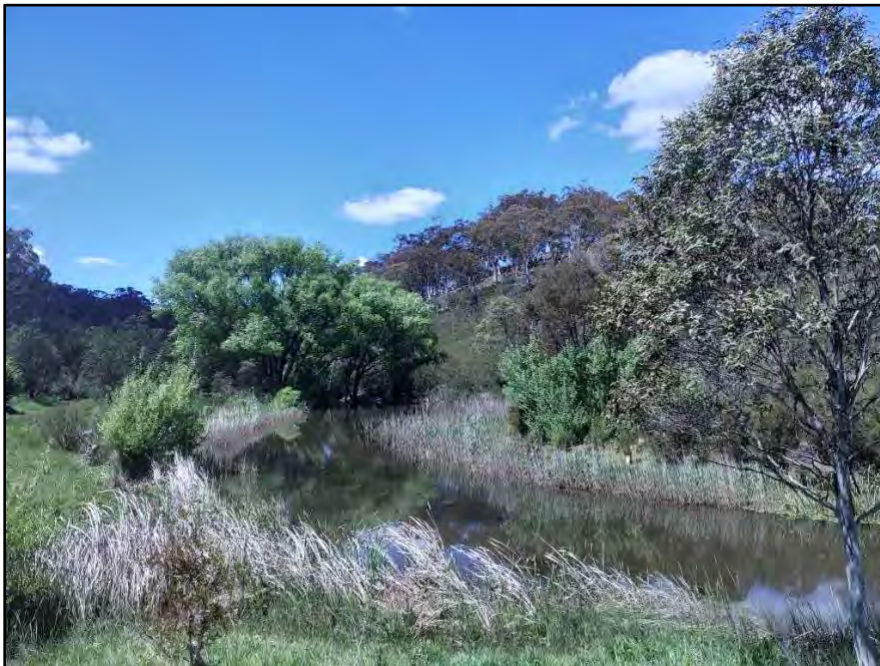
Four of the five the transects in this PMA (T10, 11, 12, and 14) have experienced significant increases in RARC Index scores since initial monitoring began in 2017 (Figures 2, 3 and 4). It is interesting to note the upper 3 transects (T10, 11, and 12) had higher increases in RARC Index during the drought (Figure 3), and the lower 2

transects had higher increases in RARC Index following the flood events (T13 and 14). Note the emergent aquatic reeds provide a buffer to flood impact along the stream banks while also providing habitat and reducing the effects of evaporation by sun and wind (Figures 19-21). Another interesting trend is how the total RARC Index for T11 to T14 progressively increases, suggesting a cumulative positive effect on RARC observations downstream. The collective RARC Index for PMA2 (Figure 4) indicates consistent improvements from 2017 to 2021, particularly due to significant increases in Cover and Natives (Figures 7 and 8).

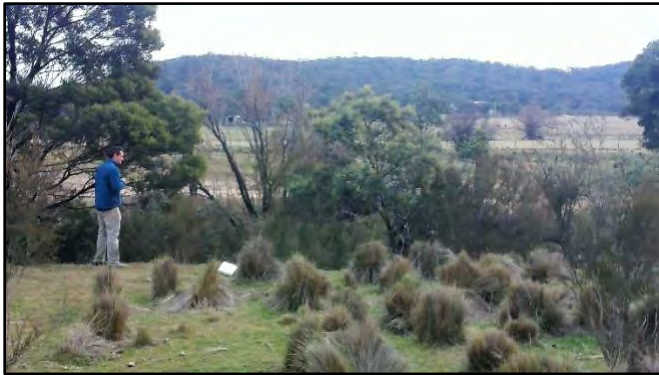
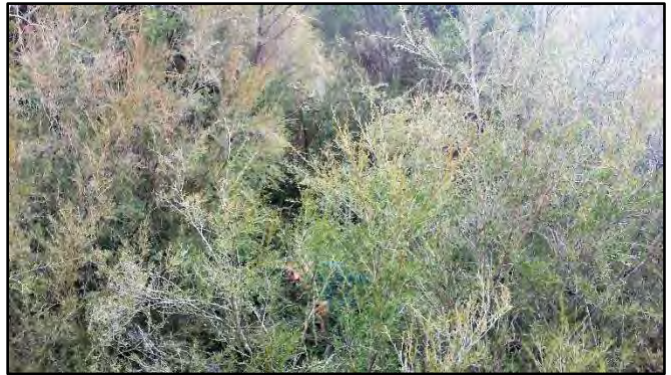
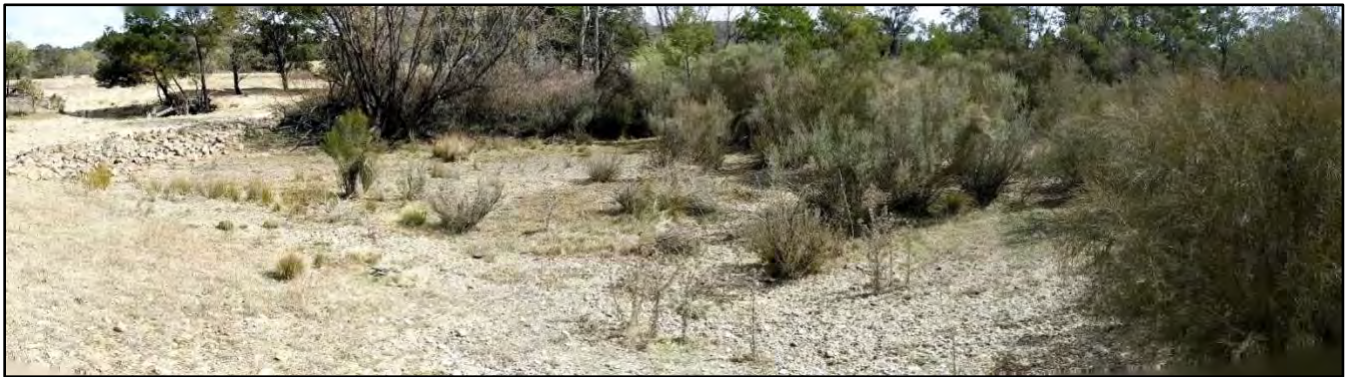
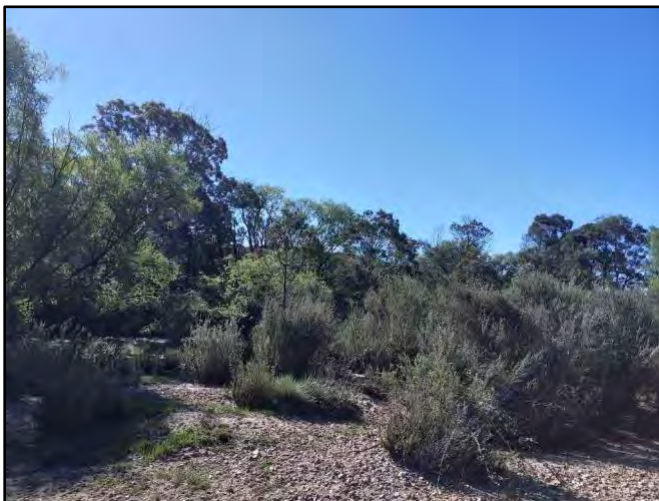
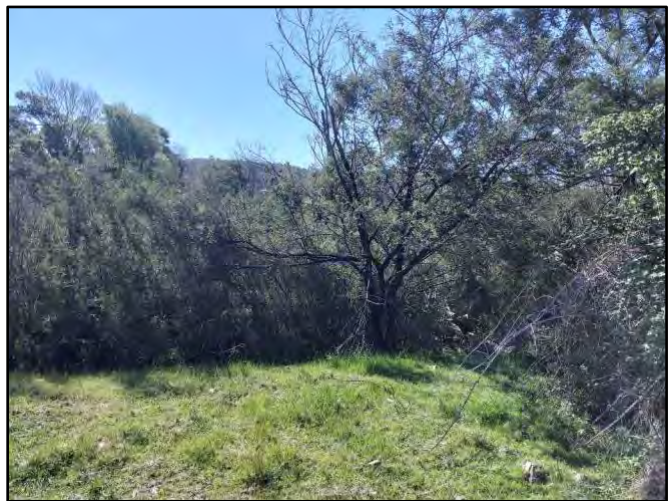
The total RARC score for T16 declined from 2017 to 2019 due to a combination of severe drought and stock, with declines in sub-indexes Habitat (Figure 6), Cover (Figure 7), and Natives (Figure 8), although offset by an increase in Debris (Figure 9). Following the drought-breaking rain and floods the 2021 survey indicates good recovery and surpassed its baseline RARC Index score (Figures 2, 3 and 4). An increase in Natives sub-index (Figure 8) was the main contributor to PMA3 RARC Index scores (Figures 2, 3, and 4), with small increases in sub-indices Cover (Figure 7), and Features (Figure 10). The in-stream structures are potentially generating much of the recovery as the riparian zone is still to be fenced off, however the property manager has indicated they minimise stock access to the waterway. With no other significant changes to other drivers (stock access, planting additional native plants), this transect provides a strong indication of the level of benefit in-stream actions with leaky weirs can generate. The understory and native shrub layers have had some improvement in 2021 as indicated in Figures 31 and 32, compared to 2019 in Figure 30.

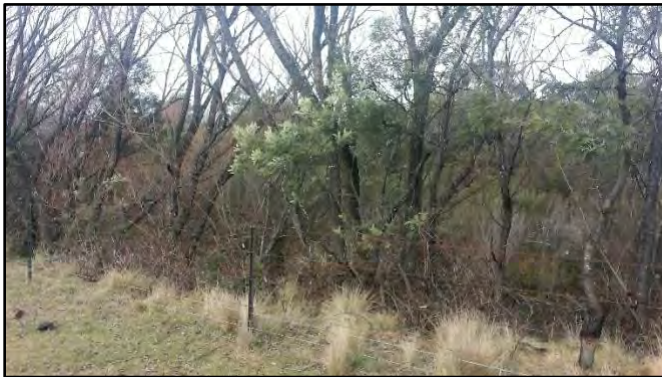
Figure 33: PMA4 T17a 2017 survey

This transect (T17) is relatively stable due to management fencing off the riparian zone for many years and has a good composition of native vegetation present with a moderate number of non-native species. The transect will benefit to have other elements such as larger native trees that in time provide hollow-bearing trunks and branches. There are thick patches of tea tree with other acacias, and patches of stony cobble and gravel evident in 2019 (Figure 35). There is a good groundcover response and a general improvement in 2021 (Figures 36 and 37) compared to 2017 (Figures 33 and 34) 2019 (Figure 35).

The transect has further benefitted from the rehydration actions implemented in 2018 that maintained existing vegetation during the extreme drought. Following the 2020 and 2021 flood events, the in-stream structures and vegetation generated a positive effect to reduce any flood impact and spread the water into the riparian zone to promote a good response in ground cover and aquatic plants (reeds and sedges). It is also worth noting that this transect has frog surveys conducted and now provides a great habitat for a variety of frog populations (2021 frog survey report).

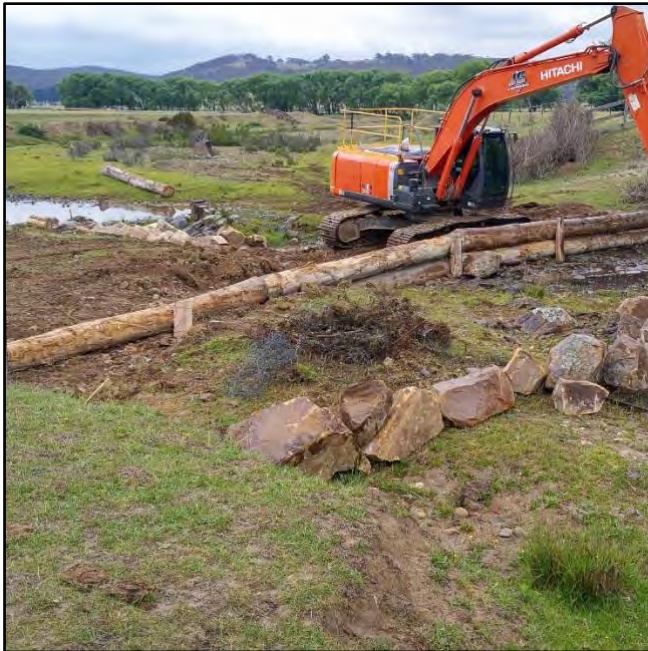
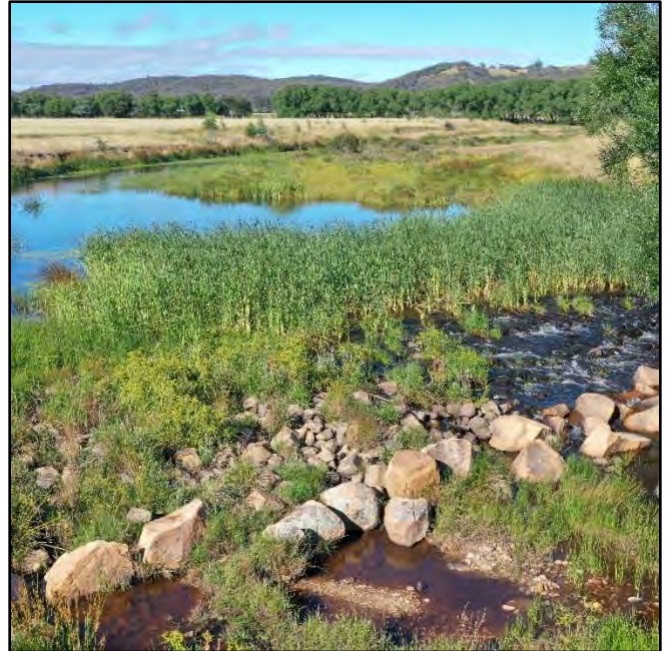
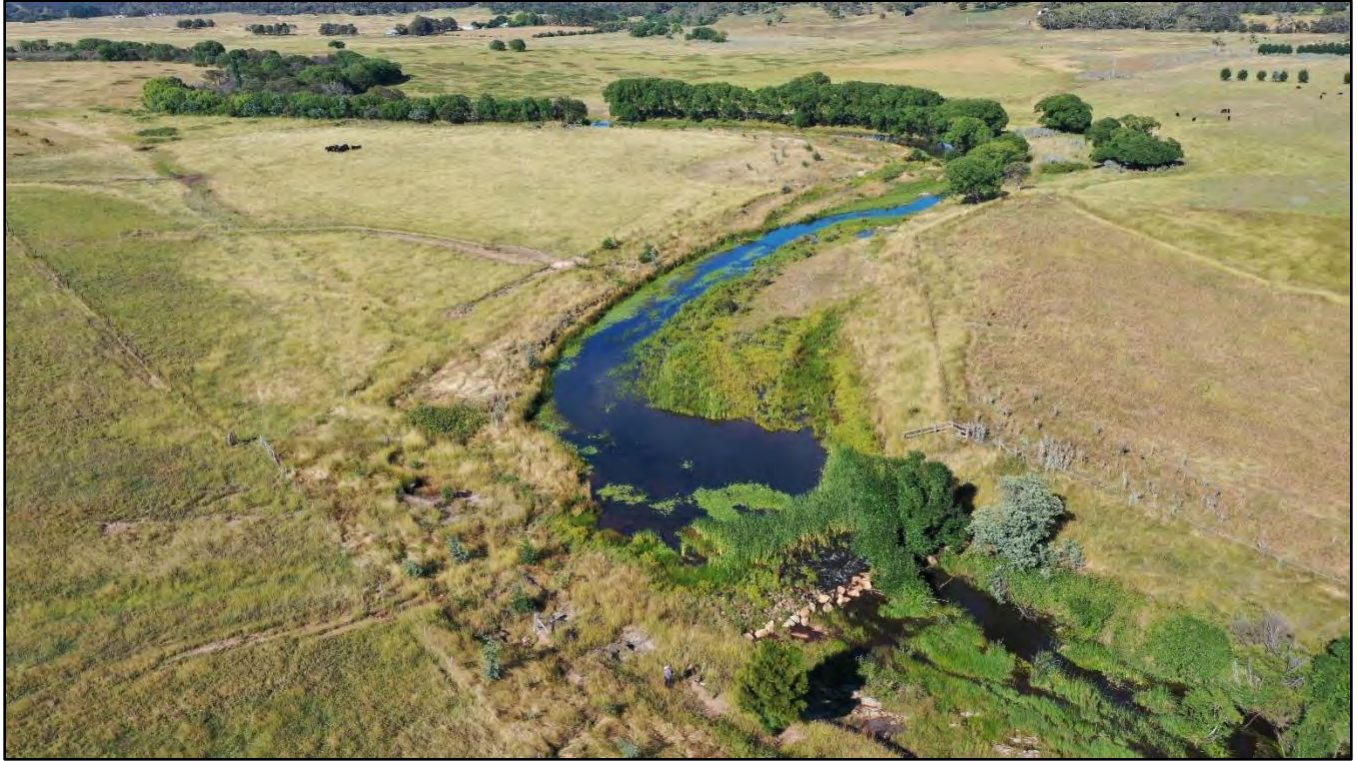
The two transects (T18 & T19) on PMA5 have been historically impacted by past clearing and stock access, with willow revetments on T18 implemented late 1970's and small patch of native shrubs/trees on T19, with a mix of groundcover dominated by non-native species. These transects are recovering from a low baseline, but recovery is underway since implementing the in-stream actions (Figure 39 and 40), assisted by the planting of native trees and shrubs and restriction of stock access (Figure 39 and 40). Despite very low average RARC Index scores (Figures 2, 3 and 4), the large improvement in RARC Index for PMA5 from 2017-2019 is due to its positive response to in-stream works in late 2018, which resulted in increased aquatic vegetation (Figures 39, 40, and 43) and planting of native trees and shrubs in 2019.
