# MULLOON REHYDRATION INITIATIVE RAPID APPRAISAL OF RIPARIAN CONDITION

2017-2021 Report

Luke Peel, Susie Miechels, and Peter Hazell

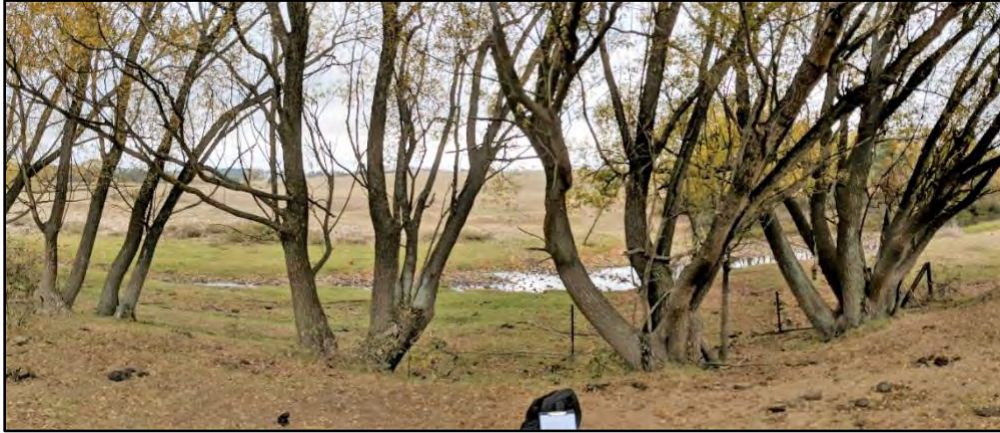
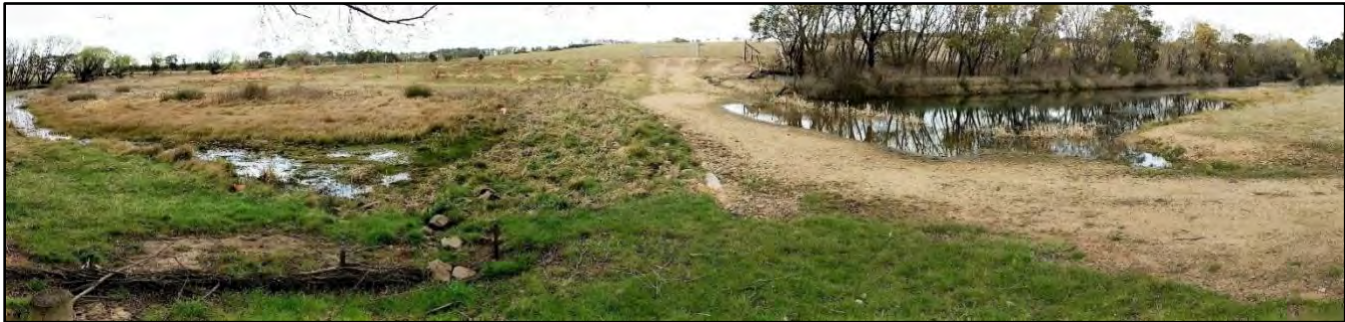
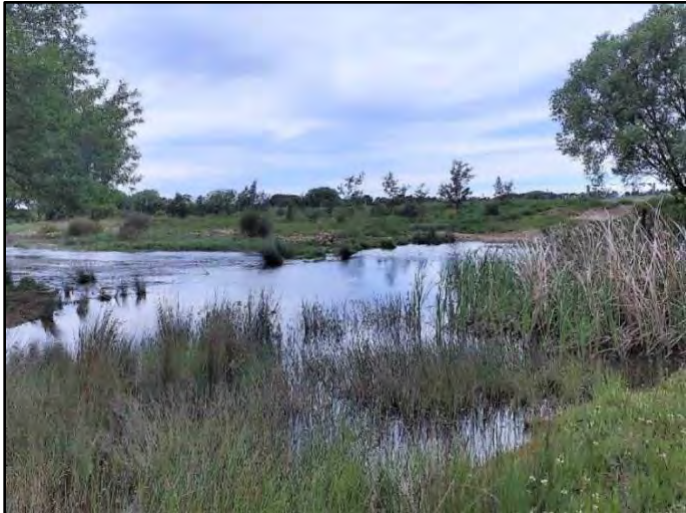
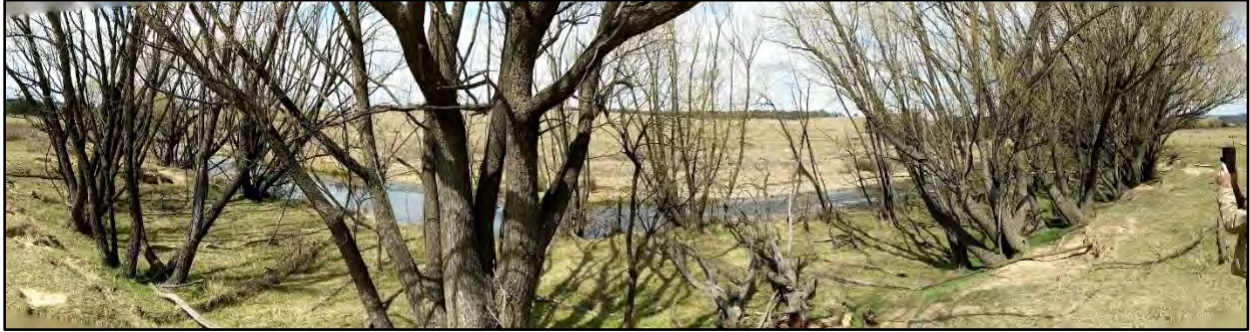
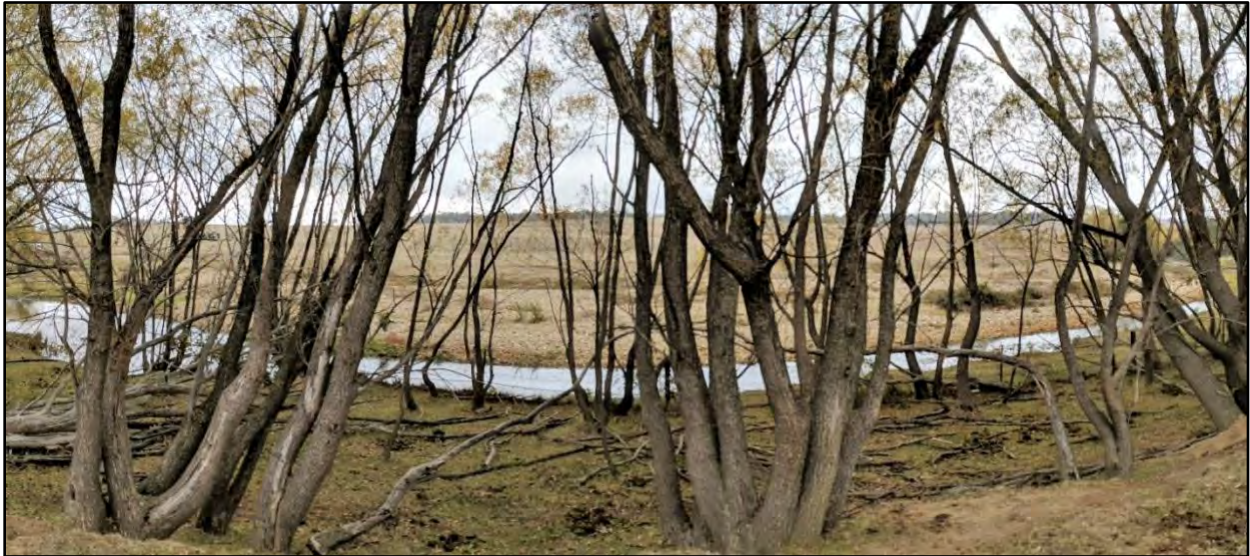
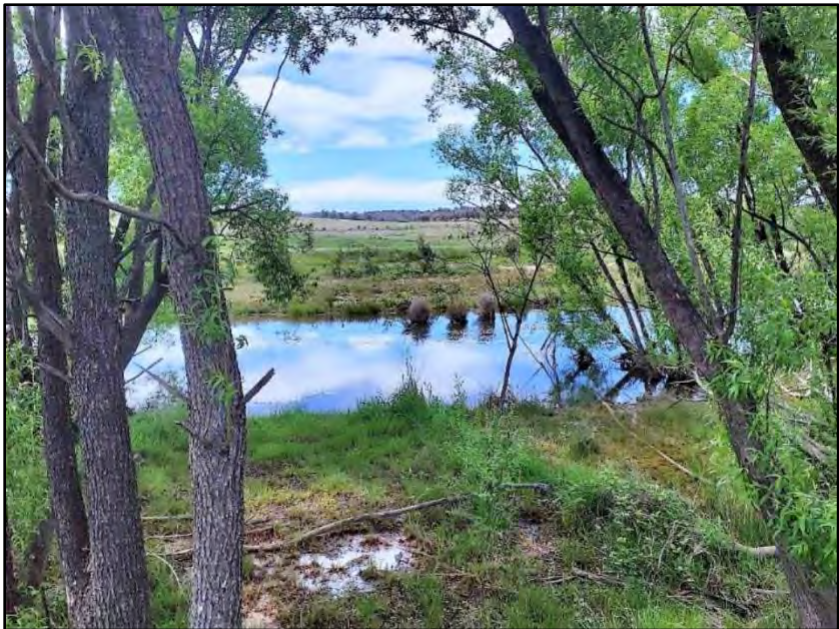
There was some loss of aquatic vegetation due to the flood events which causes the minor decline in RARC Index scores for T18, but T19 continuously improved its vegetation response. Note in Figures 43 and 46 the tube stock trees and shrubs have responded on the opposite riparian bank. There was a minor loss of cover and debris in 2021, partly due to flood inundation of exotic pasture species and these are expected to be replaced by native sedges and reeds as the transect transitions.

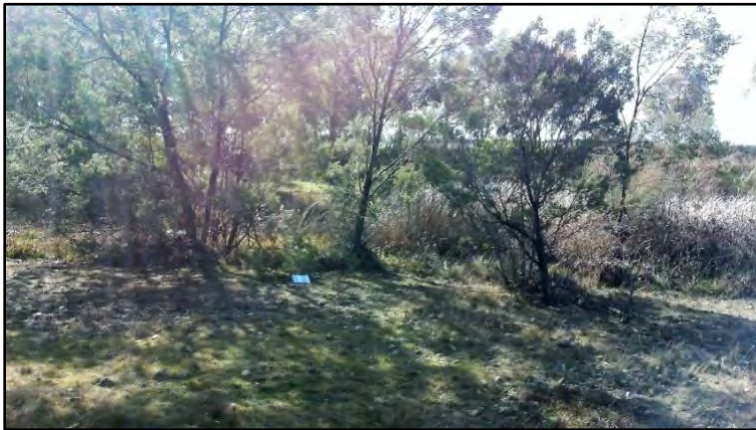
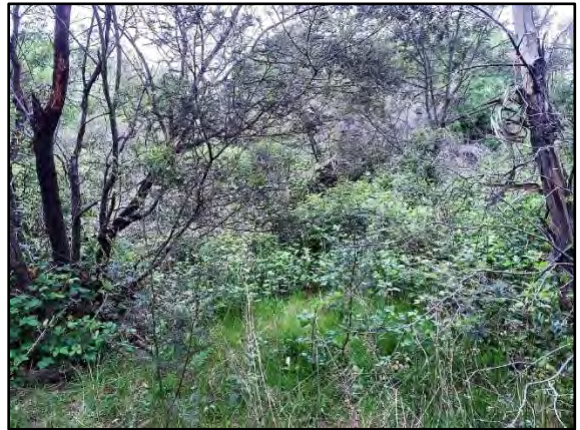
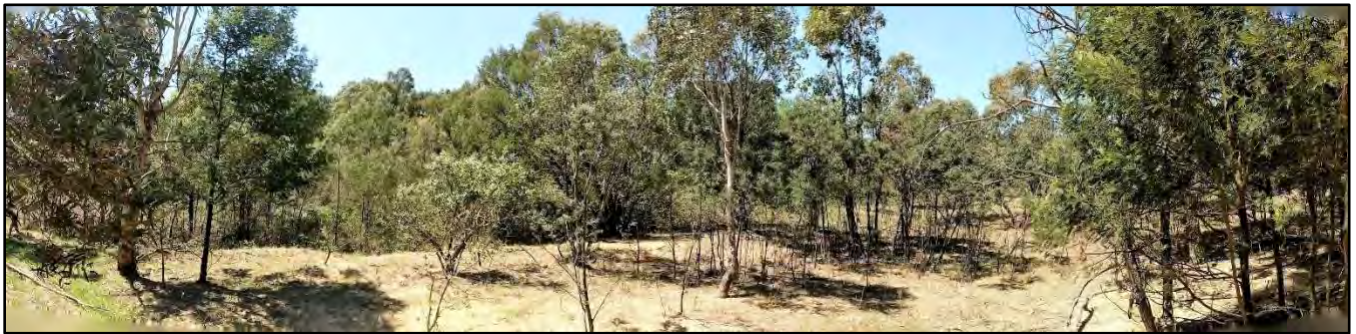
This transect (T20) has been historically impacted by clearing and stock access, and historical planting of willows, but has been fenced off for over 10 years and planting of native trees and shrubs has occurred. The transect is located immediately downstream of a major highway and impacted by the force of water channelled under the bridge and stormwater runoff from the highway. The increase in total RARC Index during the drought (Figures 2, 3 and 4) and substantial increase following the flood events (2021 survey) could be attributed to rehydration activities upstream (PMA 3, 4 and 5) that maintained some water during the drought and reduced the impact of the floods. The first half of the transect has high amounts of native shrubs and trees, willow revetment (opposite bank), and exotic species. Groundcover reduced during the drought (Figure 48) with the flood events triggering a burst of vegetation growth (Figure 49) in 2021.

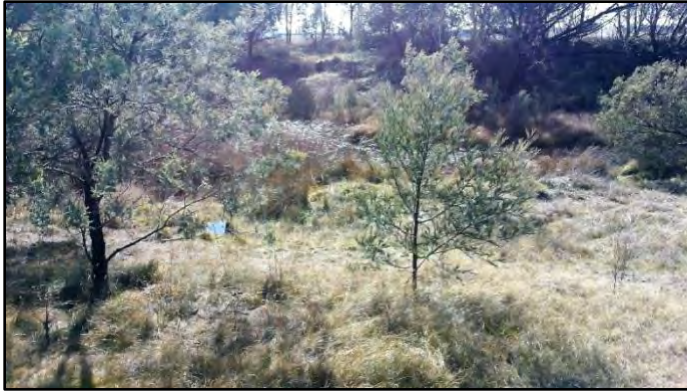
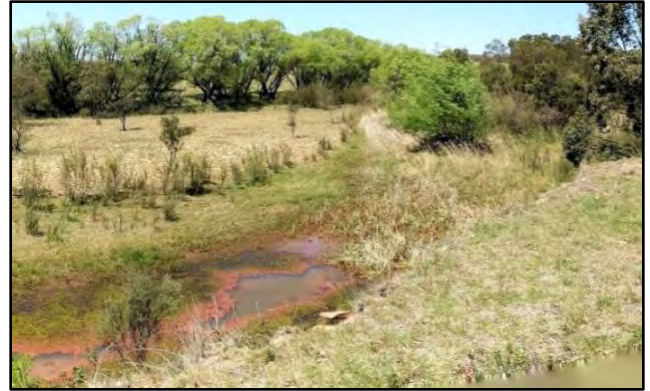
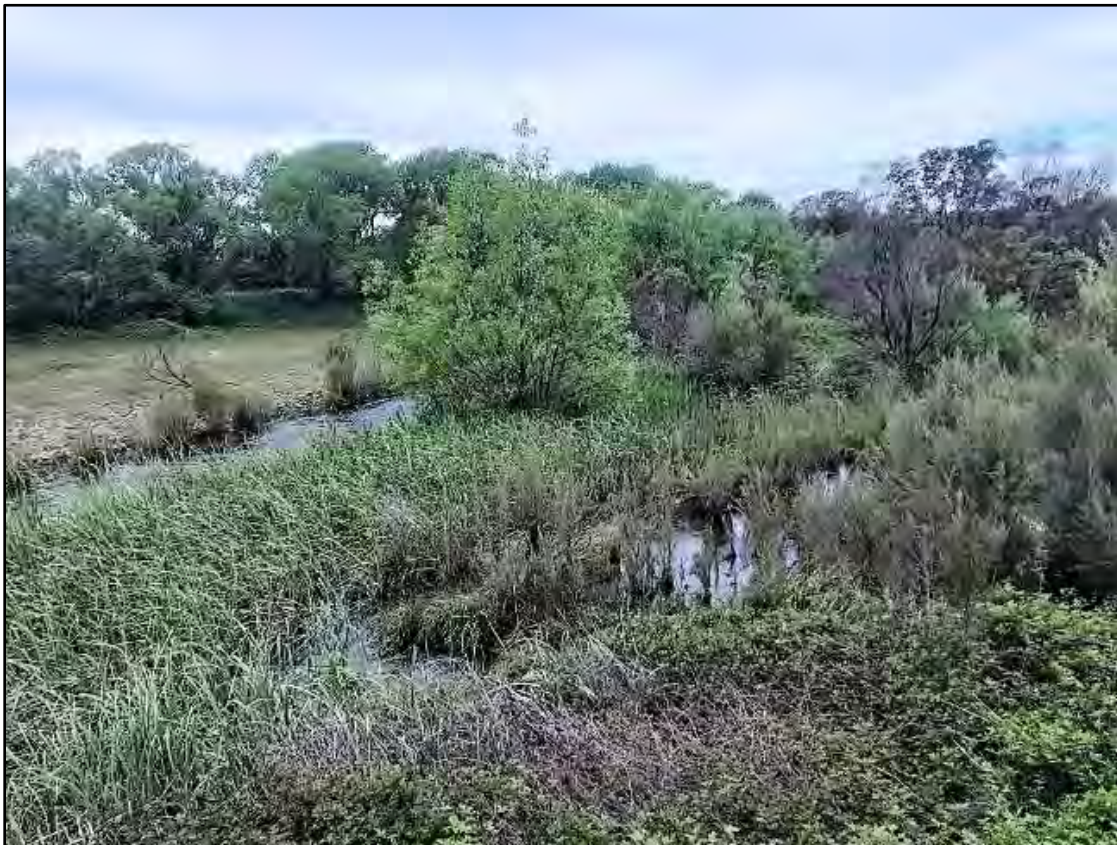
The second half of the transect is less vegetated open channel consisting of cobbles and gravel, willow revetment and other exotic plants, but less native plants (Figures 50-52). This section of T20 had had quite a transformation following the flood events in 2021 (Figure 52), with a significant increase in native plants, particularly aquatic native species, shrubs, and other groundcover.

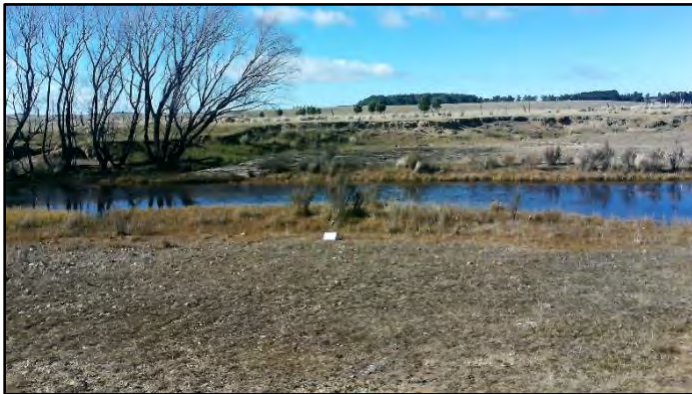
Figure 53: PMA7 T21b 2017 survey

All transects on PMA7 have been impacted by historical clearing and stock access, and upper storey vegetation is dominated by willow revelements on outer banks and introduced pasture species. Most transects increased total RARC Index scores (Figures 2, 3, and 4) during the drought, that could be attributed to the implementation of in-stream structures in 2018-19, that supported the growth of aquatic plants. Following the 2019 survey, the remaining riparian zone has been fenced, and supported by TMI and volunteers, many native shrubs and tree seedlings were planted. The two flood events had some impact as vegetation recovery was still in its infancy, particularly aquatic plants, and these did recover partially at some transects (Figure 55). Transects T21 and T22 total RARC Index scores decreased in the 2021 survey this can be partly attributed to the loss of a few of the remaining native trees that didn't survive the drought, reduction in ground cover due to inundation and loss of existing debris that was moved on by the flood. There are no in-stream structures for 1.6km upstream and this could have exacerbated the effect of the floods on the first two transects, with the first of any in-stream structures immediately below T21.

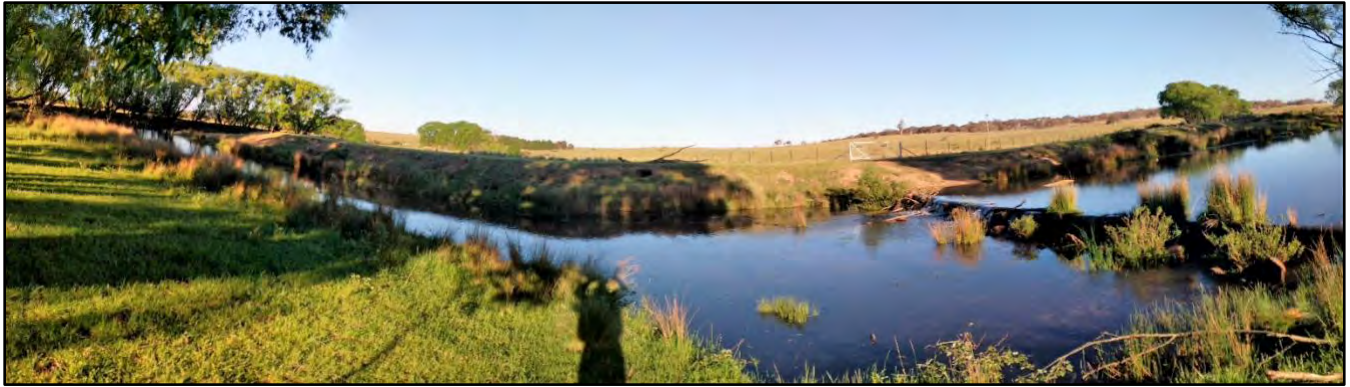
Figure 56: PMA7 T24a 2017 survey

Furthermore, the two transects further downstream (T23 and T24) were potentially protected by a series of in-stream works on PMA7 that generated an increase in RARC Index scores (Figures 56-58). The landholders and TMI are hopefully expectant of a continued increase particularly in aquatic vegetation, tube stock plantings, and that native plants self-propagating will respond positively to the increased water availability in the riparian zone.

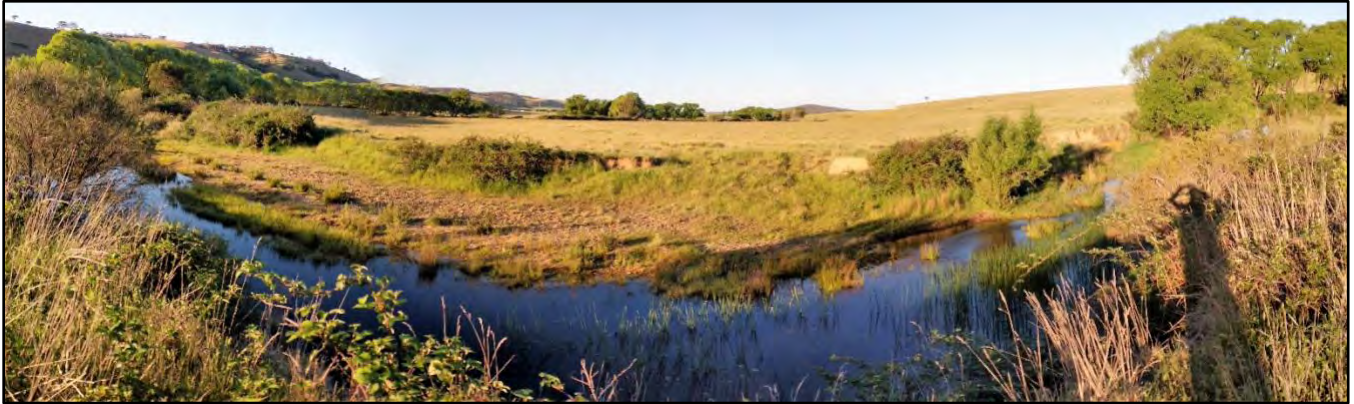
Figure 59: PMA8 25a 2017 survey

There were small improvements in total RARC scores from 2017 to 2019 for most of the transects (Figure 4), however T25 indicated a small decrease as could be expected during the extreme drought (Figures 59 & 60). In-stream interventions were implemented mid-2020 and had minimal time for regeneration yet three of the four transects had minor increases in total RARC score (Figure 4). The exception, T27 total RARC scores decreased in 2021 due to significant loss of non-native terrestrial plants, plus loss of aquatic species and inundation of groundcover during the flood events (Figures 62-64).
