Controls on flow and patterns in physico-chemical properties of groundwater on a landscape rehydration enterprise at Mulloon Creek, New South Wales, Australia.

Moore C.L. and Bernardi T.

Centre for Applied Water Science (CAWS),
University of Canberra, ACT 2601

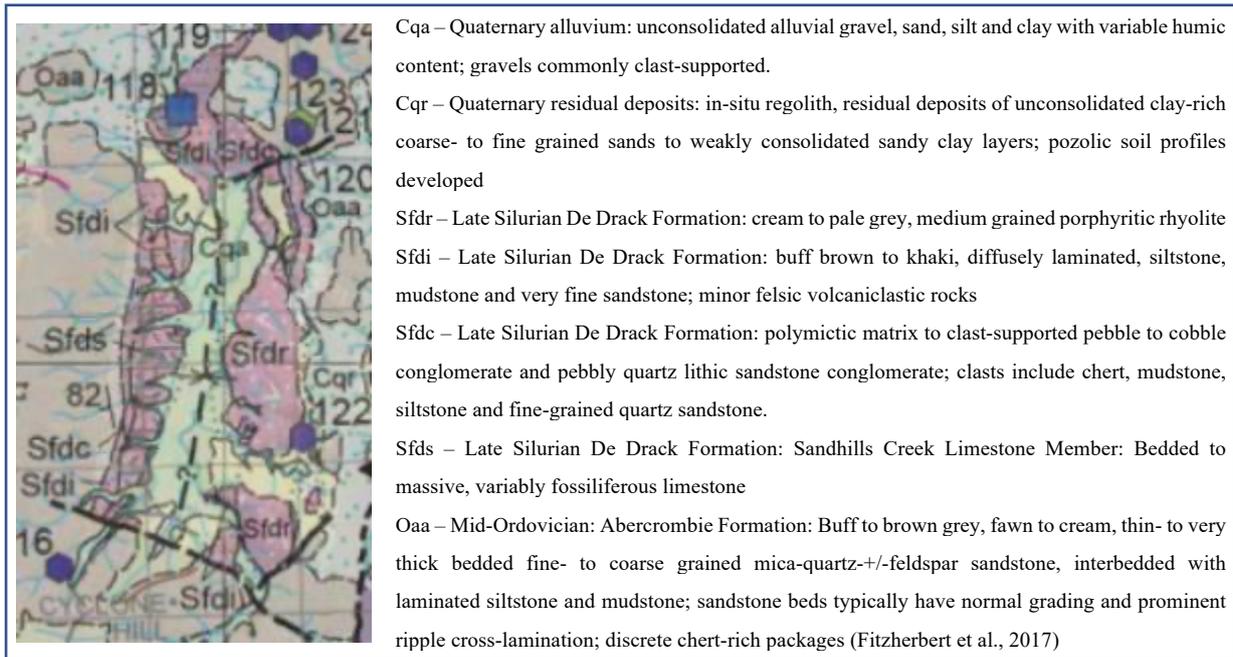
Figure 2. Geology of mid-Mulloon Creek (Fitzherbert et al. 2017).

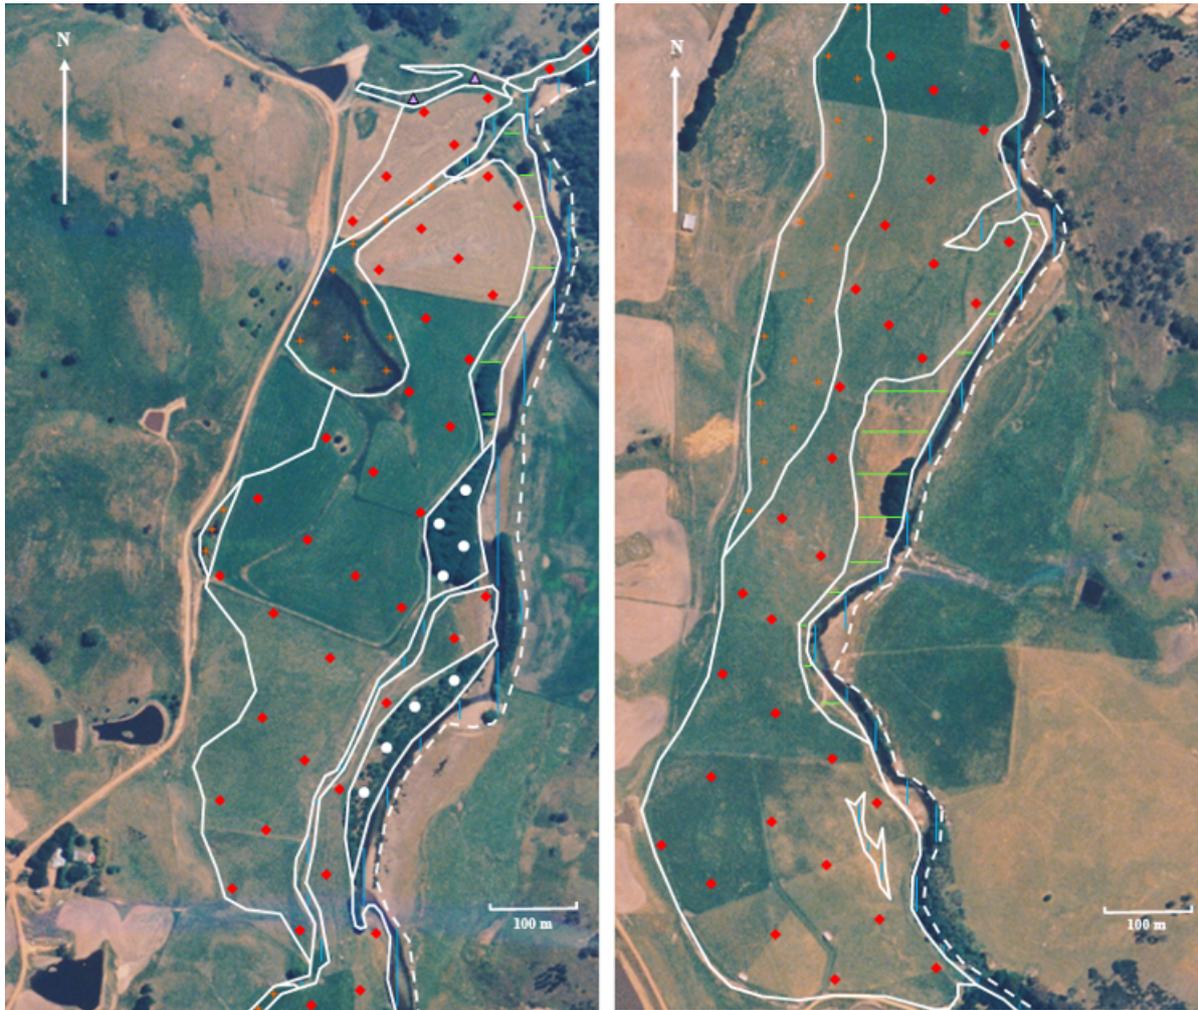
Regolith landform mapping of the mid-Mulloon Creek floodplain has defined 6 regolith landform units (RLUs) on the eastern side of the channel (Figure 3). They are: an Alluvial Channel RLU (ACah) following the course of the contemporary stream, the lower parts of four tributary streams and a small remnant channel deposit (flood runner) south west of the channel on the alluvial plain (Figure 3b); an Alluvial Overbank floodplain RLU (AOaf) running the length of the mid-Mulloon Creek valley; an Alluvial Overbank floodout RLU (AOao) adjacent to the Creek on the mid- and northern floodplain; an Alluvial Channel alluvial terrace RLU (ACat) (rudimentary levee) proximal to the Creek on the mid-northern part of the valley floor; a back plain Alluvial Overbank alluvial swamp RLU (AOaw) on the western side of the valley

AOaw – Alluvial Overbank alluvial swamp

AOaf – Alluvial Overbank floodplain

ACah – Alluvial Channel alluvial channel

AOao – Alluvial Overbank floodout

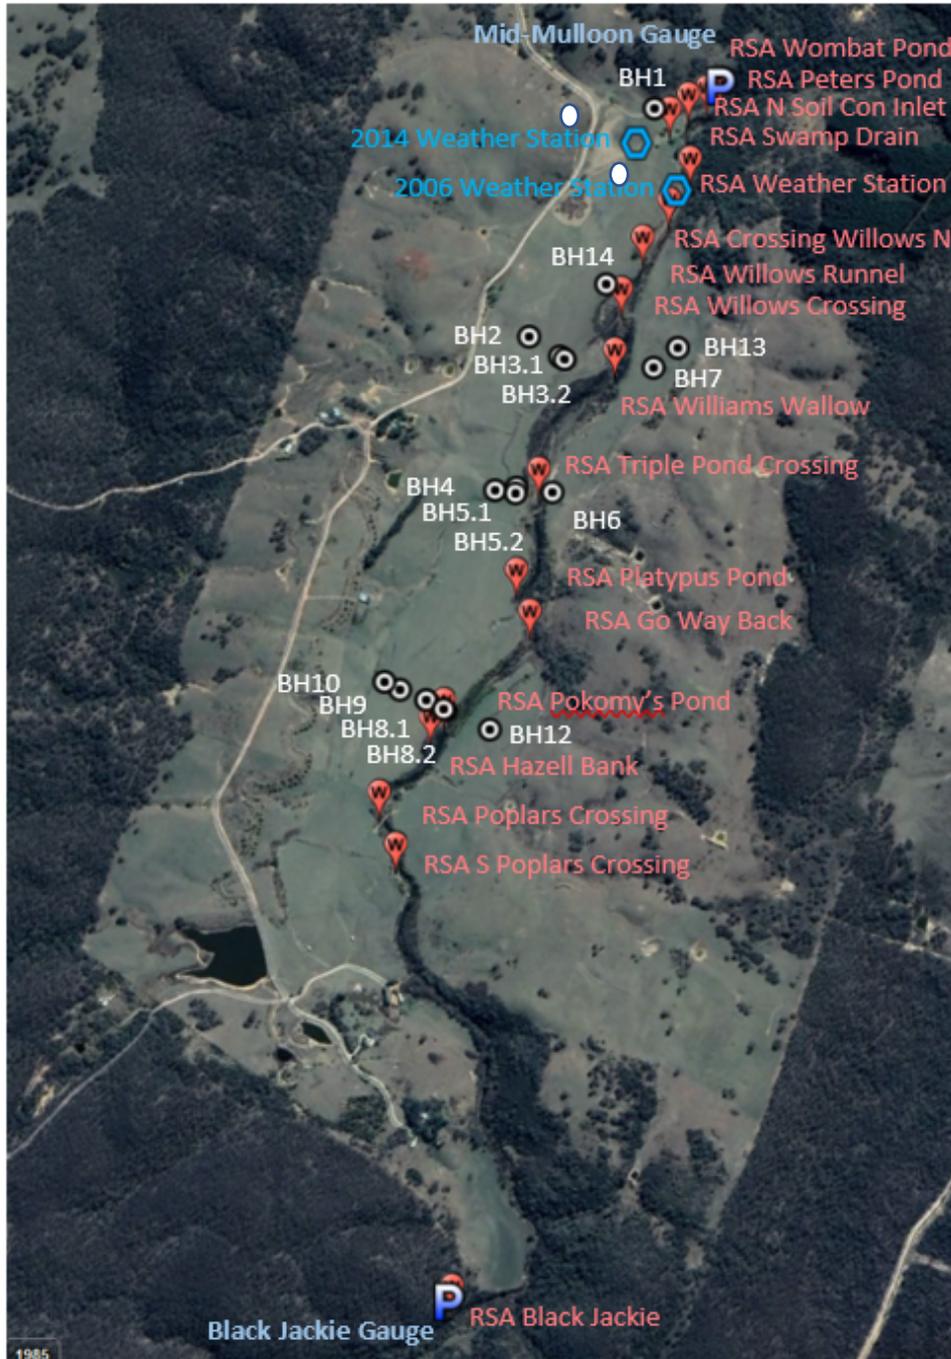
Figure 5. Location of stream gauging stations (n=2; P), weather stations (n=2; ○), boreholes (n=17; ●), rapid stream survey sites (n=17; W) and pond sampling sites (n=8) on the Mulloon Home Farm on the mid-section of Mulloon Creek.

A new weather station, located west of Peter's Pond (Figure 5), was commissioned in August 2020 and is measuring: rainfall (mm); air temperature (°C); relative humidity (%); wind speed (km/hr); wind direction; barometric pressure (hPa); incoming solar radiation (W/m²); outgoing solar radiation (W/m²); calculated evaporation (mm); soil heat flux (8cm soil depth) (W/m²); soil temperature (8cm soil depth) (°C); and calculated dew point (°C), with scope to add a soil moisture sensor. Rainfall data is recorded at one-minute intervals, and all other measurements are recorded at daily, hourly and at ten-minute intervals. Collection of incoming and outgoing solar radiation, soil heat flux, soil temperature, and soil moisture enables calculation of the energy budget in this system. It provides information on the energy available for plant growth (including transpiration) and evaporation.

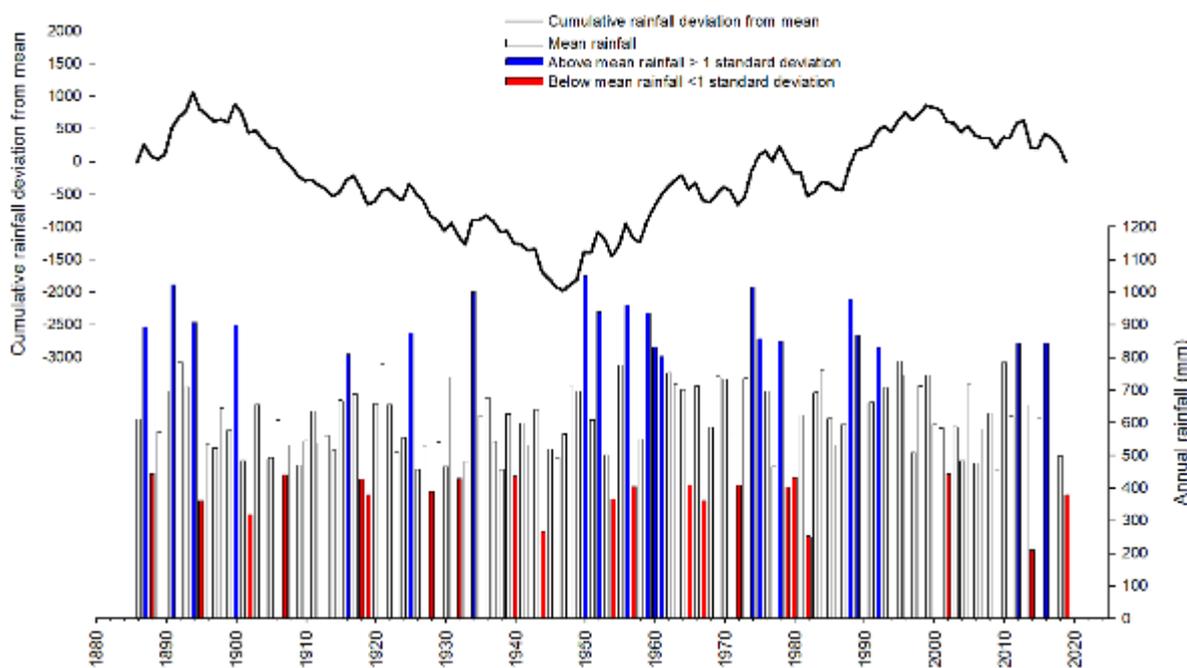
Figure 6. Historic rainfall information for the Mulloon Home Farm area, including: the cumulative rainfall deviation from mean, mean rainfall and indication of when rainfall was above the mean and below the mean for the period 1886 to 2020.

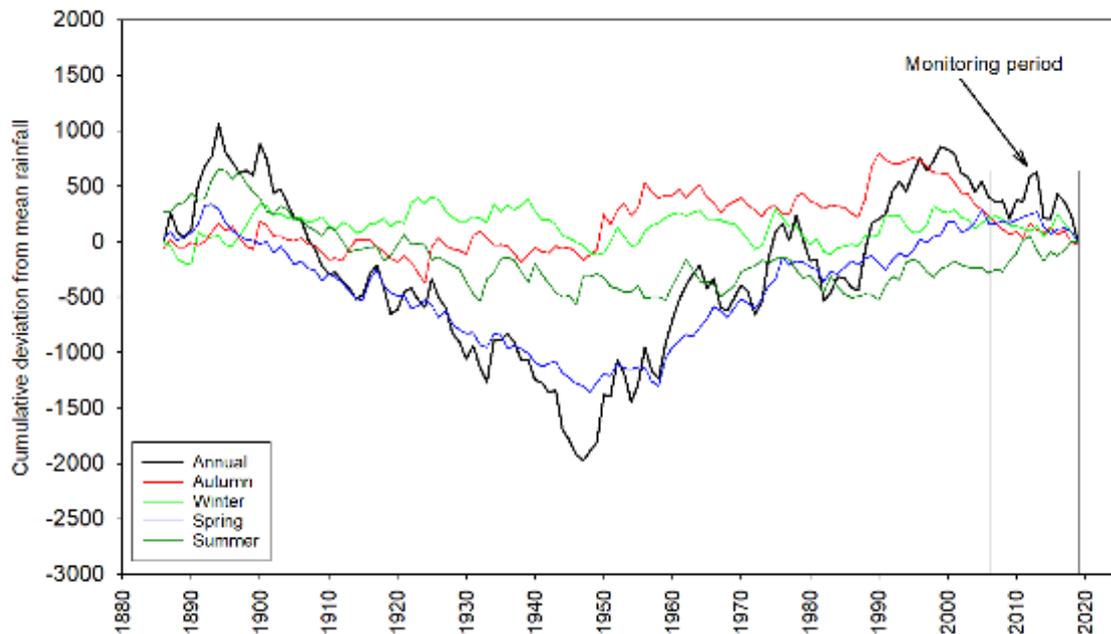
Figure 9. Historical cumulative rainfall deviation from the mean by season in the Mulloon area for the period 1886 to 2020.

When the historical cumulative rainfall deviation from the mean for the Mulloon area is considered by season (Figure 9) wetting and drying trends can be observed. When spring rainfall is below average (1886 to 1948), we see a decreasing (drying) trend, and when spring rainfall is above average (1948 to 1998), we see an increasing (wetting) trend. However, in recent decades (since 1998), rainfall in the autumn season most strongly reflects the drying trend. Changes in this pattern are potentially linked to a changing climate.

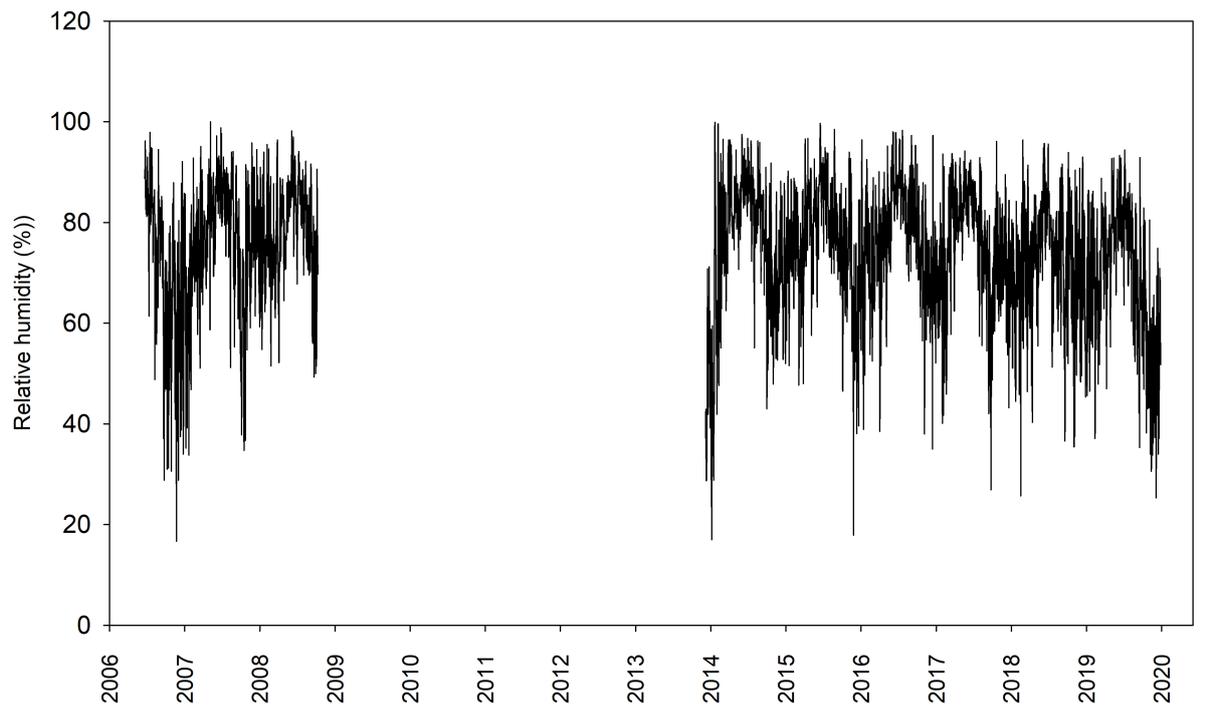
Figure 13. Measured relative humidity at the Mulloon Home Farm for the period 2006 to 2020.

Relative humidity is the amount of water vapour present in the air (%) relative to the amount of water the air could potentially hold if saturated, at the same temperature. At the Mulloon Home Farm the relative humidity varies seasonally, with values lower in summer (20-60%_{sat}) and higher in winter to early spring (60-90%_{sat}) (Figure 13). Relative humidity was low for an extended period in the hot, dry summer of 2007 (late Millennium Drought), and every summer in the 2017-2019 Tinderbox Drought. There is a small decrease in maximum relative humidity over the study period.

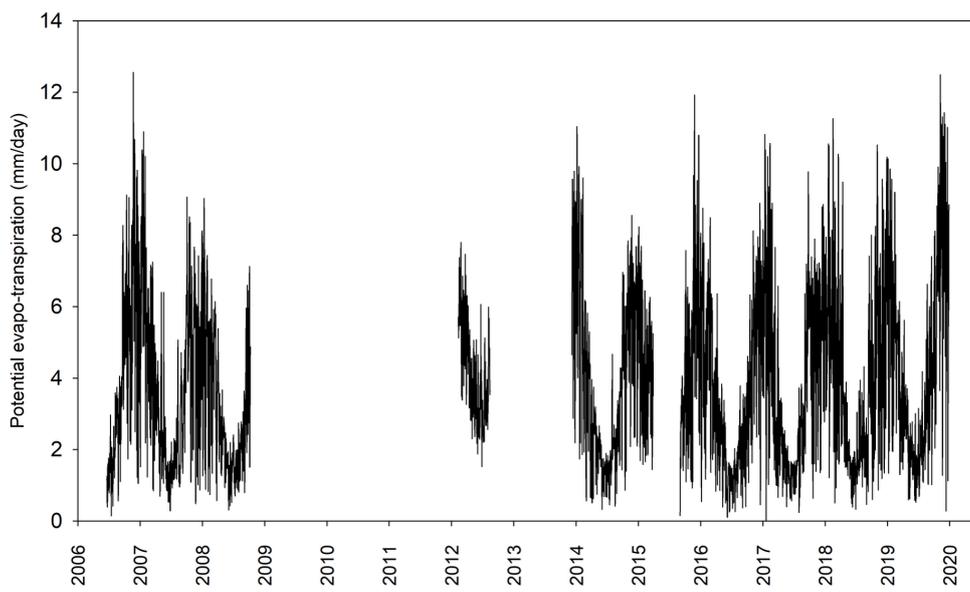
Figure 15. Potential evapotranspiration at the Mulloon Home Farm for the period 2006 to 2020.

Potential evapotranspiration (PET) is the amount of evapotranspiration that would occur under optimum conditions where water is readily available. The potential evapotranspiration pattern is similar to the global solar radiation pattern, as these two parameters have a causal link; that is, the amount of evapotranspiration is related to the amount of solar radiation. At the Mulloon Home Farm, the PET has a higher maximum and a larger range in summer (1.5-13.0 mm/day) than in winter (0.5-2.0 mm/day) (Figure 15). The highest PET values (13 mm/day) were recorded in 2007 (late Millennium Drought) and in 2020 (late 2017-2019 Tinderbox Drought).

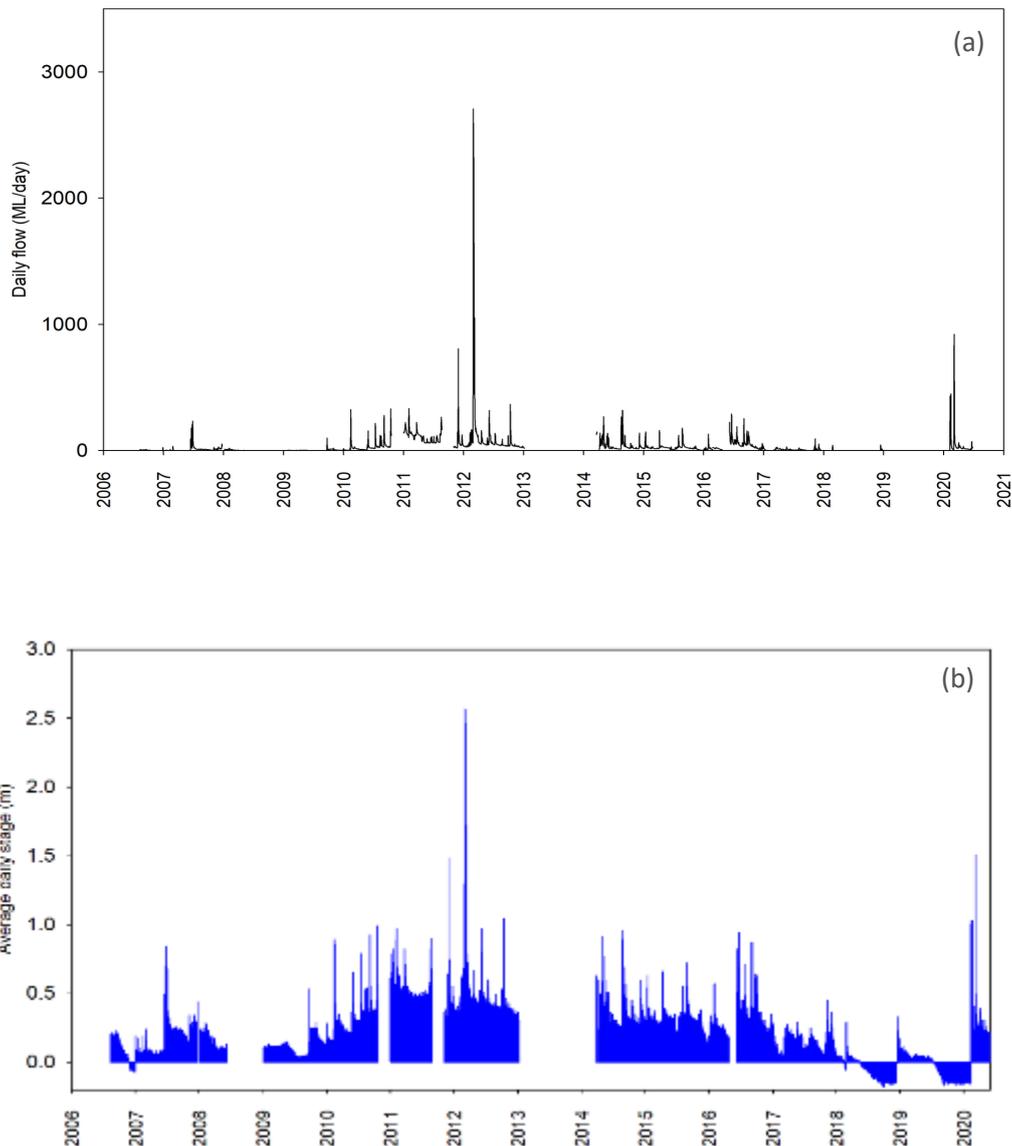
Figure 16. (a) Daily flow (ML/day), and (b) average daily stage (water depth in m) at the (southern) Black Jackie Stream Gauge, Mulloon Home Farm, for the period 2006 to 2020.

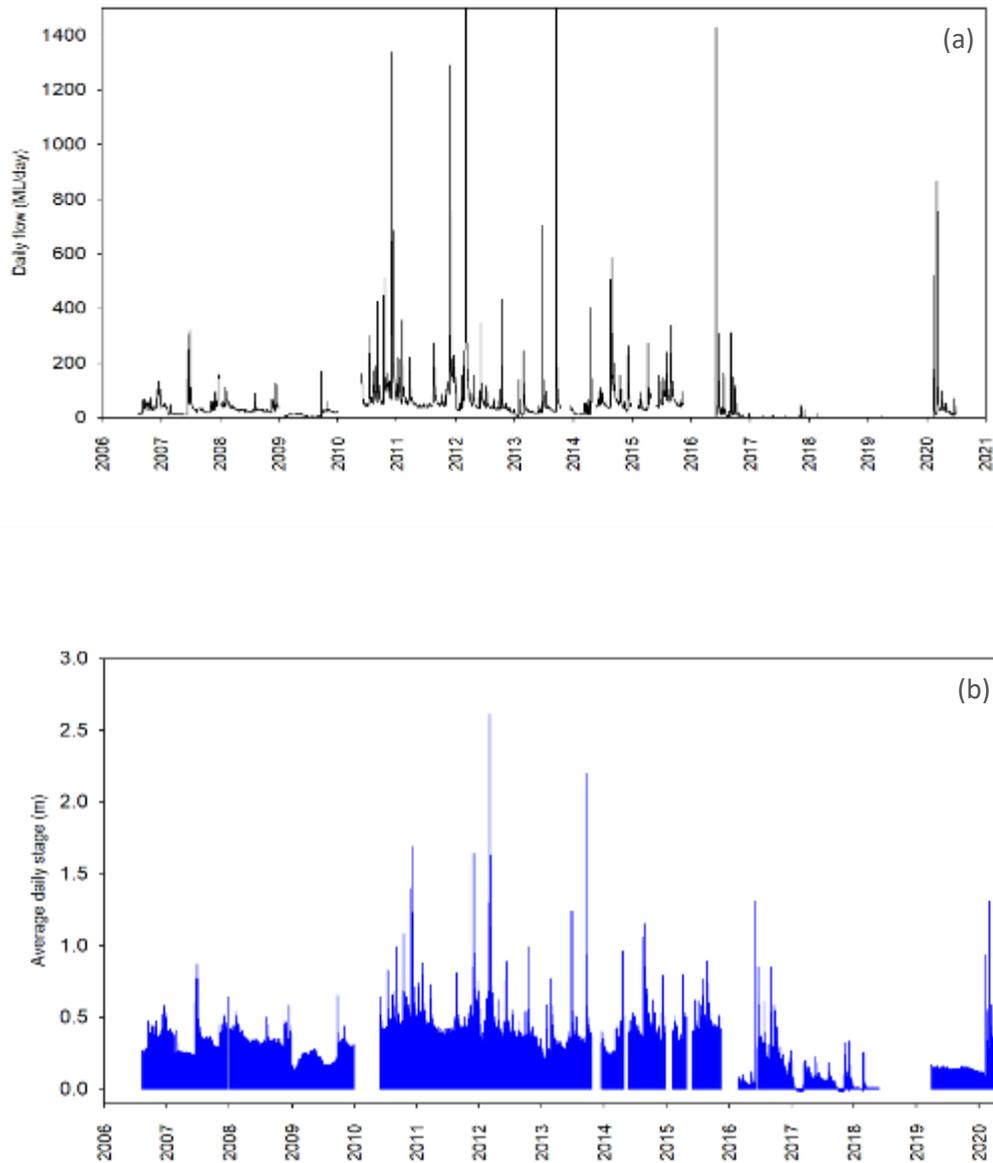
Figure 17. (a) Daily flow (ML/day), and (b) average daily stage (water depth in m) at the (northern) Mid-Mulloon Stream Gauge, Mulloon Home Farm, for the period 2006 to 2020.

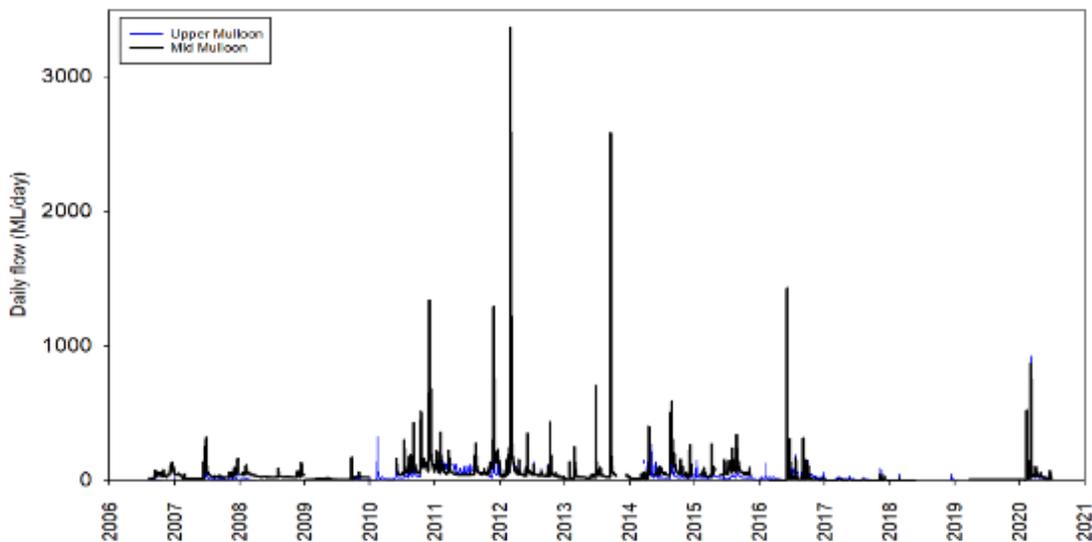
Figure 19. Daily flow (ML/day) for the Black Jackie and Mid-Mulloon Stream Gauges showing when the flow leaving the Mulloon Home Farm equals or exceeds the flow entering the Mulloon Home Farm, for the period 2006 to 2020.

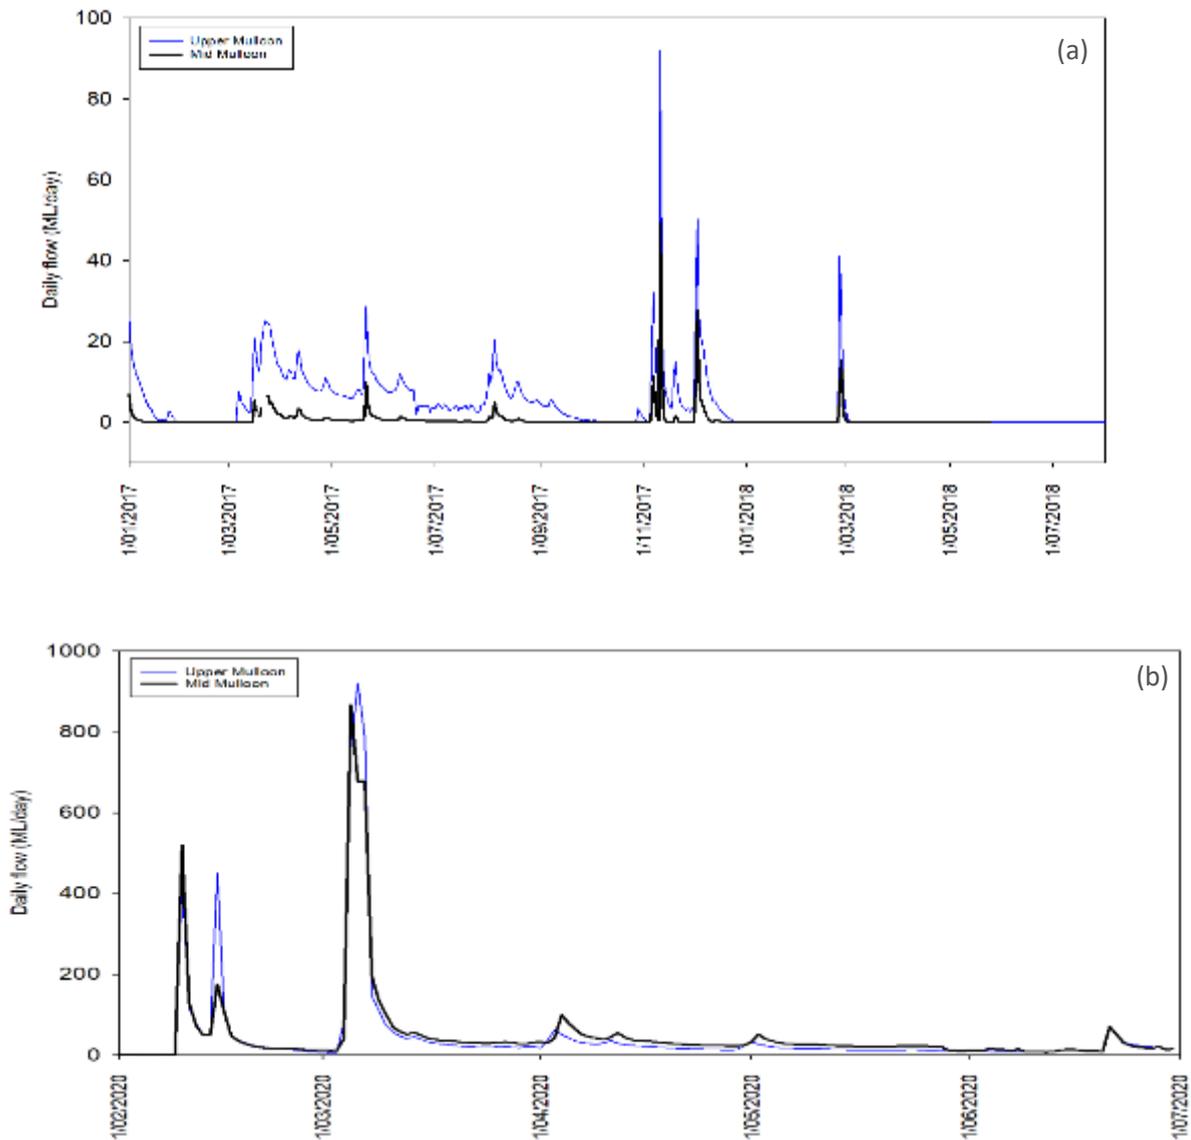
Figure 20. (a) Daily flow (ML/day) for the Black Jackie and Mid-Mulloon Stream Gauges in early 2017 and (b) in early 2020, showing a period when water exited the Mulloon Home Farm equals and at times exceeds the flow entering via Mulloon Creek.

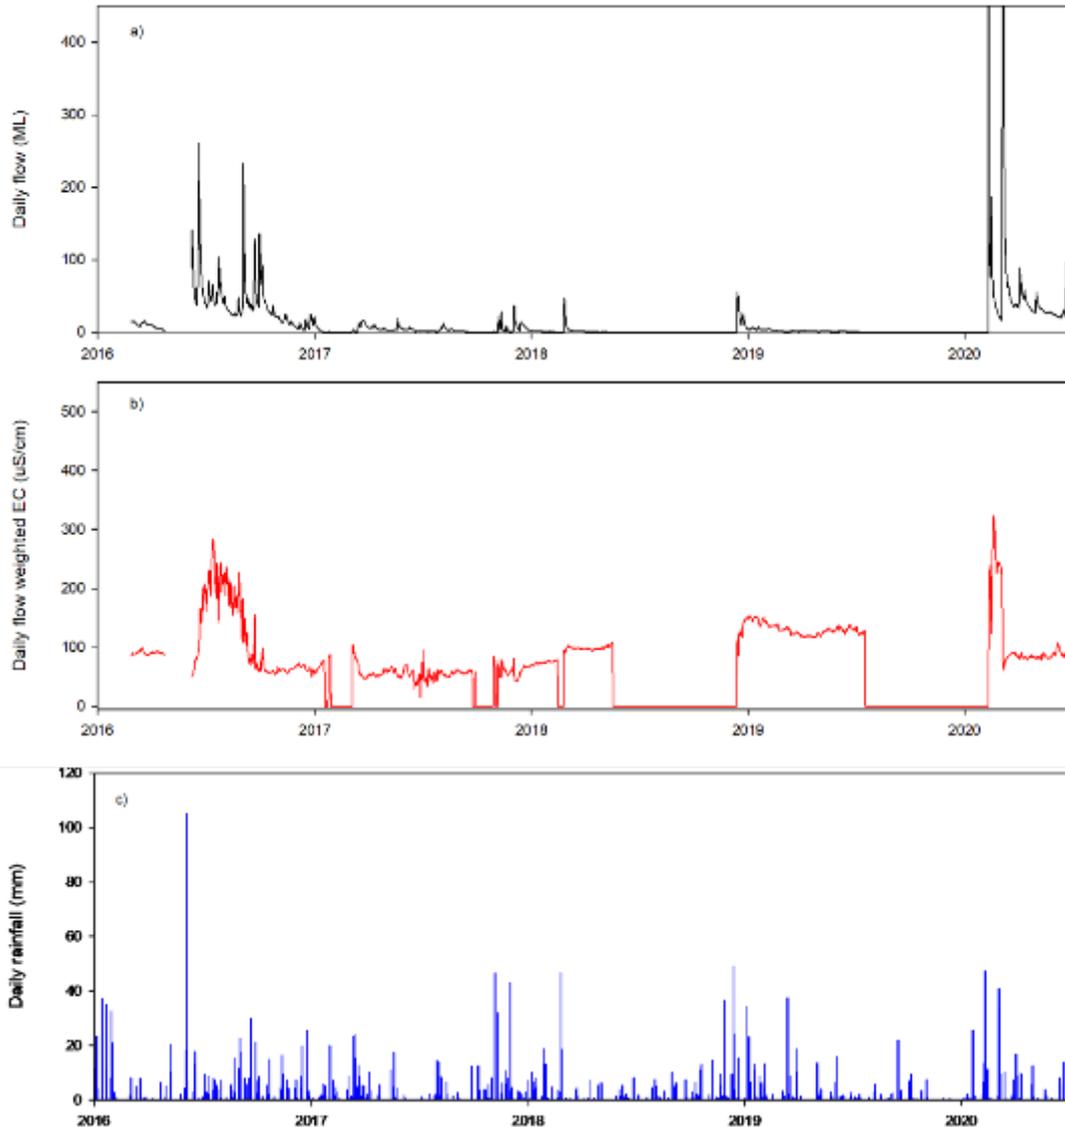
Figure 21. (a) Daily flow, (b) daily flow weighted electrical conductivity and (c) daily rainfall at the (southern) Black Jackie Stream Gauge, Mulloon Home Farm, for the period 2016 to 2020.

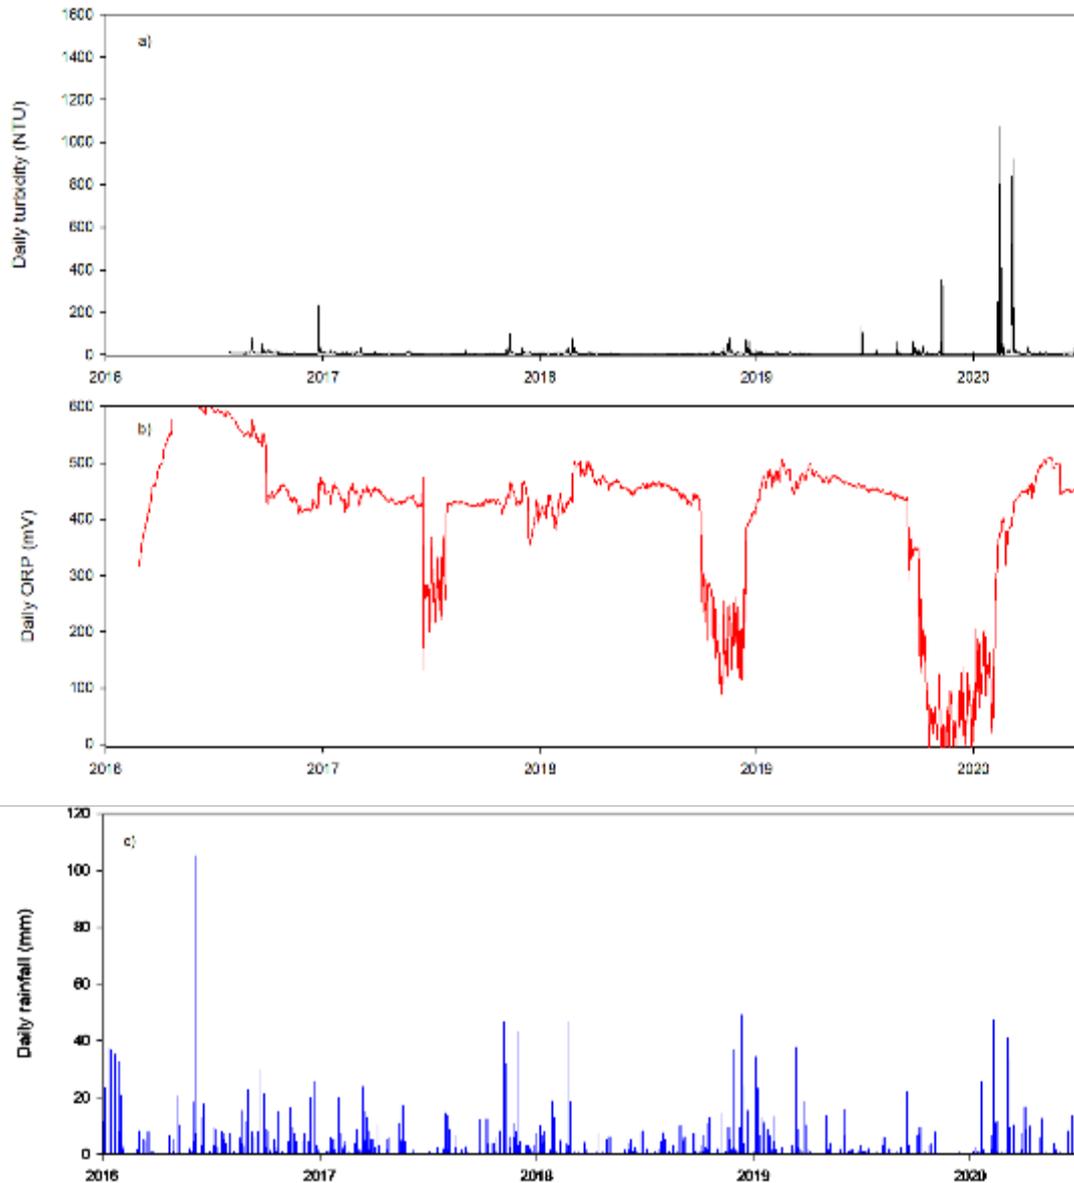
Figure 22. (a) Daily turbidity, (b) daily oxidation-reduction potential (ORP) and (c) daily rainfall at the (southern) Black Jackie Stream Gauge, Mulloon Home Farm, for the period 2016 to 2020.

Under normal flow conditions, the turbidity measurements are typically low ($\ll 100$ NTU) and the water relatively clear. Stream water is more turbid (400-1100 NTU) when there is higher velocity flow during and post major rain events (Figure 22 a; Figure 22 c).

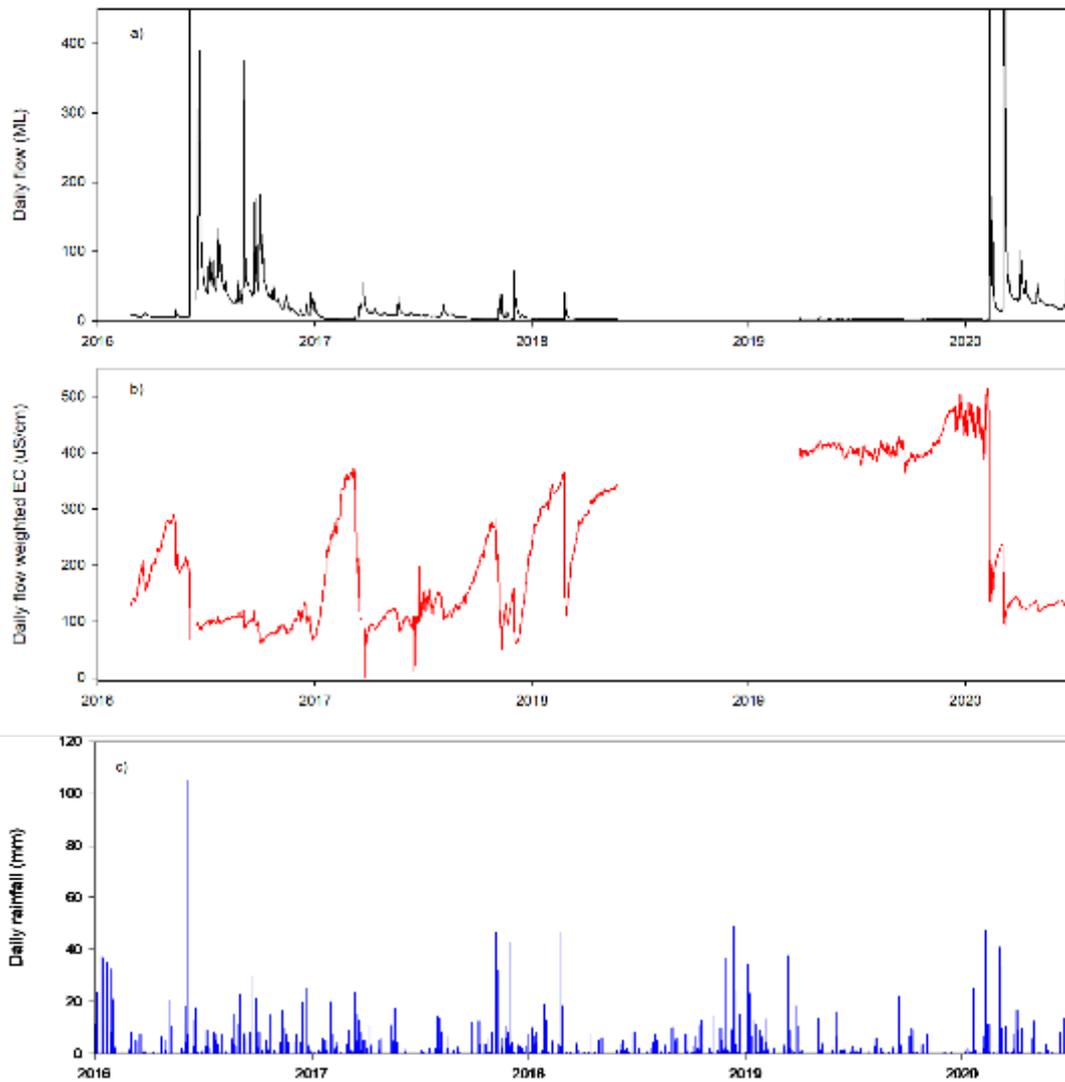
Figure 23. (a) Daily flow, (b) daily flow weighted electrical conductivity and (c) daily rainfall at the (northern) Mid-Mulloon Stream Gauge, Mulloon Home Farm, for the period 2016 to 2020.

Mulloon Creek leaves Mulloon Home Farm to the north, and the Mid-Mulloon Stream Gauge monitors the water exiting this part of the valley (Figure 4). Stream flow is typically low for the study period, reflecting the low flow entering the valley from the south. Again, significant increases in flow are observed after rainfall events, notably in the second half of 2016, and in early 2020 (Figure 23a).

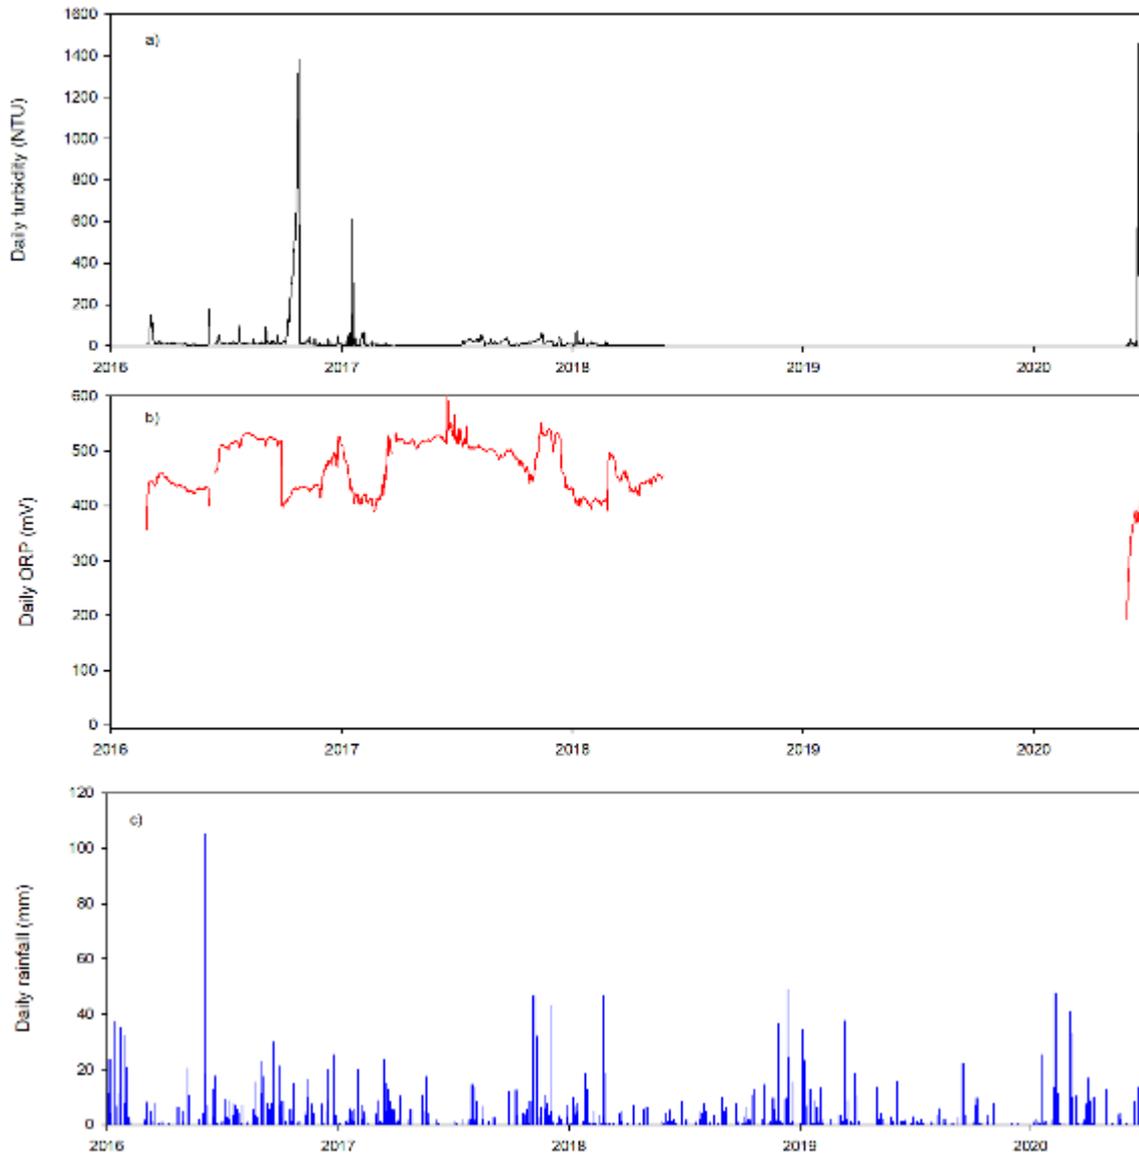
Figure 24. (a) Daily turbidity, (b) daily oxidation-reduction potential (ORP) and (c) daily rainfall at the (northern) Mid-Mulloon Stream Gauge, Mulloon Home Farm, for the period 2016 to 2020.

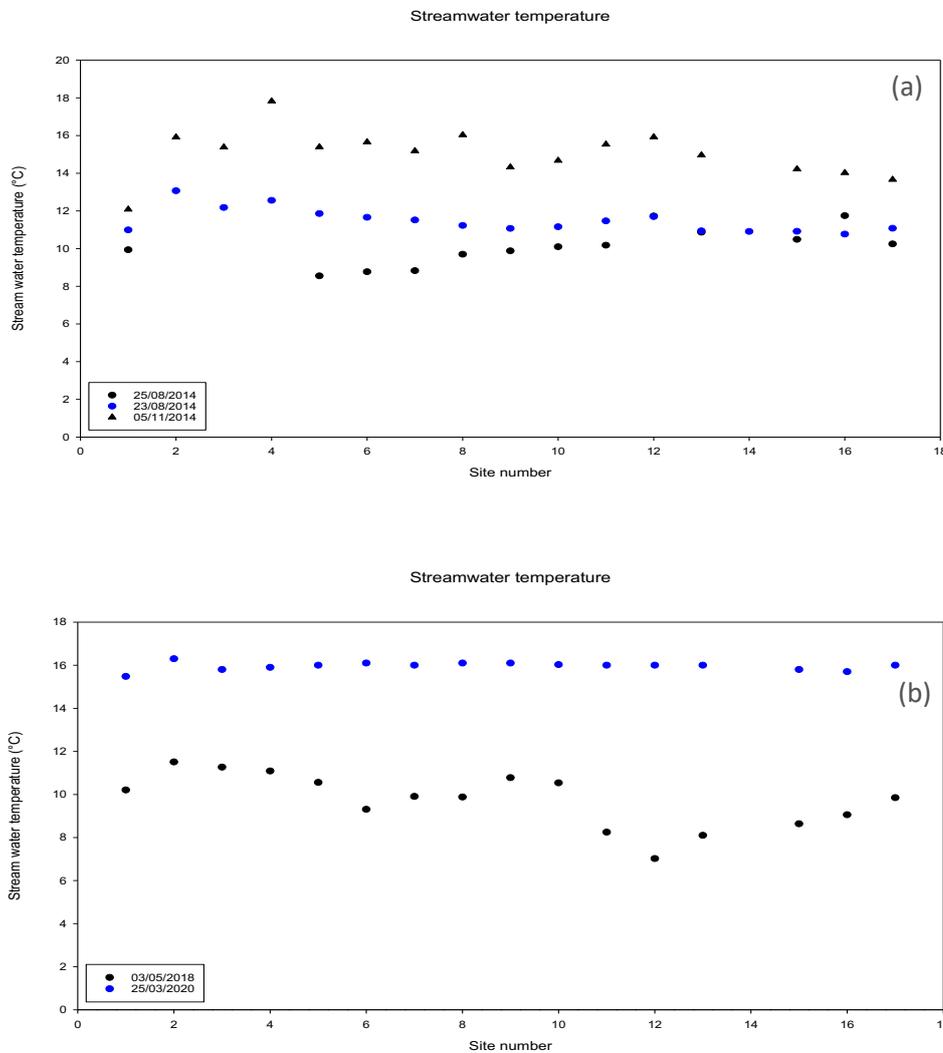
Figure 25. Stream Water Temperature at 17 sites on mid-Mulloon Creek (a) 2014; (b) 2016/2017; (c) 2018/2020

Stream water temperature showed a slight decreasing trend (13°C to 10°C) (Minimum to Maximum Air Temperature (M-MAT 6.3°C to 13.3°C) as it flowed northward on 23 August 2014, with a similar pattern observed, at higher temperatures on 25 September 2014 (18°C to 13°C) (M-MAT 9.8°C to 17.8°C) (Figure 25a). In both cases, stream water temperature increases were observed South of Poplars Crossing and at the Crossing North of the Willows. On 5 November 2014, the opposite trend was observed with temperatures increasing downstream (9°C to 11°C) (M-MAT 7.7°C to 26.0°C).

Winter stream water temperature ranges in June 2016 (4°C to 6°C) (M-MAT -0.7 to 14.2°C) and July 2017 (4°C to 7°C) (M-MAT -4.3 to 11.0°C) were the lowest observed, with no apparent increase or decrease in stream water temperature along mid-Mulloon Creek (Figure 25b). In the region, 2016 was a period of high rainfall and flooding. In contrast, the summer temperatures in November 2016 were much higher (24°C to 19°C) (M-MAT 9.4°C to 26.6°C), with the highest temperature (24°C) measured at 3 locations: South of Poplars Crossing, at Williams Wallow and North of the Soil Con Outlet. The lowest temperatures were measured at Willows Crossing (20°C) and Wombat Pond (19°C).

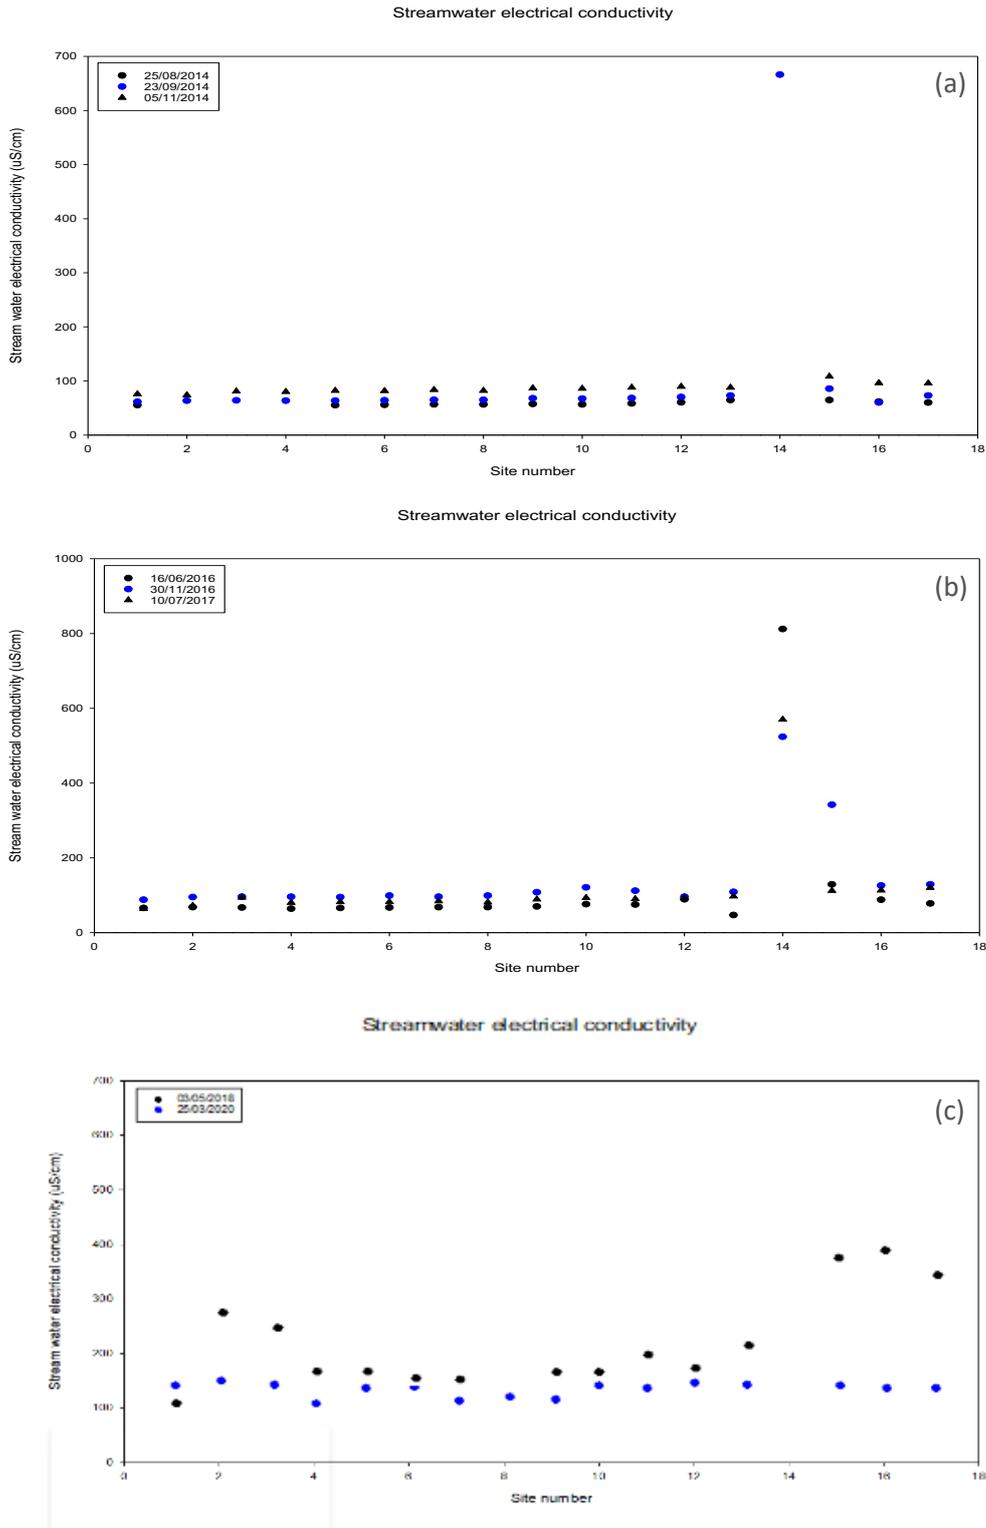
Figure 26. Stream Water EC at 17 sites on mid-Mulloon Creek (a) 2014; (b) 2016/2017; (c) 2018/2020

The exception to this pattern is water measured at the outlet to the Swamp Drainage Channel, where elevated EC values were measured in late winter 2014, 780µS/cm; winter 2016, 800µS/cm; late spring 2016, 500µS/cm; and winter 2017, 520µS/cm. The higher EC water from the Swamp Drainage Channel caused elevated values immediately downstream (North of

the Soil Con inlet), but these typically stabilised below $100\mu\text{S}/\text{cm}$ at Peter's Pond. A similar pattern was observed in the 2018 mid-drought, but EC levels downstream of the Swamp Drainage Channel stayed elevated at around $300\mu\text{S}/\text{cm}$. These data suggest that salts are concentrated due to evaporation from the Swamp, and waters draining this area introduce slightly saline water to mid-Mulloon Creek at the Swamp Drainage Channel outlet. In 2018, during the 2017-2019 Tinderbox Drought, EC values for water sampled South of and at Poplars Crossing had slightly elevated EC ($280\mu\text{S}/\text{cm}$ and $240\mu\text{S}/\text{cm}$), possibly associated with evaporation from ponded stream water.

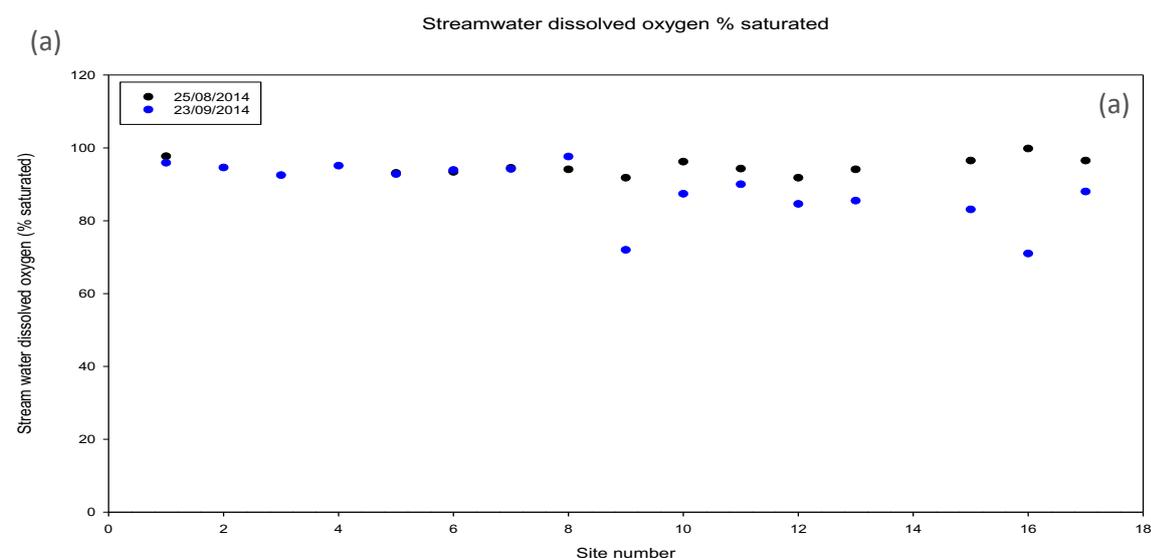
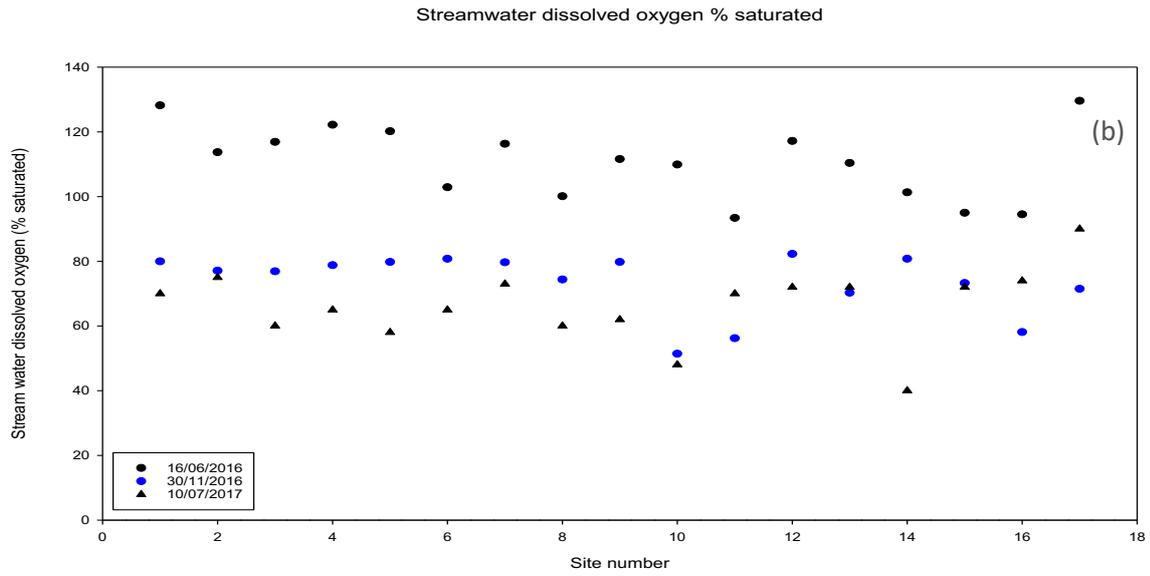
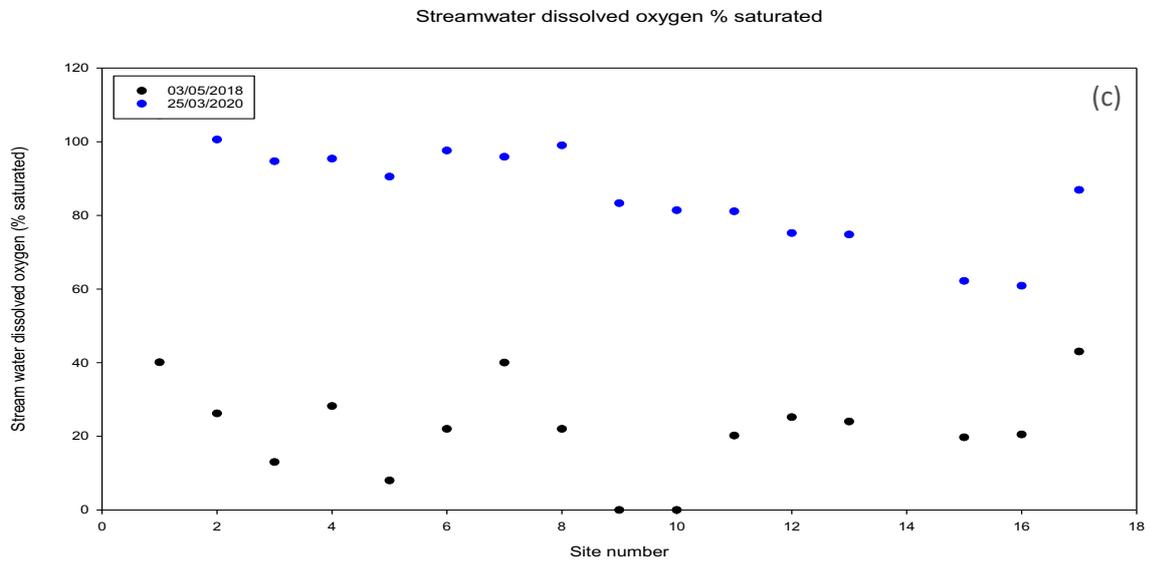
Figure 27. Stream Water DO (% sat.) at 17 sites on mid-Mulloon Creek (a) 2014; (b) 2016/2017; (c) 2018/2020

Waters measured in late spring 2016 and winter 2017 (Figure 27b; Figure 28b), as the 2017-2019 Tinderbox Drought commenced, had DO values mostly in the 60-80% saturation (6 - 8mV at 15°C) range. Dissolved oxygen at these levels can sustain aquatic ecosystems, but these conditions are sub-optimal.

In the winter of 2018 (Figure 27c; Figure 28c), mid-drought, the DO levels were in the range 0-40% saturation ($< 4\text{mV}$) saturation with considerable variation from site to site. Highest DO levels (40% saturation; $\sim 4\text{mV}$) were observed for Black Jackie, Platypus Pond and Wombat Pond. The lowest levels (0%) were observed at Williams Wallow and Willows Crossing, where flow was extremely low. In general, pond areas were able to sustain some aquatic ecosystems, but elsewhere these ecosystems were impacted.
