Controls on flow and patterns in physico-chemical properties of groundwater on a landscape rehydration enterprise at Mulloon Creek, New South Wales, Australia.

Moore C.L. and Bernardi T.

Centre for Applied Water Science (CAWS),
University of Canberra, ACT 2601

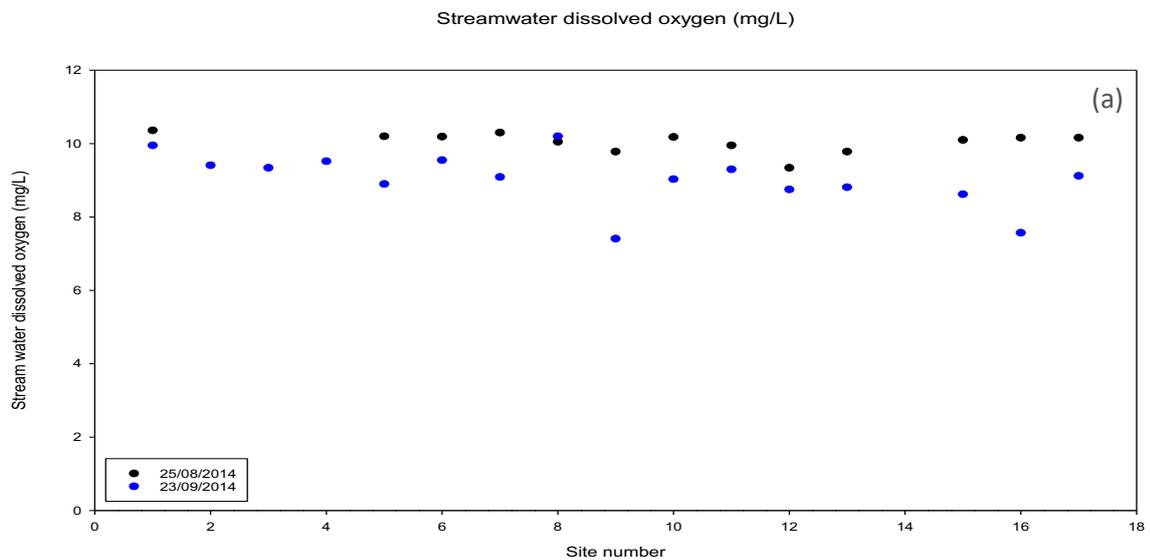
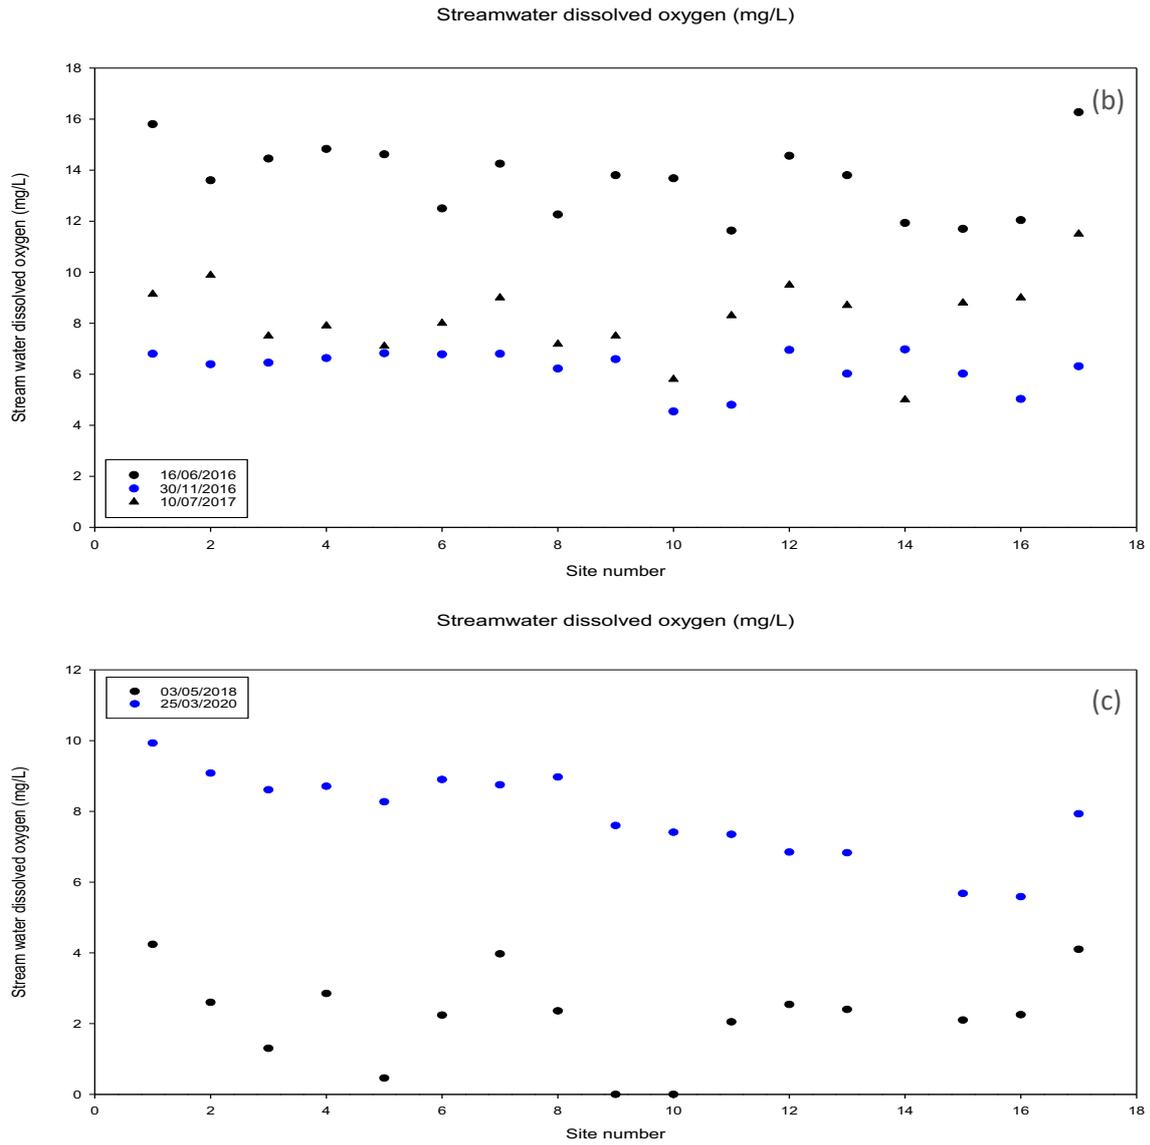
Figure 28. Stream Water DO (mg/L) at 17 sites on mid-Mulloon Creek (a) 2014; (b) 2016/2017; (c) 2018/2020

Waters measured in late spring 2016 and winter 2017 (Figure 27b; Figure 28b), as the 2017-2019 Tinderbox Drought commenced, had DO values mostly in the 60-80% saturation (6 - 8mV at 15°C) range. Dissolved oxygen at these levels can sustain aquatic ecosystems, but these conditions are sub-optimal.

In the winter of 2018 (Figure 27c; Figure 28c), mid-drought, the DO levels were in the range 0-40% saturation ($< 4\text{mV}$) saturation with considerable variation from site to site. Highest DO levels (40% saturation; $\sim 4\text{mV}$) were observed for Black Jackie, Platypus Pond and Wombat Pond. The lowest levels (0%) were observed at Williams Wallow and Willows Crossing, where flow was extremely low. In general, pond areas were able to sustain some aquatic ecosystems, but elsewhere these ecosystems were impacted.

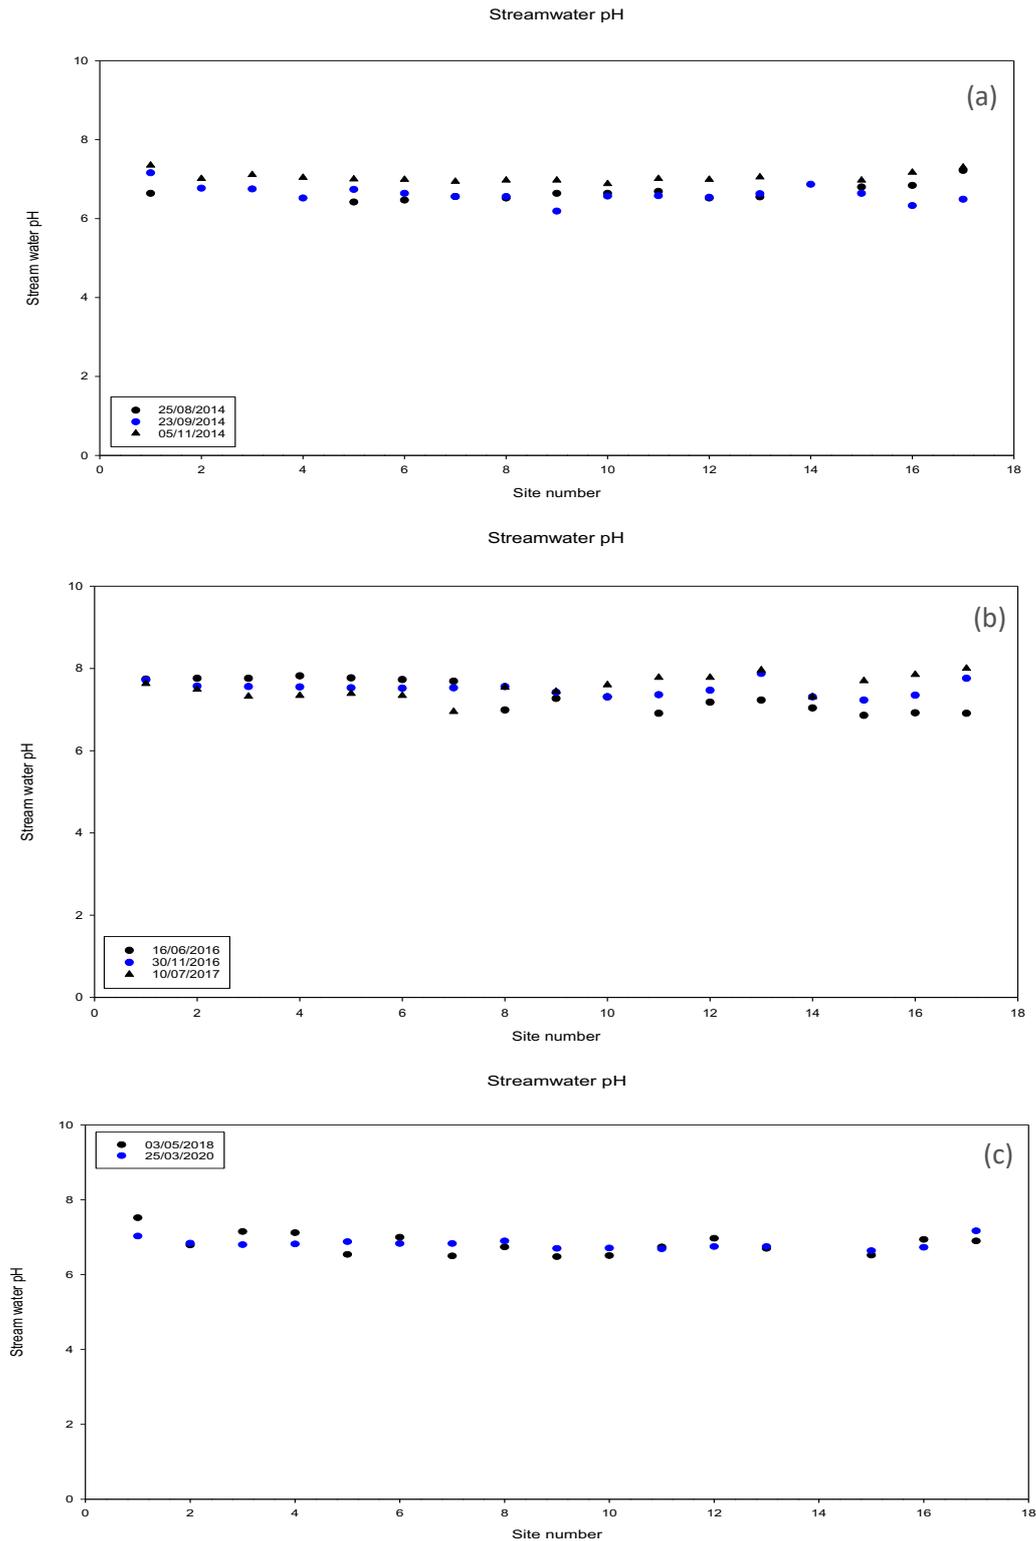
Figure 29. Stream Water pH at 17 sites on mid-Mulloon Creek (a) 2014; (b) 2016/2017; (c) 2018/2020

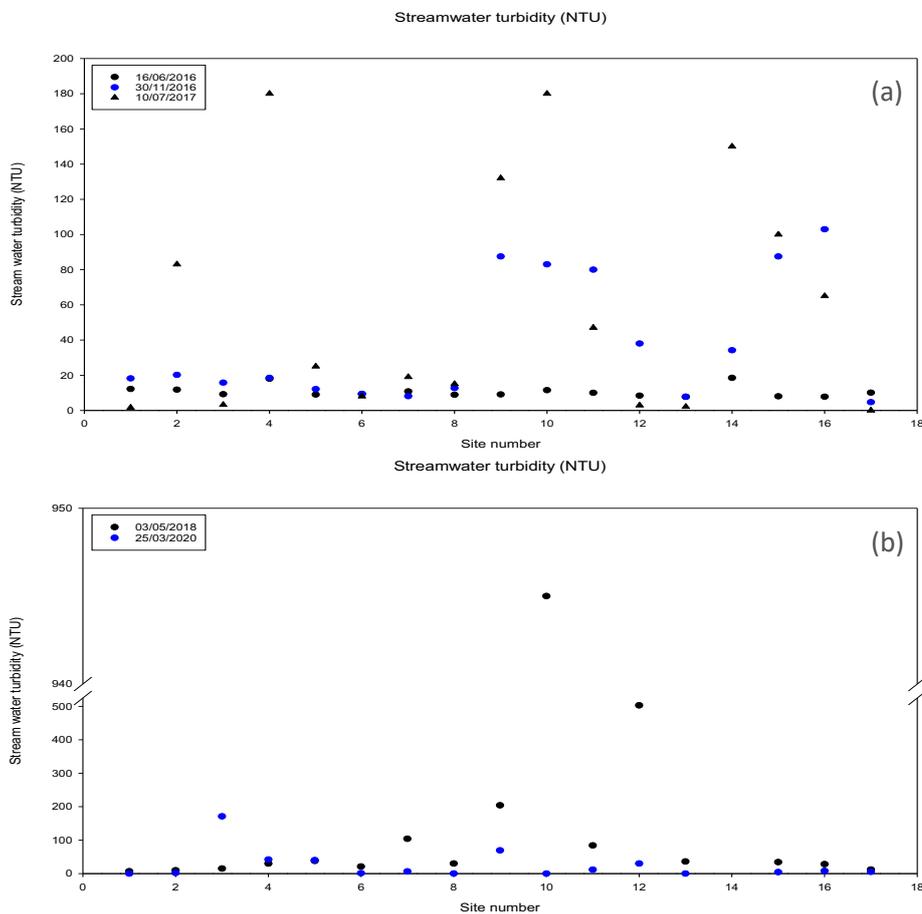
Figure 30. Stream Water Turbidity (NTU) at 17 sites on mid-Mulloon Creek (a) 2016/2017; (b) 2018/2020. In 2014, most turbidity readings were less than 20 NTU (Site 14 Swamp Drain >2500 NTU).

exceeded 25 ML/day (Table 4). However, elevated turbidity was observed in spring 2016 (Figure 30a), winter 2017 (Figure 30a), and winter 2018 (Figure 30b) when flow was low (< 11 ML/day).

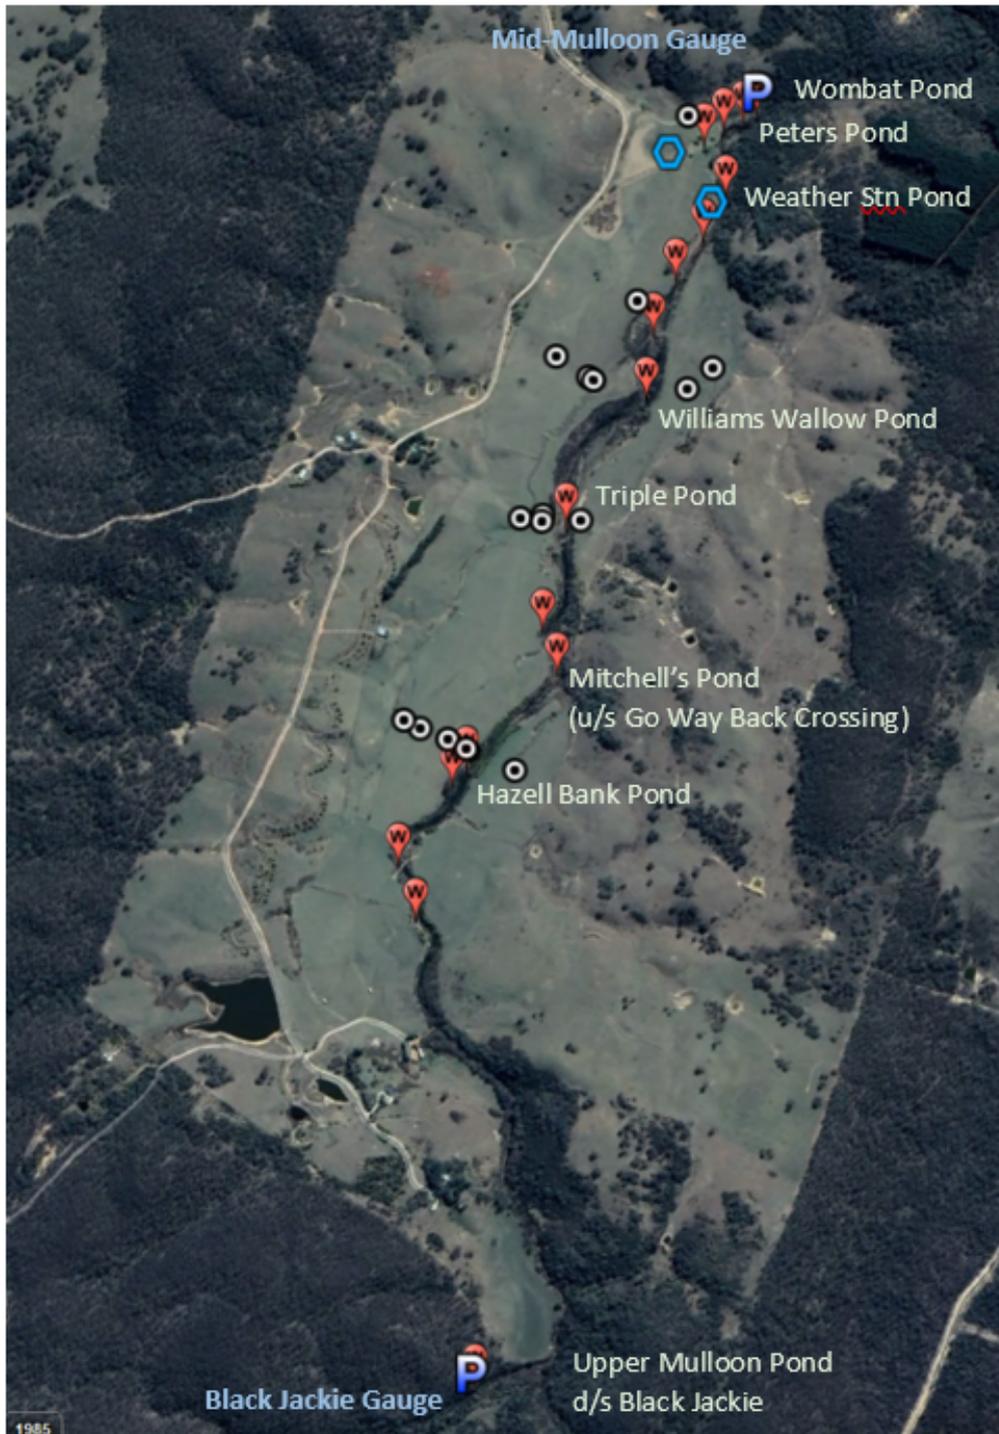
Figure 31. Location of stream gauging stations (n=2; P) and pond sampling sites (n=8) on the Mulloon Home Farm on the mid-section of Mulloon Creek.

For mid-Mulloon Creek, pond water level and manual electrical conductivity were sampled at 8 in-stream ponds at relatively regular intervals from 2014 to 2020. Gaps in the pond water level data relate to periods when the water level was below the base of the manual stage, the manual stage was damaged, or the manual stage could not be read (e.g. during flood events). From upstream to downstream, the Ponds are: Upper Mulloon Pond (downstream of the Black Jackie stream gauge), Hazell Bank Pond, Mitchell's Pond (upstream of Go Way Back Crossing), Triple Pond, Williams Wallow Pond, Weather Station Crossing Pond, Peter's Pond and Wombat Pond (Figure 31).

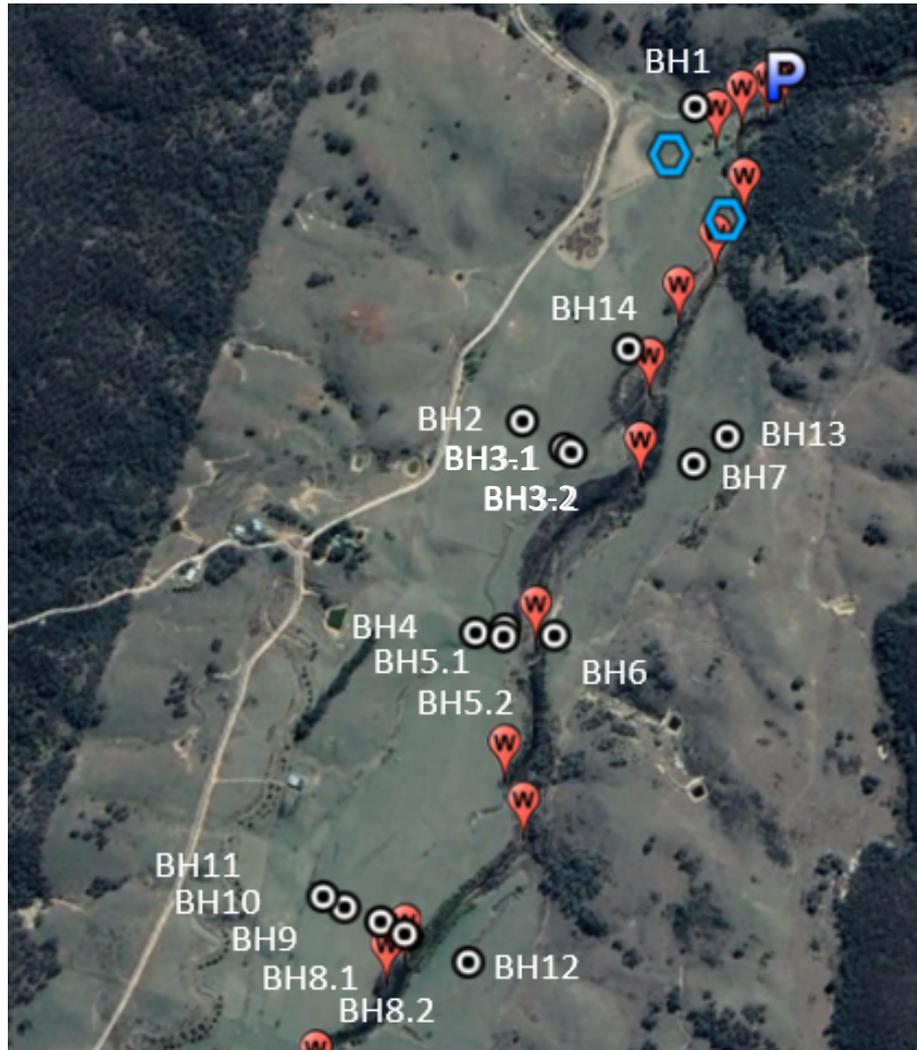
Figure 33. Location of borehole sites (n=17) forming three transects:
Transect A (BH11, BH10, BH9, BH8-1, BH8-2, BH12)
Transect B (BH4, BH5-1, BH5-2, BH6)
Transect C (BH2, BH3-1, BH3-2, BH7, BH13)
and two single boreholes (BH14, BH1)
on the Mulloon Home Farm on the mid-section of Mulloon Creek.

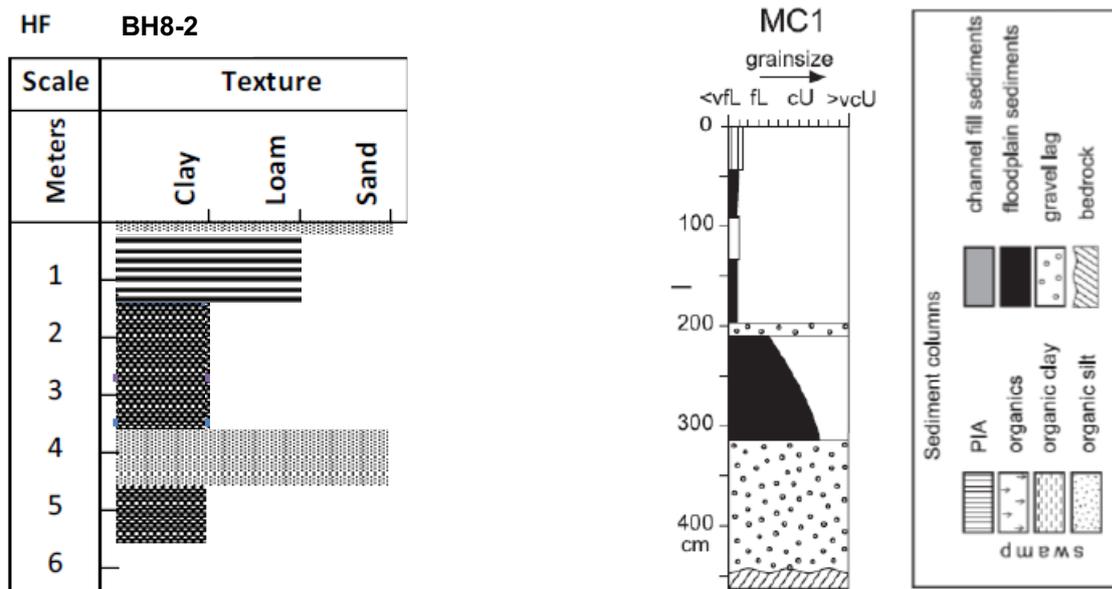
Figure 34. Stratigraphic log for Borehole 8-2 (Table 6; after Hickson, 2017) and stratigraphic log for borehole MC1 is more proximal to mid-Mulloon Creek (after Dobes et al. 2013).

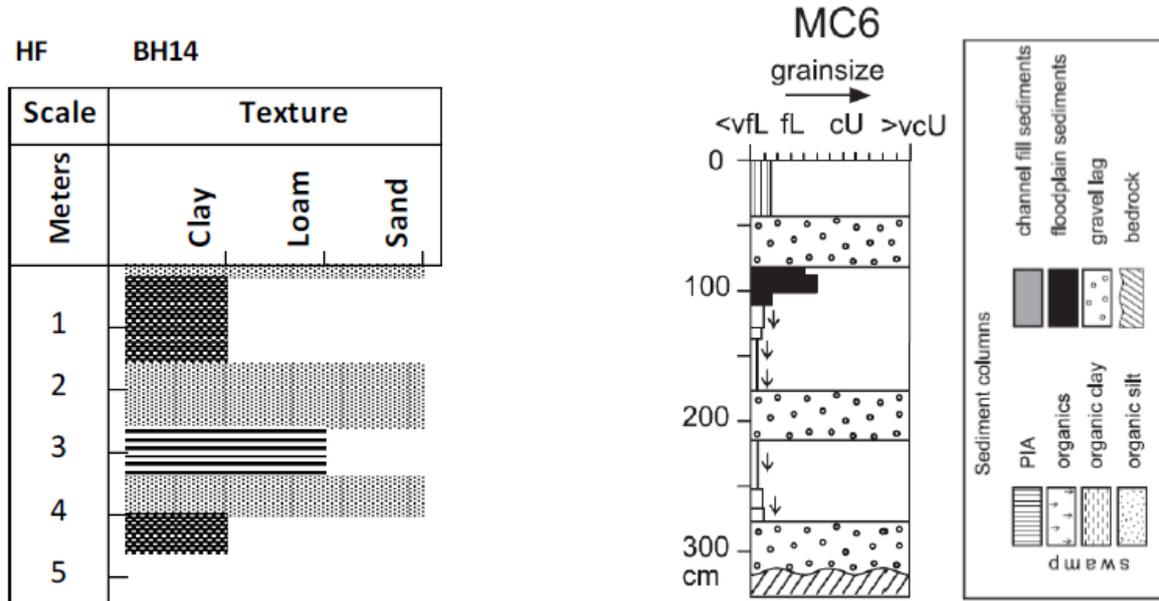
Figure 37. Stratigraphic log for Borehole 14 (Table 6; after Hickson, 2017) and stratigraphic log for borehole MC6 more proximal to mid-Mulloon Creek (after Dobes et al. 2013).
BH14 piezometer installed to 4 m. Screened from 1 m to 3.9 m.

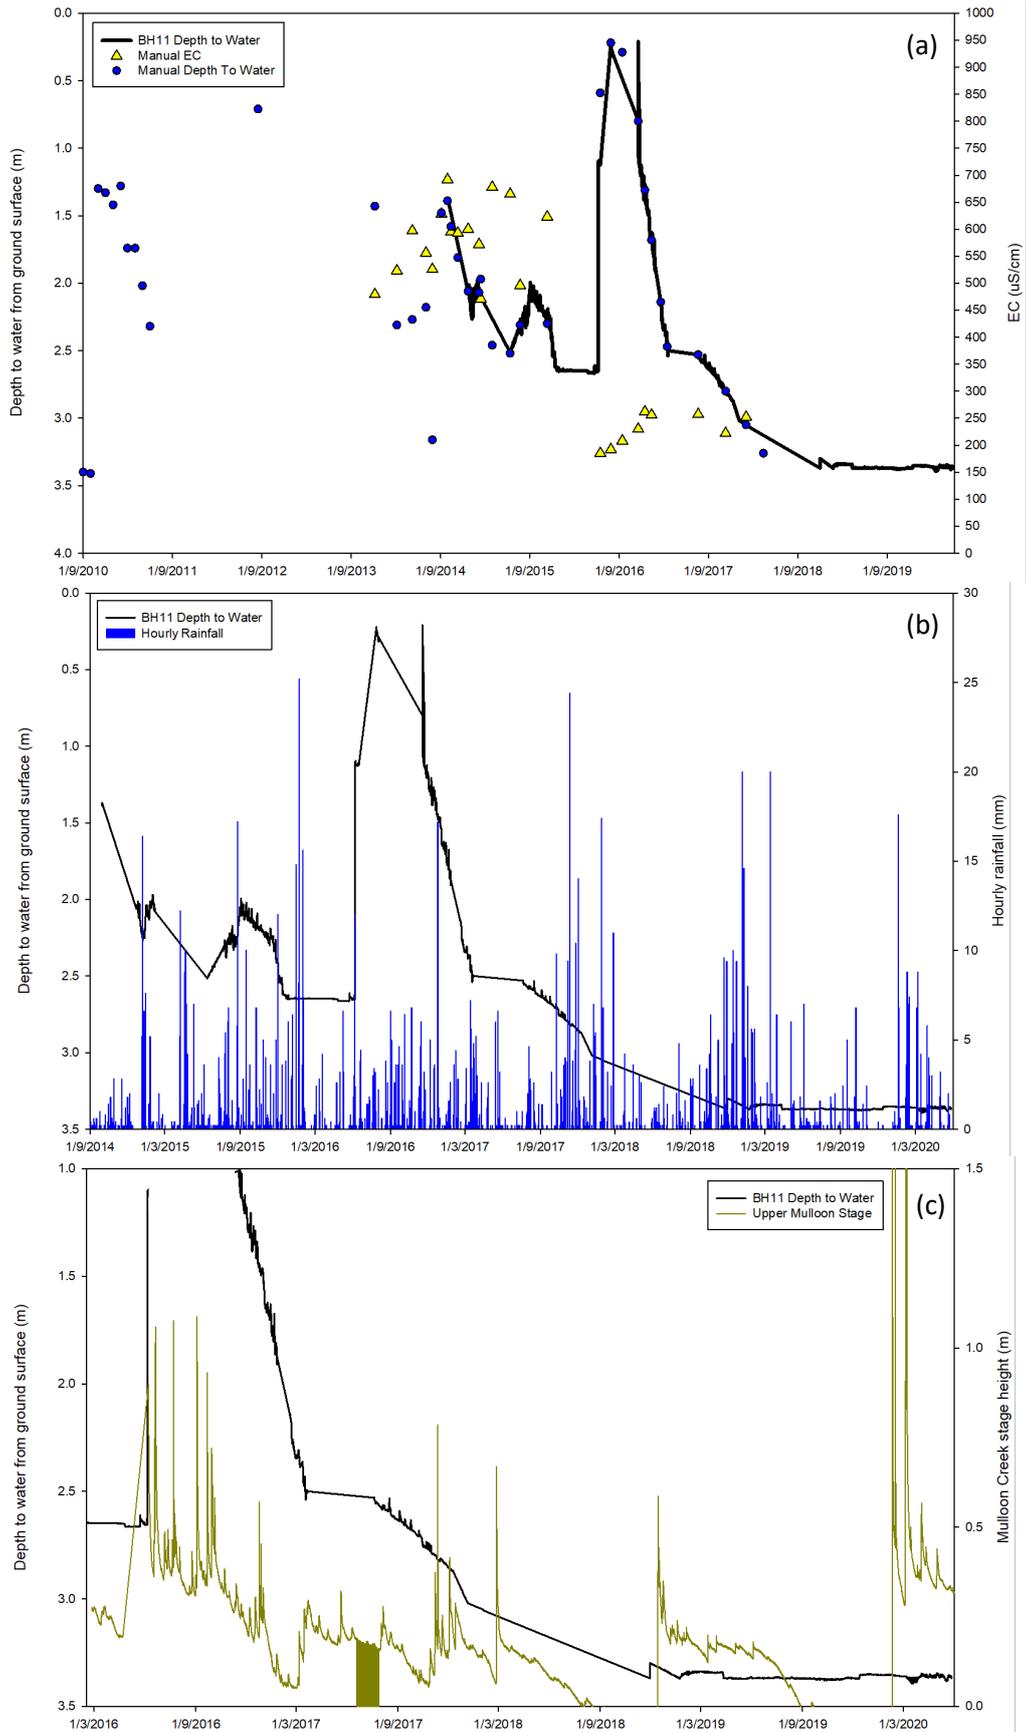
Transect A - Borehole 11

Figure 40. (a) BH11 water level and EC (2010-2020); (b) BH11 water level and rainfall (2014-2020); (c) BH11 water level and stream water level (2016-2020)

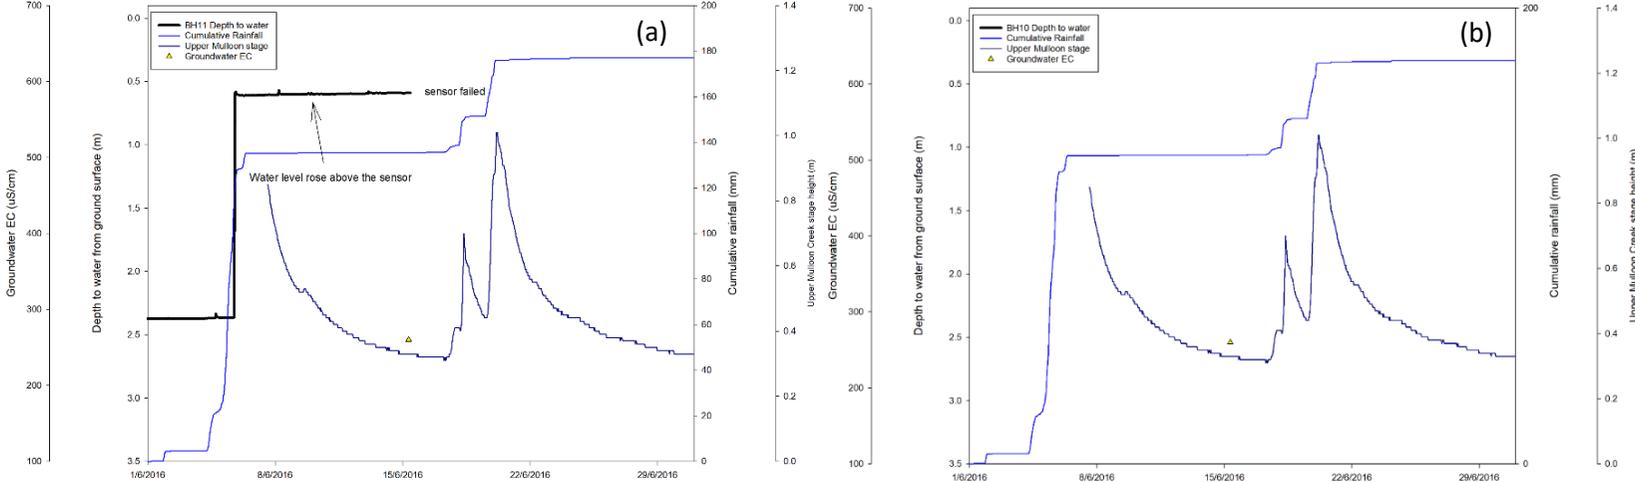
Figure 62. Groundwater Depth (BGL), Cumulative Rainfall, Stream Manual Stage Height, and Groundwater EC from 1 June to 1 July 2016 for Transect A (southern west-east transect): (a) BH11, (b) BH10 at Mulloon Home Farm.

for several days (to 15 June 2016) until sensor failure (Figure 62a). The groundwater EC recorded during this event was 250 μ S/cm.

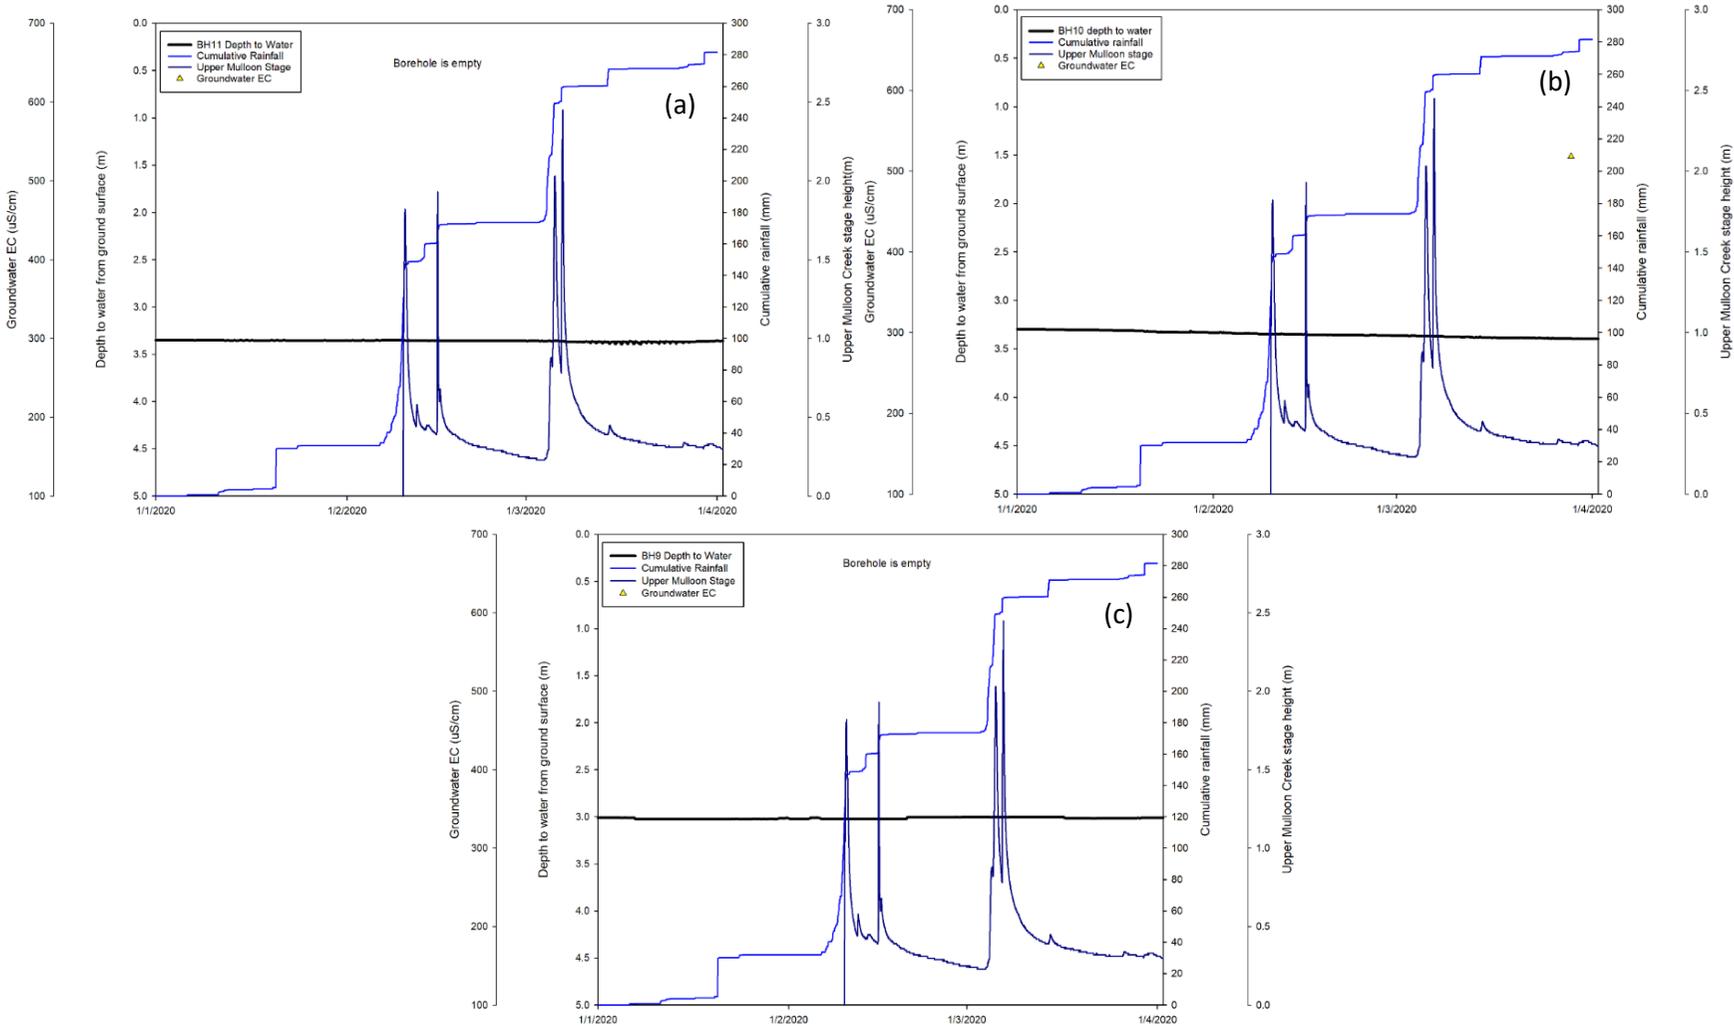
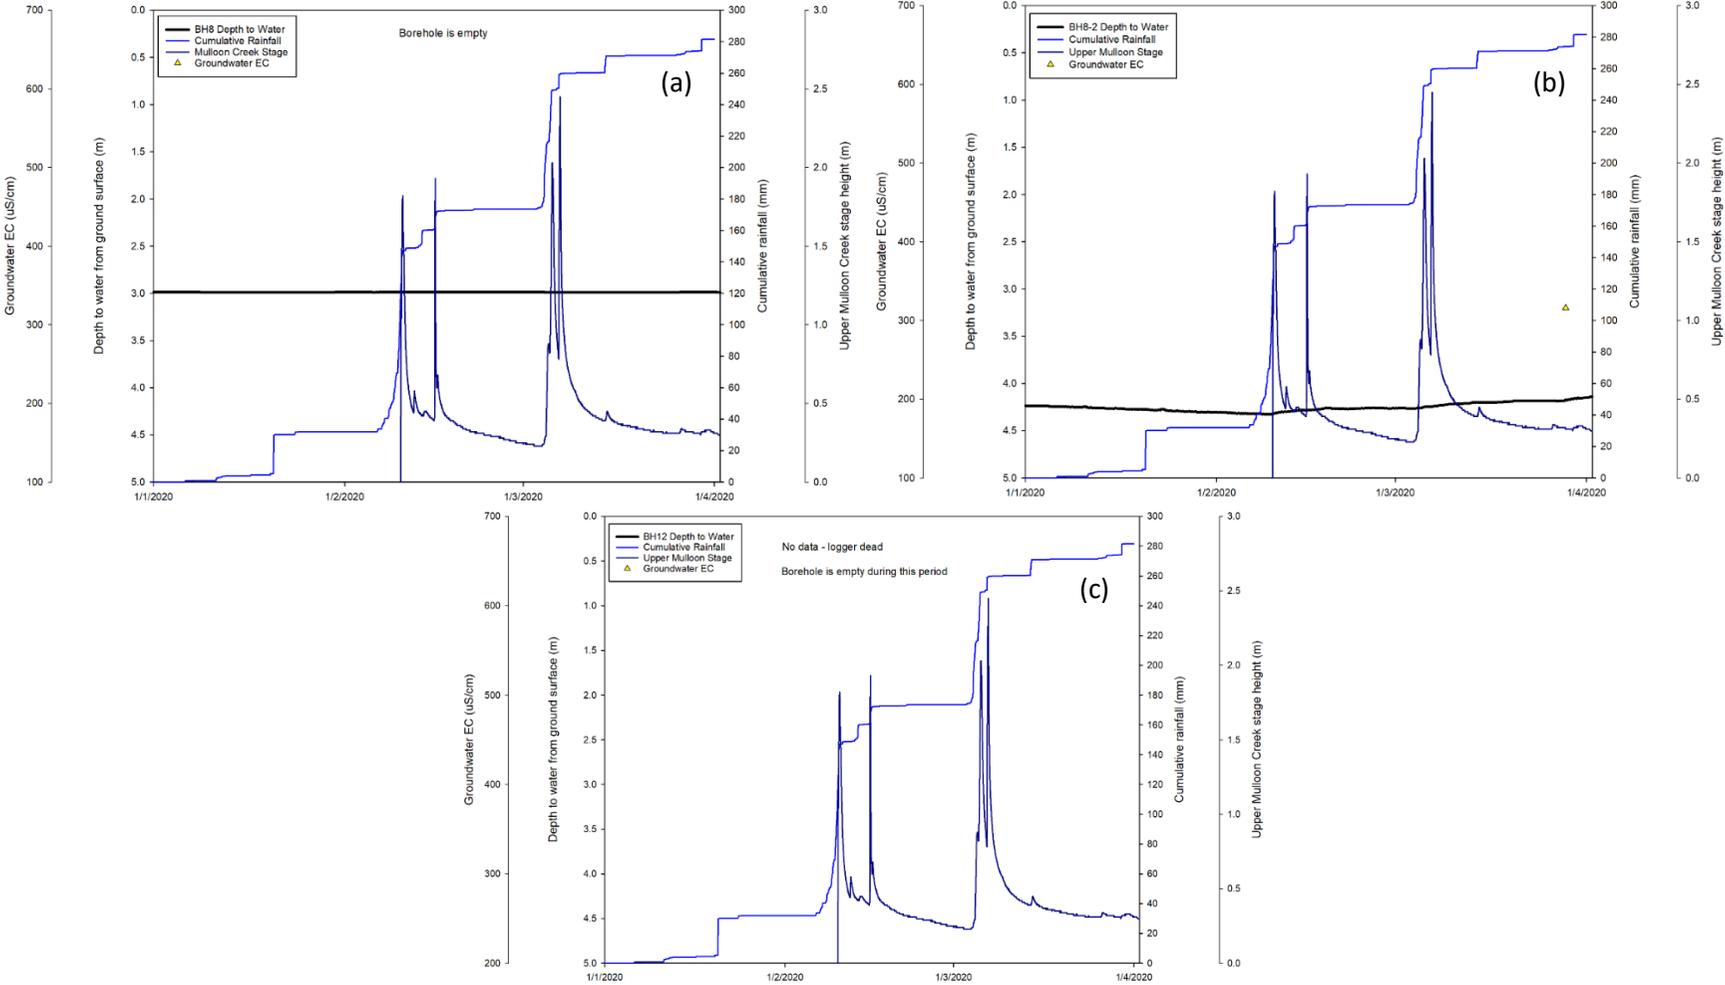
Figure 63. Groundwater Depth (BGL), Cumulative Rainfall, Stream Manual Stage Height, and Groundwater EC from 1 January to 1 April 2020 for Transect A (southern west-east transect): (a) BH11; (b) BH10; (c) BH9, at Mulloon Home Farm.

Figure 63. Groundwater Depth (BGL), Cumulative Rainfall, Stream Manual Stage Height, and Groundwater EC from 1 January to 1 April 2020 for Transect A (southern west-east transect): (d) BH8-1, (e) BH8-2, (f) BH12, at Mulloon Home Farm.

Borehole 12 did not have a sensor recording water level during these events (Figure 63f). Antecedent conditions were extremely dry prior to these rain events.

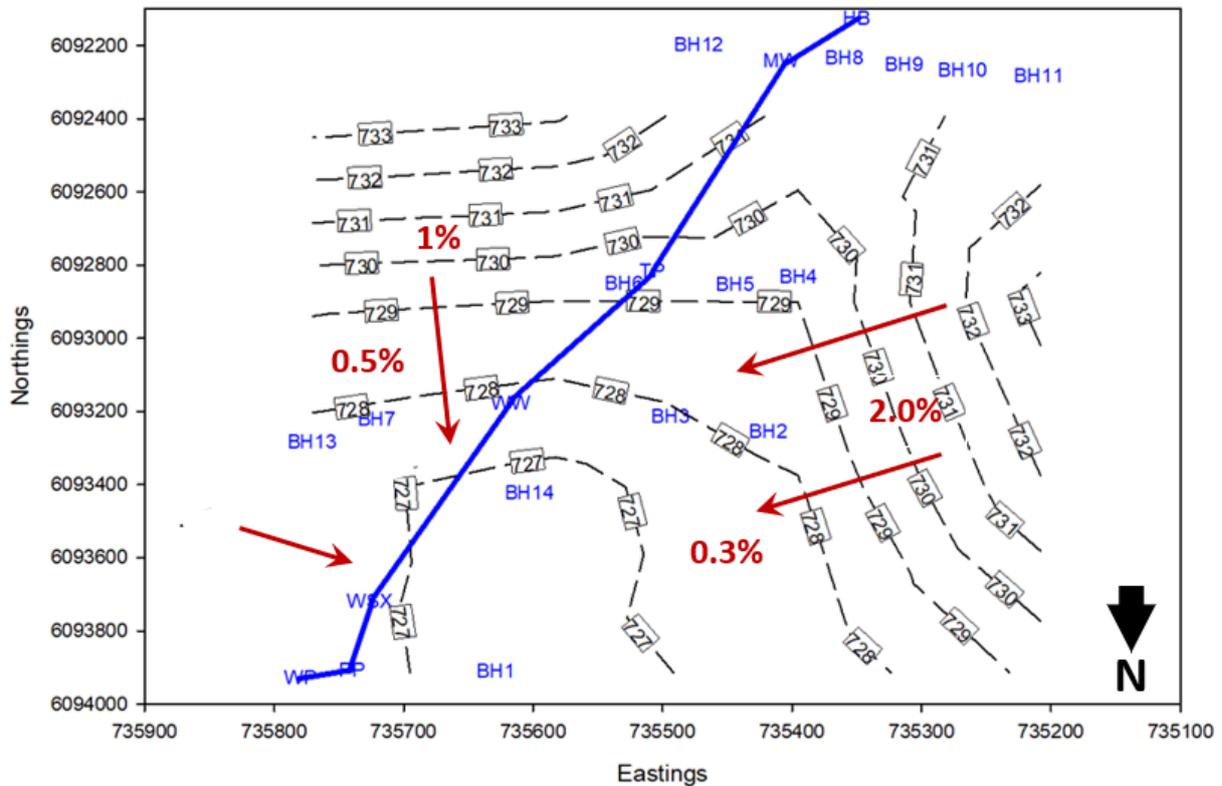
Figure 73. Interpolated potentiometric surface for 15 June 2016 at the Mulloon Home Farm.

Mapping of potentiometric surfaces indicates that the net flux of groundwater (and interflow) in regolith-hosted sequences (weathered rock, colluvial and alluvial sediments, soil) is toward the stream from adjacent hills (the local groundwater flow system). Similar patterns of flow from the hills toward the stream were reflected in measured geochemical signatures in west-east borehole arrays in the adjacent lower Mulloon Creek catchment (de Lorenzo, 2021). This indicates that, although some groundwater recharge can occur due to infiltration at the land surface in low-lying areas - especially in wetter periods, most recharge occurs as flow from higher parts of the landscape to low-lying areas.

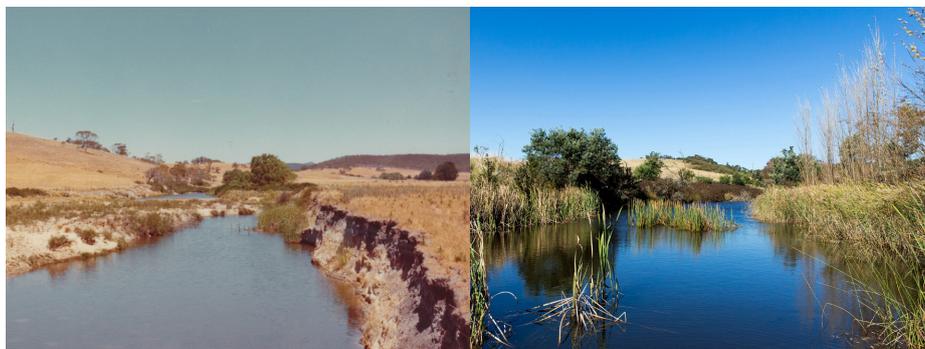
Figure 76. Mulloon Creek upstream of Peter’s Pond in 1977 and in 2015 showing invigorated riparian condition after the emplacement of a leaky weir (TMI, 2024).

Several landscape hydrological strategies have been employed in the Mulloon landscape. However, the foundation of the landscape rehydration program is the establishment of carefully designed and sited in-stream leaky weirs. At the Home Farm, these features modified mid-Mulloon Creek in a manner that paralleled the role of past natural watercourses, including the re-establishment of some chain-of-pond features. Slowing the velocity of the water created conditions that slowed channel incision and bank erosion, improved streambank soil health (hydration) and in-stream water quality, and enabled native vegetation to regenerate, thereby restoring the riparian zone (Figure 76). Measures of floodplain rehydration were equivocal.

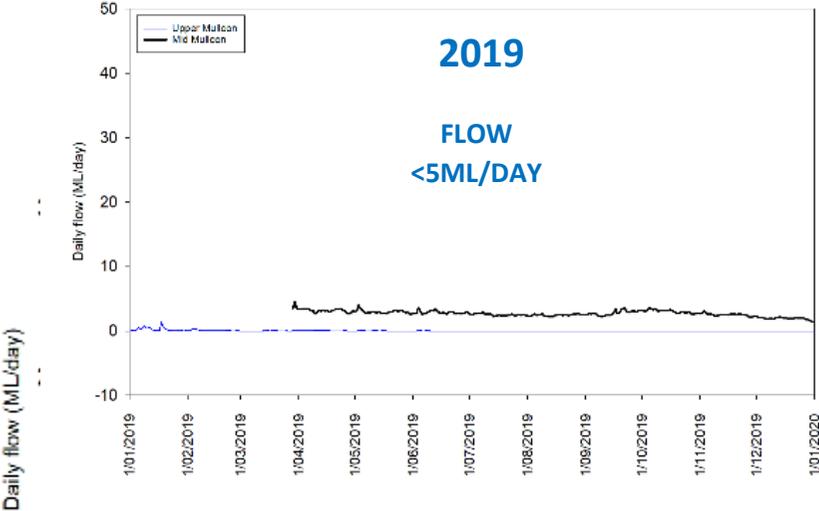
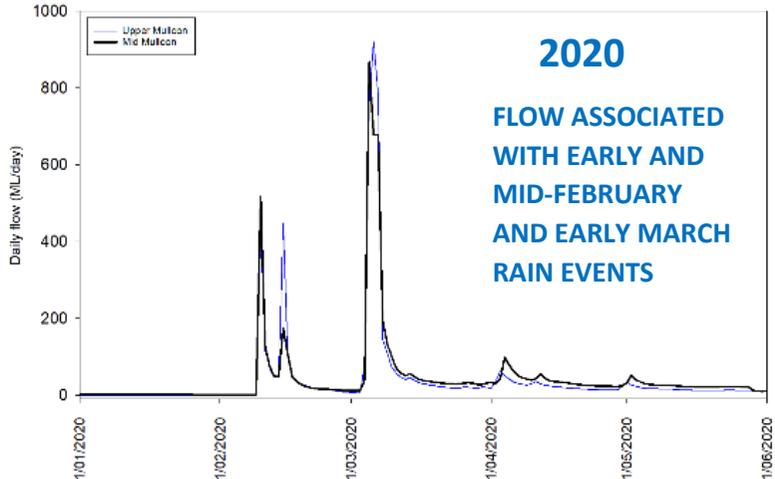
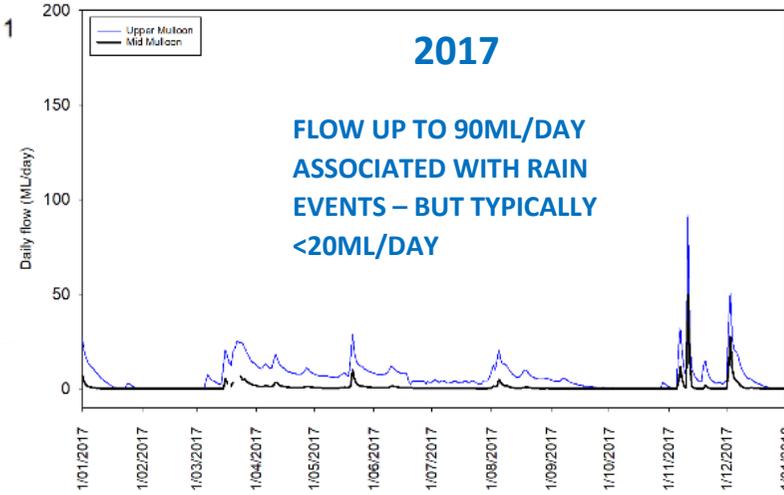
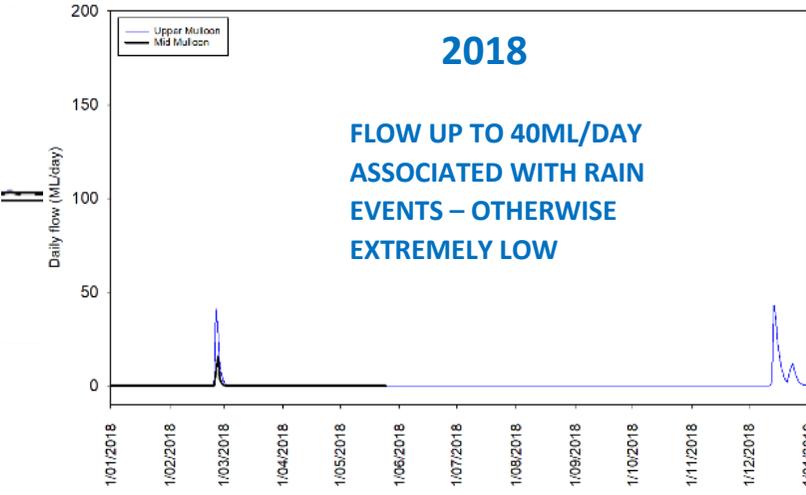
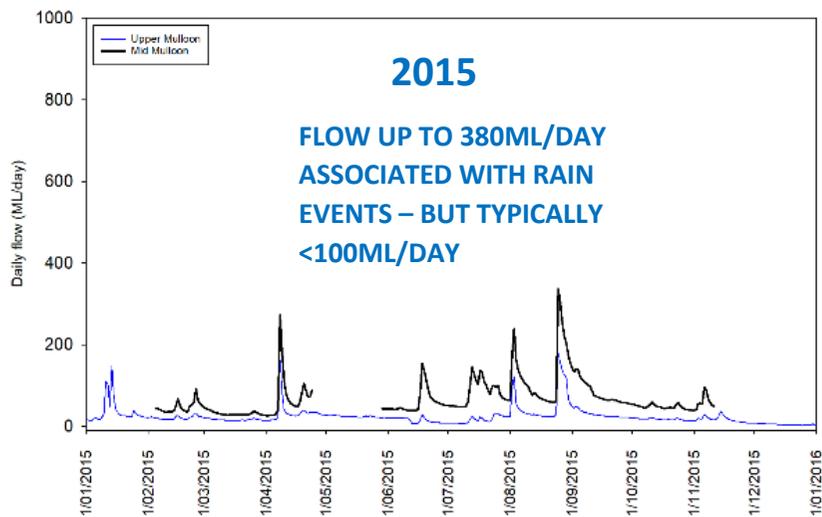
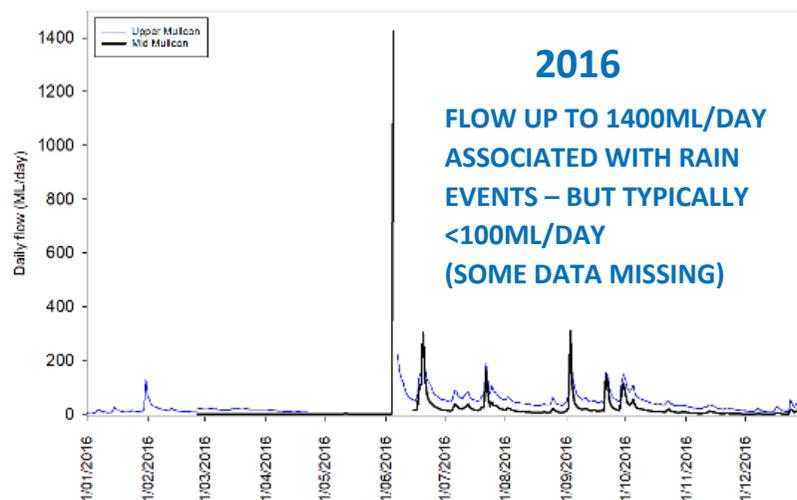
Daily Flow (ML/day) at Black Jackie and Mid-Mulloon River Gauges from 2006 to 2020.

(Note some 2016 data was lost because of an extremely large and sustained rain period in June/July.)
