## Case study: Teale

Property location: Bellmount Forest, NSW  
 Size: 21 hectares  
 Owners: Jim & Liz Teale  
 Project completion: November 2020

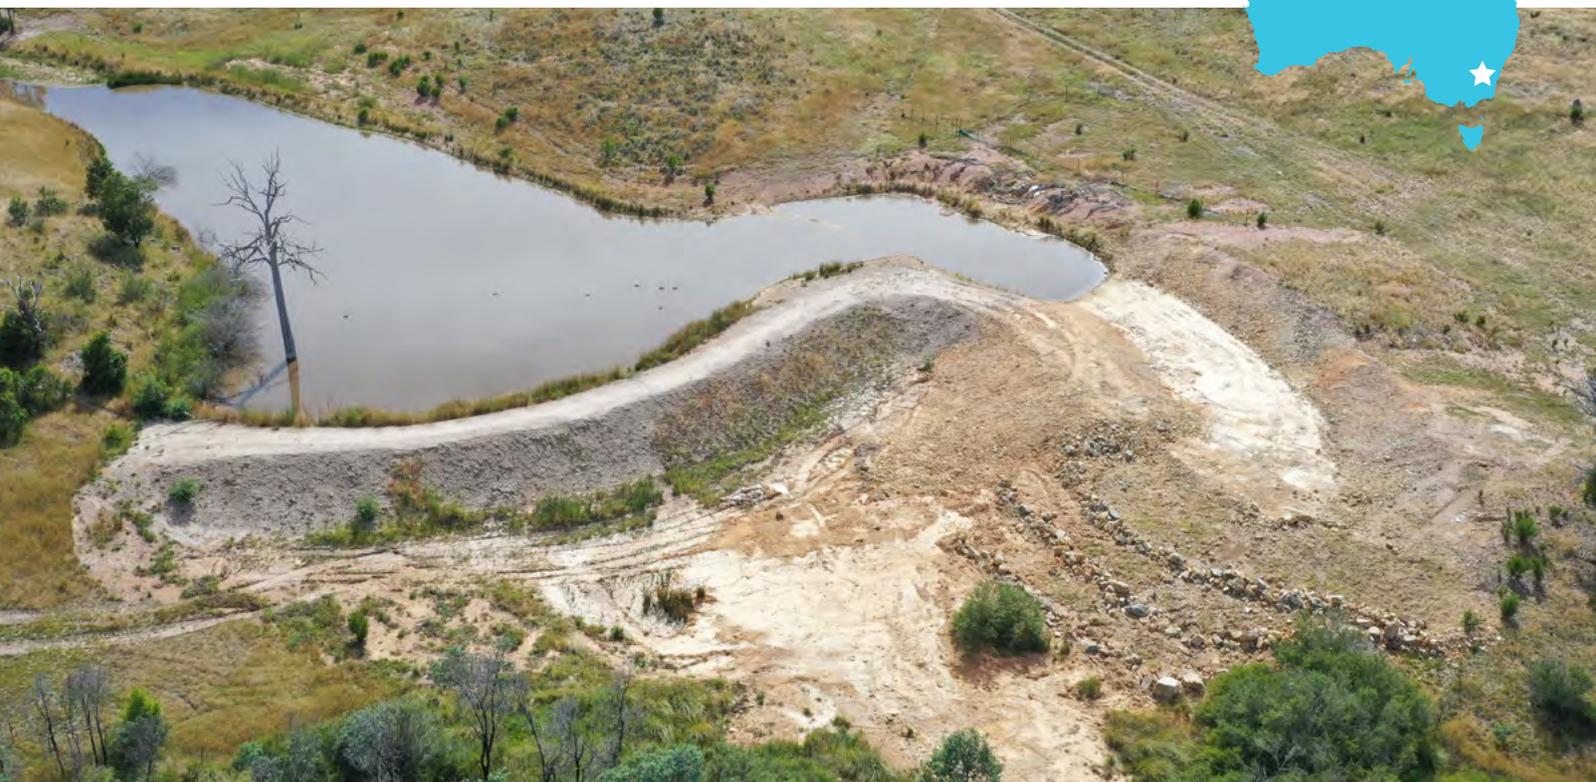
**Top:** After – Lower dam spillway. Completed repair works.  
**Right:** Before – Lower dam spillway. Site prior to on-ground works.
