# Mulloon Creek Fish Survey Autumn 2022

Final report to the Mulloon Institute  
Centre for Applied Water Science  
University of Canberra

Authors: Rhian Clear, Ben Broadhurst, Danswell Starrs and Mark Lintermans

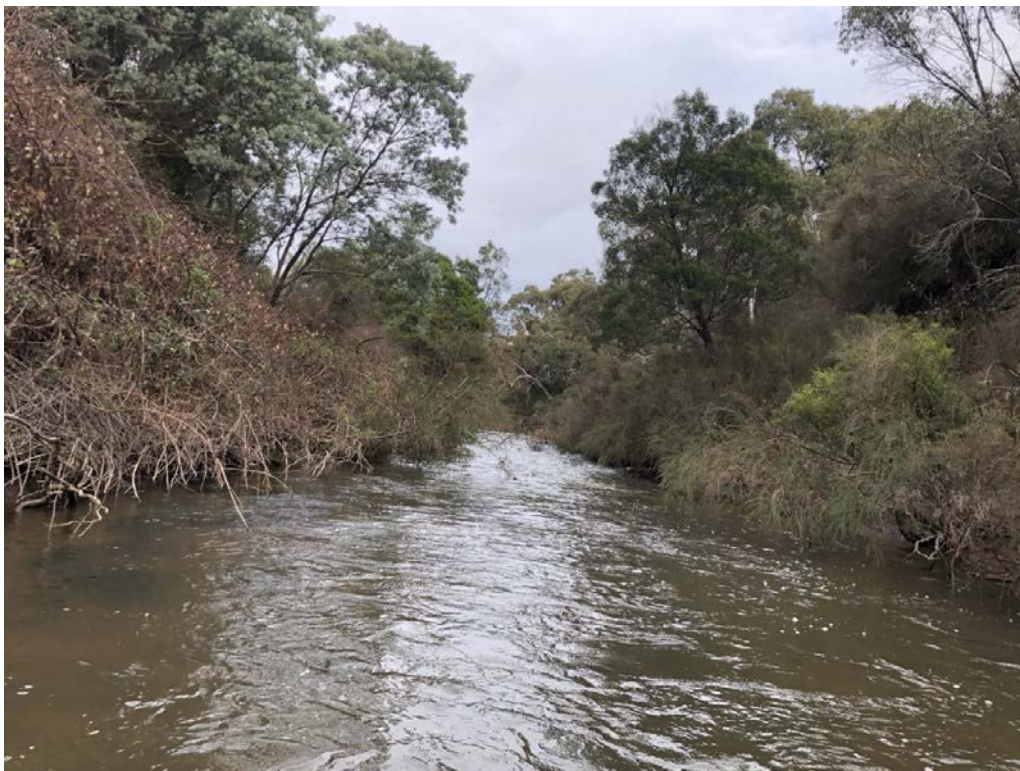
Mulloon Creek Site 1.

Description: The upstream-most site sampled on Mulloon Creek. This site occurs at the downstream end of a large tract of gorge country. At this point the creek is in a deeply (~15-20m) incised channel. Blackberries are the dominant riparian vegetation along this reach. Stream consisted of long pools, and short riffle sequences. The creek height was up and flowing faster at the time of sampling for all sites on Mulloon Creek.

Stream Width: 2-5m wide

Average Stream Depth: 0.75-1m

Substrate Composition: Approximately 50% cobble, 25% sediment and 25% submerged vegetation. Small proportion was bedrock

Other Structure: Large amounts of drowned timber and large boulders and bedrock structures.

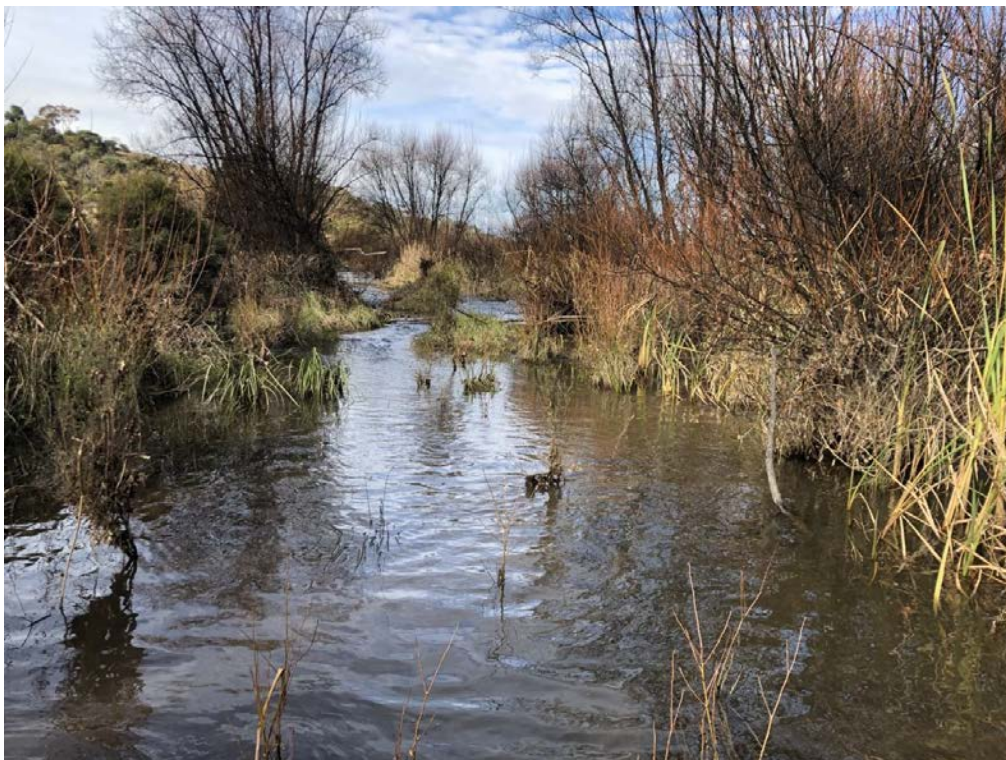
Mulloon Creek Site 2.

Description: The second site sampled on Mulloon Creek. This site occurs downstream of the homestead and is situated downstream of what was the first leaky weir in the system. It is now situated below an additional 10 leaky weirs since the first survey was conducted in 2016. The weir pool was sampled with the bait traps. Consisted of very long pools and runs, with very minimal riffle habitat. Willows are the dominant riparian vegetation. Considerable stands of tall emergent macrophytes present, and very dense submerged vegetation throughout this reach.

Stream Width: ~3-5m wide

Average Stream Depth: 0.5-0.75m

Substrate Composition: Primarily sediment and submerged vegetation. Very small amounts of cobble, with proportionally more cobble in the upstream riffle section of this reach.

Emergent Macrophytes: Large stands greater than 2m wide. Height of the emergent vegetation is greater than 1m.

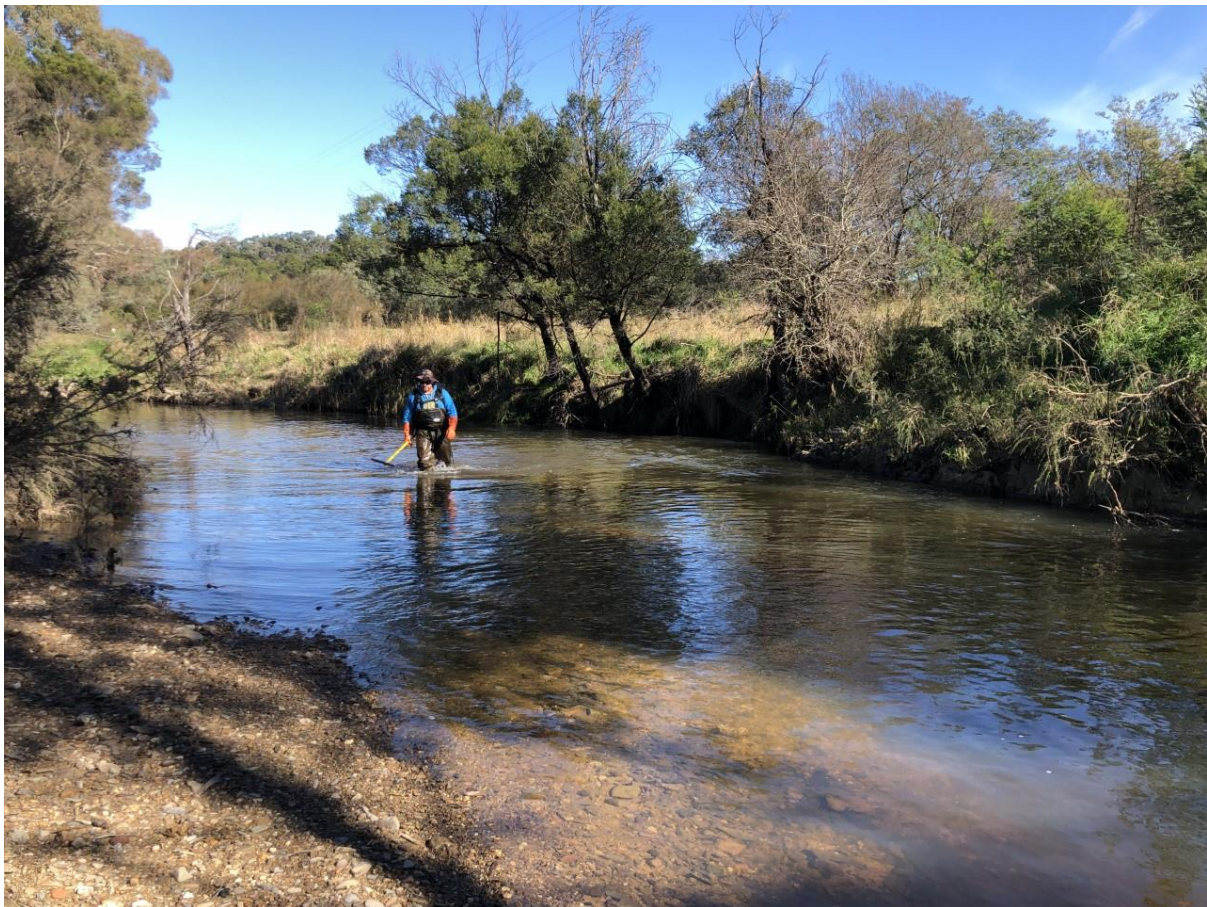
Mulloon Creek Site 3.

Description: The third site sampled on Mulloon Creek. This reach occurs on the downstream side of Mulloon Road. The bait traps were set in the large pool on the upstream side of the road crossing. This reach is wide with considerable shallow sections. Native vegetation dominates in this reach.

Stream Width: ~5-10m wide

Average Stream Depth: 0.75-1m at the downstream end, but shallower (< 0.5m) closer to the road crossing.

Substrate Composition: Sediment, sand and cobble dominated in this reach. Some submerged vegetation in places, and predominantly cobble up near the road crossing.

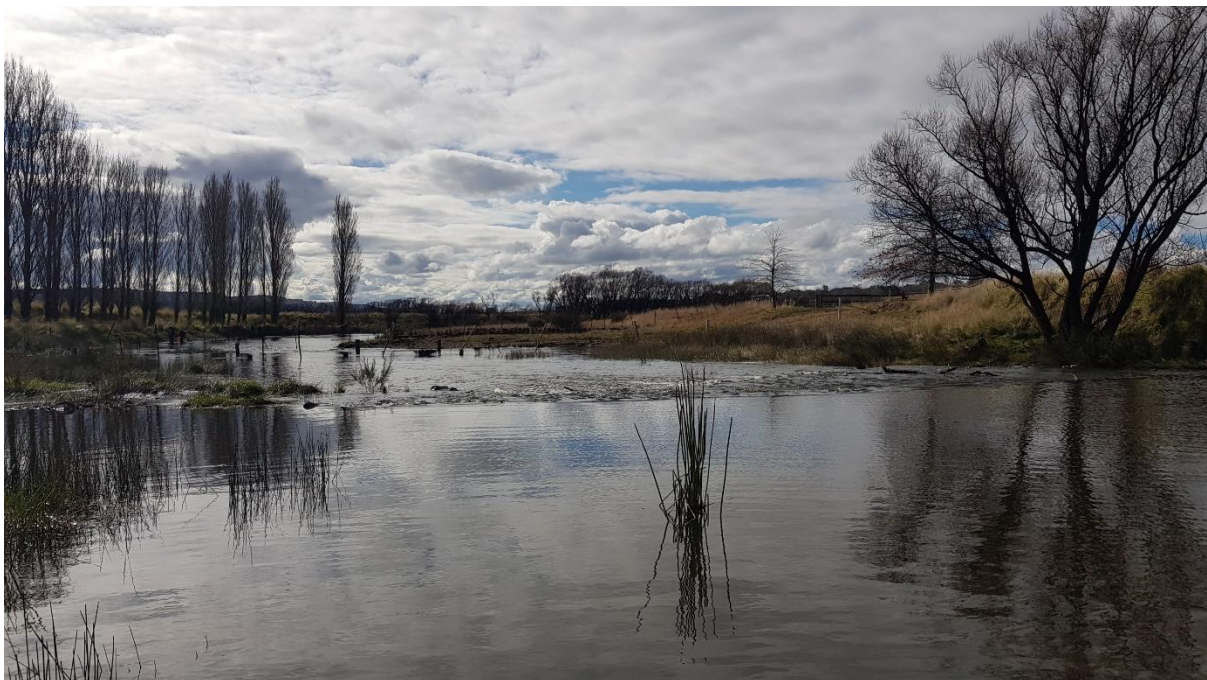
Mulloon Creek Site 4.

Description: The fourth site sampled on Mulloon Creek. This site is on the north side of the Kings Highway, off Hazeldell Road on Palarang crossing near homestead. The reach is immediately downstream of a leaky weir, with the bait traps set in the weir pool at the upstream end of the reach. This reach was wide and with moderate flow with very dense submerged vegetation in sections. Riparian zone greatly depleted, consisting of willows and blackberries where present.

Stream Width: ~8-12m wide

Average Stream Depth: Varied between 0.5-1m at the downstream end, but shallower (< 0.5m) closer to the road crossing.

Substrate Composition: Sediment, cobble and sand dominated in this reach.

Emergent Macrophytes: Emergent macrophytes present along the edges below the weir and dense emergent macrophytes in the weir pool.

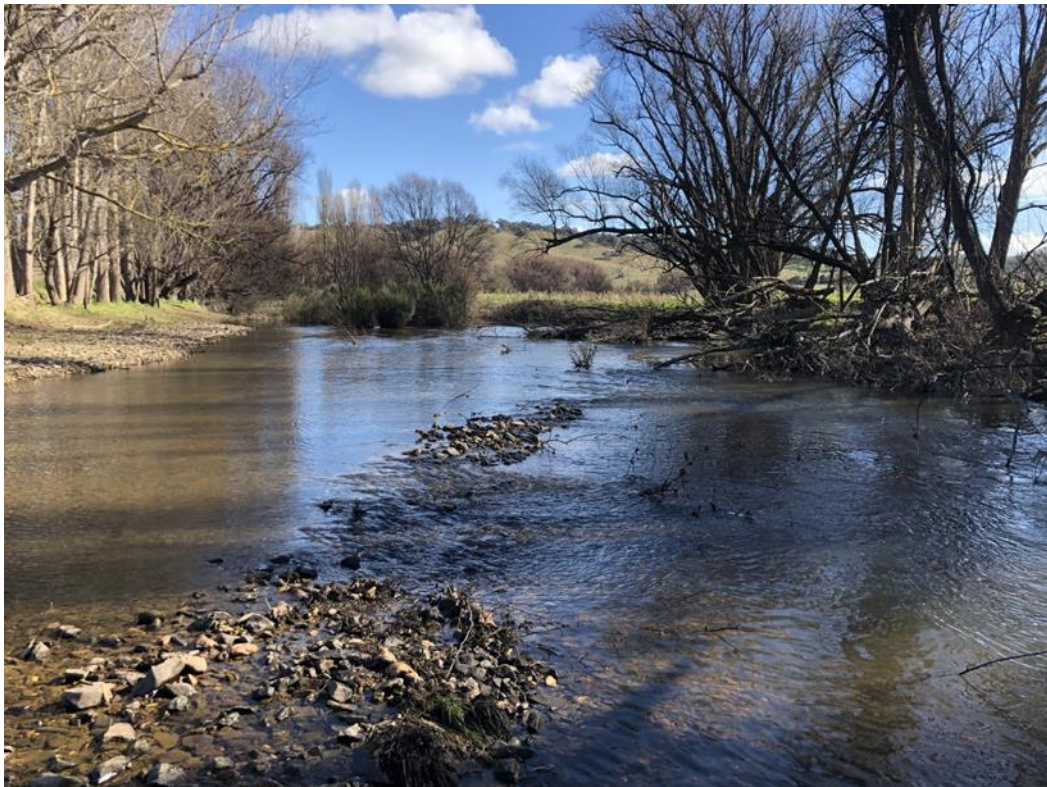
Mulloon Creek site 5.

Description: The fifth site sampled on Mulloon Creek. This reach occurs near the confluence of Mulloon Creek and Sandhills Creek. The bait traps were set in a pool at the downstream end of the weir and upstream of the crossing (see pic.). Willows, blackberries and large stands of emergent vegetation dominated the riparian zone.

Stream Width: ~3-10m wide

Average Stream Depth: 0.5-1.2m.

Substrate Composition: Substrate highly variable. Cobble present in the previously riffle sections, while pools consisted of sediment, sand and submerged vegetation.

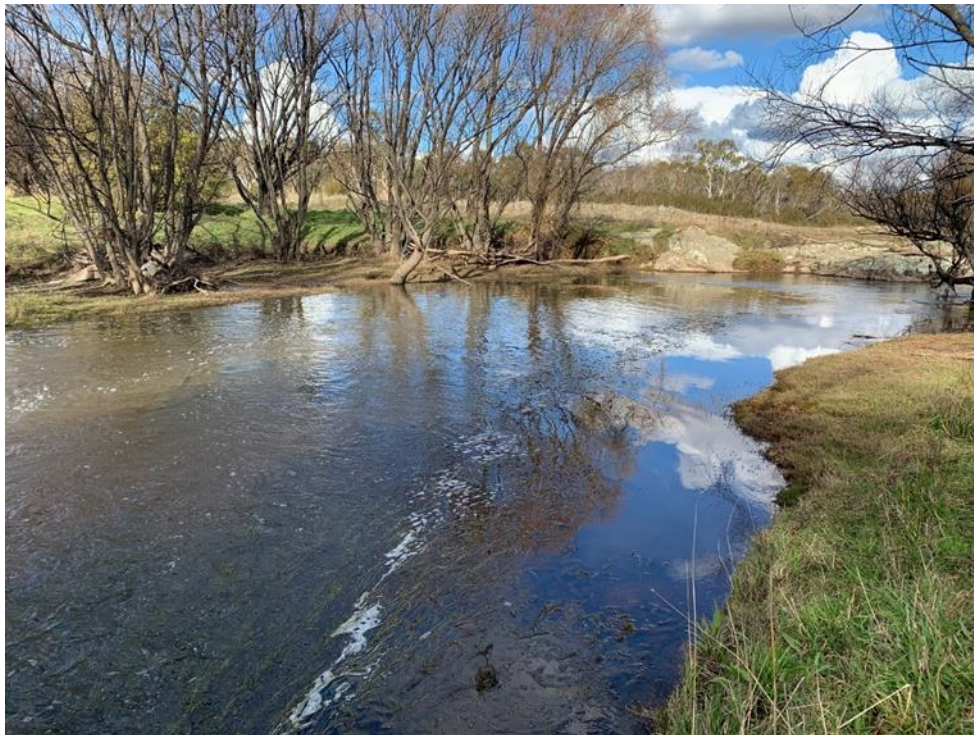
Mulloon Creek site 6.

Description: The downstream-most site sampled on Mulloon Creek. This reach occurs downstream of the confluence of Mulloon Creek and Sandhills Creek. The bait traps were set in the pool where the water quality station is located at the downstream end of this reach. Willows, blackberries and large stands of emergent vegetation dominated the riparian zone.

Stream Width: ~5-10m wide

Average Stream Depth: 0.75 to >1m.

Substrate Composition: Consisted primarily of silt, sand and cobble and submerged vegetation.

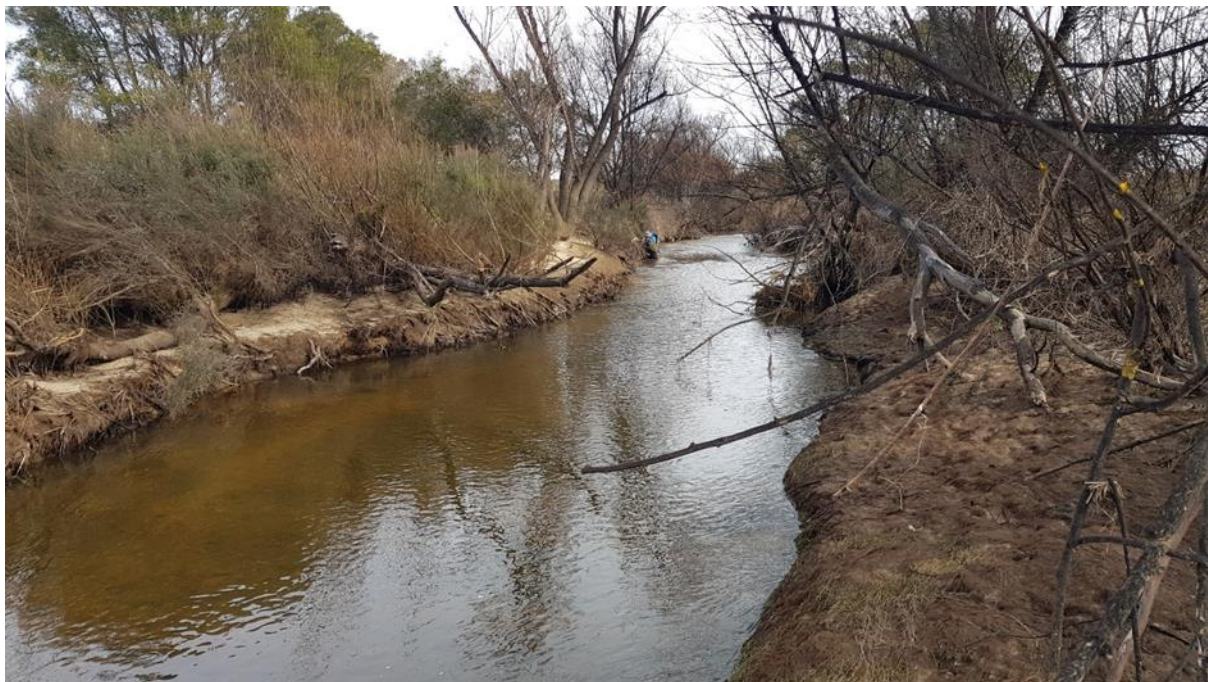
Reedy Creek at Mayfield Road crossing.

Description: This site occurs on the downstream side of the Mayfield Road crossing of Reedy Creek. This reach is heavily overgrown with native understorey, willows and blackberries. Channel is quite wide in places, but stream greatly restricted within this region. Flow was moderate at the time of sample and had recently receded after high flows from heavy rainfall.

Stream Width: ~5-10m wide

Average Stream Depth: 0.6 - >1m.

Substrate Composition: Consisted primarily of cobble, sand and sediment.

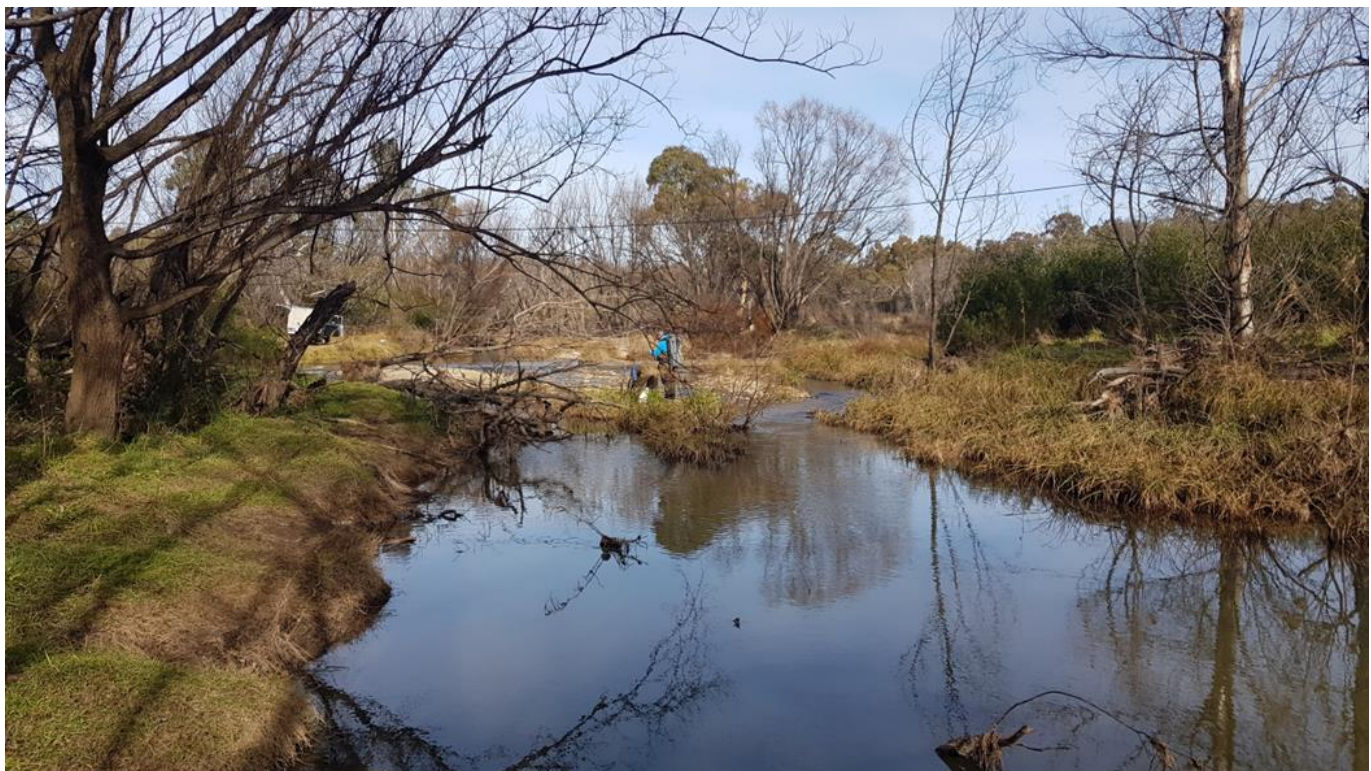
Bombay Creek at Hoskinstown Road crossing.

Description: This site occurs on the downstream side of the Hoskinstown Road crossing of Bombay Creek. This reach has a dense native and willow canopy.

Stream Width: ~5-10m wide

Average Stream Depth: 0.75-1m

Substrate Composition: Primarily sediment, with small amounts of cobble and submerged vegetation.

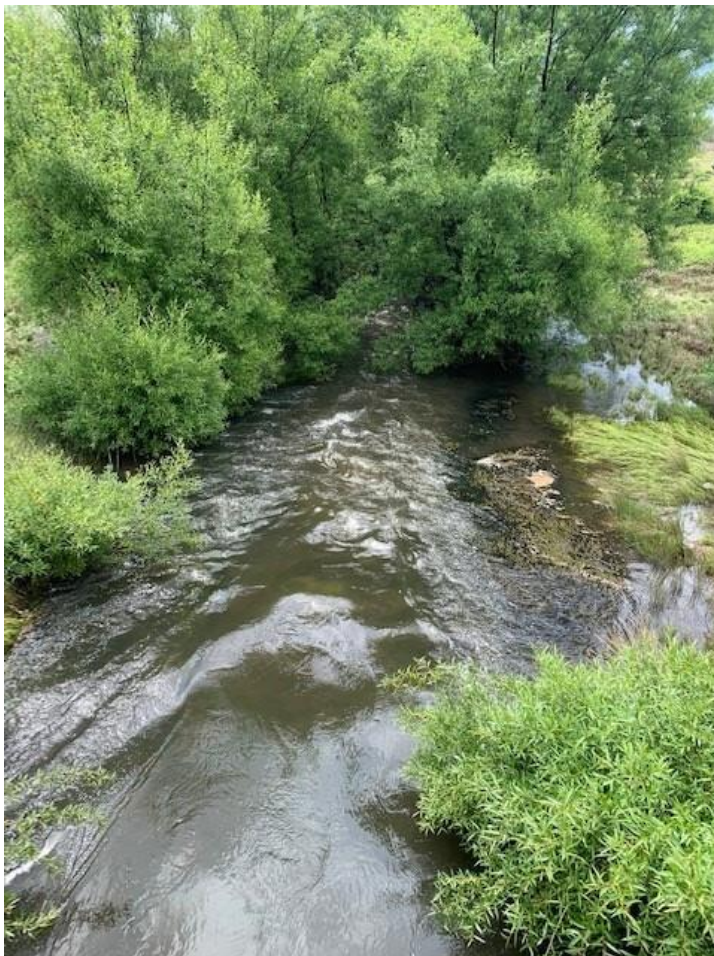
Jembaicumbene Creek at Cooma Road crossing

Description: This site occurs on the downstream side of the Cooma Road crossing of Jembaicumbene Creek. The bait traps were set in the pool underneath the bridge and upstream of the bridge. This reach has a Willow canopy and numerous Willows instream and thick blackberry understorey.

Stream Width: ~5-10m wide

Average Stream Depth: Deep, >1m.

Substrate Composition: Downstream end consisted primarily of sediment, while upstream end made up of sediment, cobble and submerged vegetation.
